SUMMARY
1234 Main Street Waco TX 76712
Buyer Name
01/26/2024 9:00AM

Jose Caraballo
TREC #25913
Rook Home Inspections LLC
(254) 856-3371
rookinpections@gmail.com

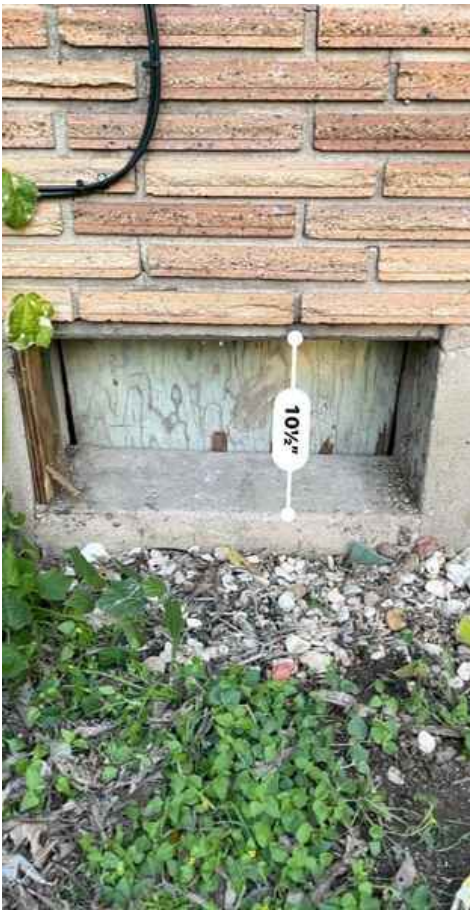
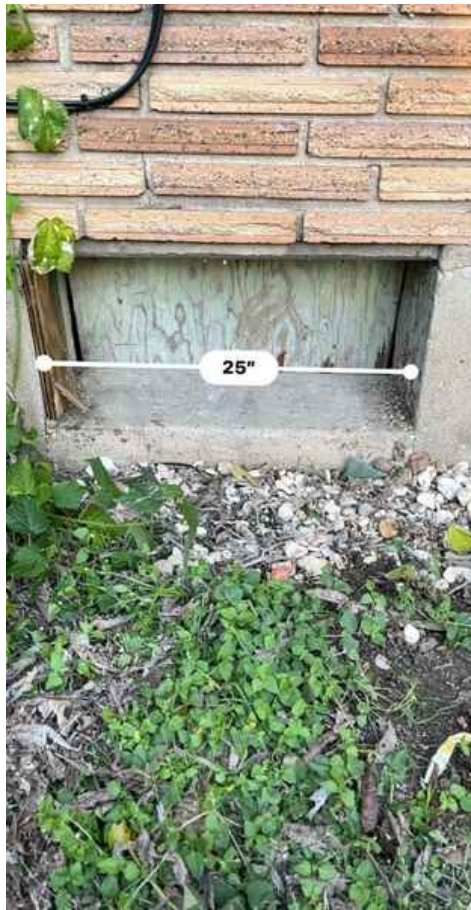
West- Crawl space Opening

CRAWLSPACE ACCESS INADEQUATE

Access to the crawlspace is inadequate or unsafe. The minimum dimensions for access opening should be 18x24 inches (floor) or 16x24 inches (wall). This limits the inspector's ability to enter and view the components within the area of the crawlspace. Inspector's findings are based on limited access, visibility, and best judgment.

Recommendation
Contact a qualified professional.

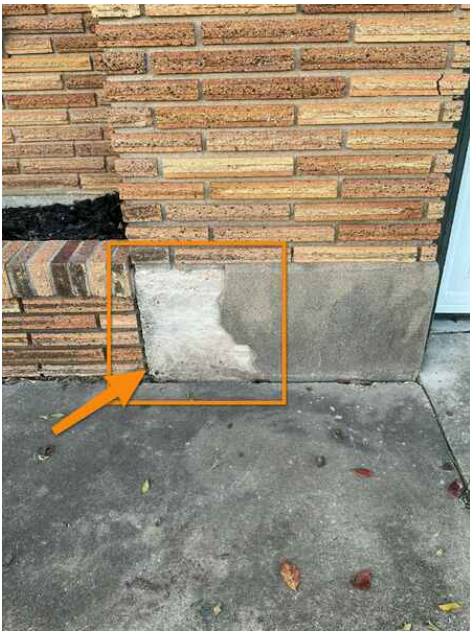
East- Garage

SPALLING

The foundation is spalling at one or more areas. Spalling is the breakdown of concrete from natural weathering and/or chemical reaction that results in sections of cement chipping off the main body; often resulting in fractured, compromised concrete. This is considered a cosmetic issue. If you desire to correct the issue, I recommend a concrete specialist evaluate and repair it if needed.

Contact a qualified general contractor.

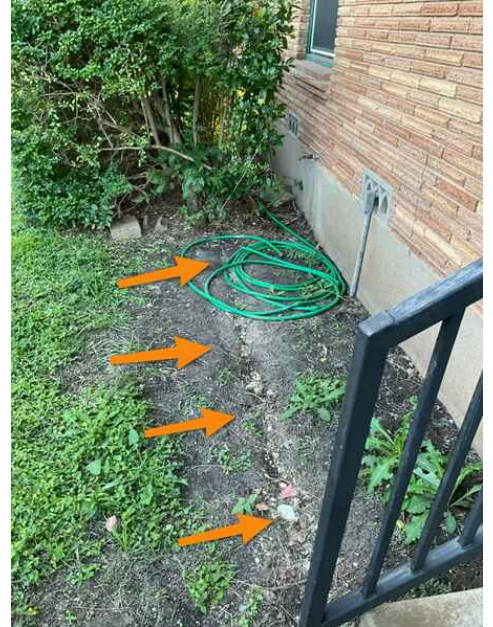
Southeast

There is evidence of soil erosion at various locations around the property. In this case, the lack of gutters and downspouts appears to be eroding the soil beneath the roof and creating a trough around the property. I recommend a qualified contractor evaluate and install gutters and downspouts. Backfill may be needed to replace the eroded soil.

Recommendation
Contact a qualified professional.

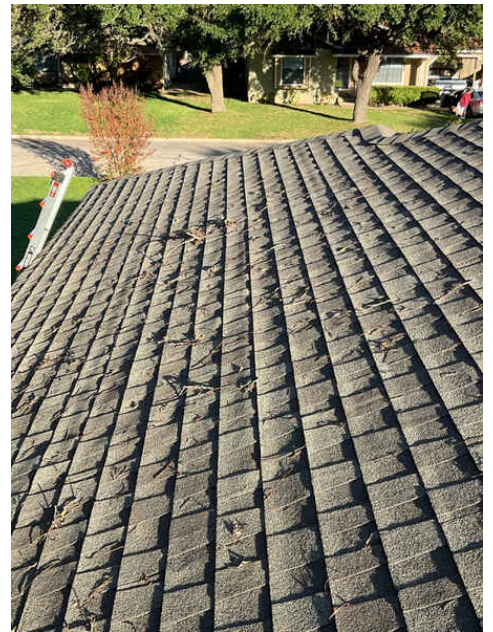
North Roof

The roof surface has standing debris in some areas. This can lead to damaged shingles and moisture intrusion if not corrected. I recommend clearing the debris to allow for water to be shed from the roof as intended.

Recommendation
Contact a qualified professional.

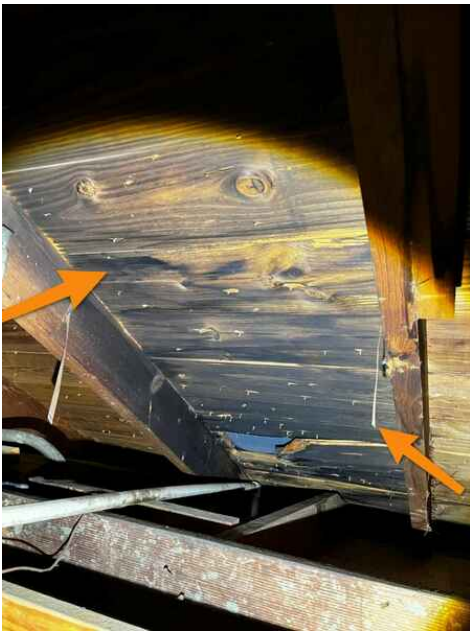
Attic

There is evidence of water intrusion on the rafters in the attic space. Water stains are visible in several areas. These may have been from a previous problem that is now resolved or an ongoing issue. I recommend a licensed roofer evaluate and repair as needed.

Contact a qualified roofing professional.

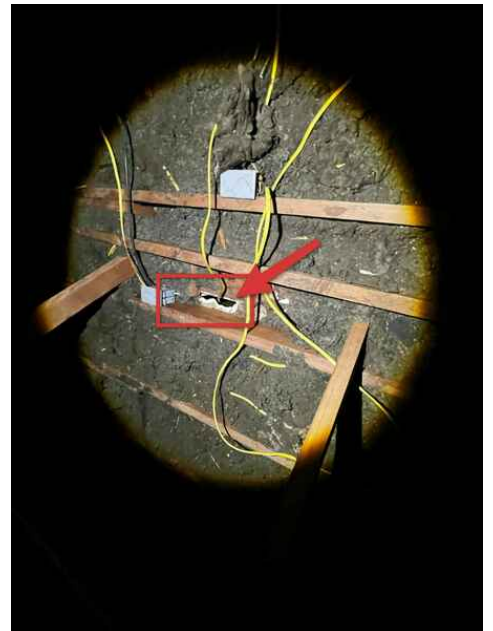
Attic

2.4.3 D. Roof Structures and Attics
**FIRE SEPARATION INADEQUATE/
DAMAGED**

The fire separation in the attic was observed to be inadequate or damaged. Adequate fire separation is crucial in protecting the home and its occupants by containing the spread of fire and providing valuable time for evacuation. The absence of proper fire separation in the attic poses a potential risk, as fire could rapidly progress through concealed spaces and compromise the structural integrity of the building. I recommend a qualified professional evaluate and repair as needed.

Recommendation
Contact a qualified professional.

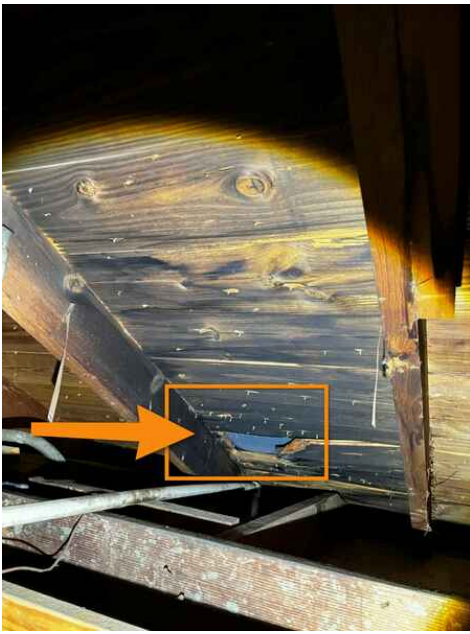
Attic

2.4.4 D. Roof Structures and Attics
ROOF DECKING DAMAGED

The roof decking was observed to be damaged in one or more areas at the time of the inspection. The roof decking, a critical component of the roofing system, provides structural support and a base for roofing materials. Visible indicators of roof decking damage may include sagging, bowing, holes or missing parts, or areas of deterioration such as rot, water stains, or mold growth. Such damage can result from various factors, including water leaks, prolonged exposure to the elements, or inadequate ventilation. I recommend a licensed roofing contractor evaluate and repair as needed.

Recommendation
Contact a qualified roofing professional.

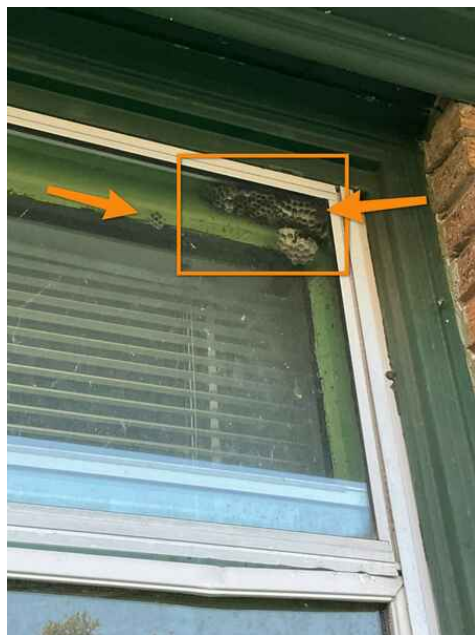
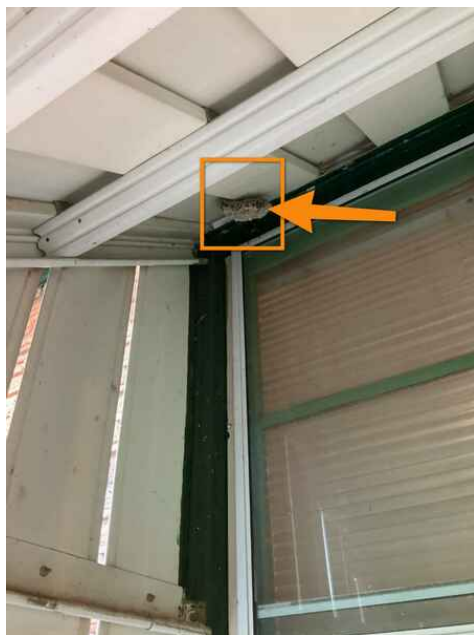
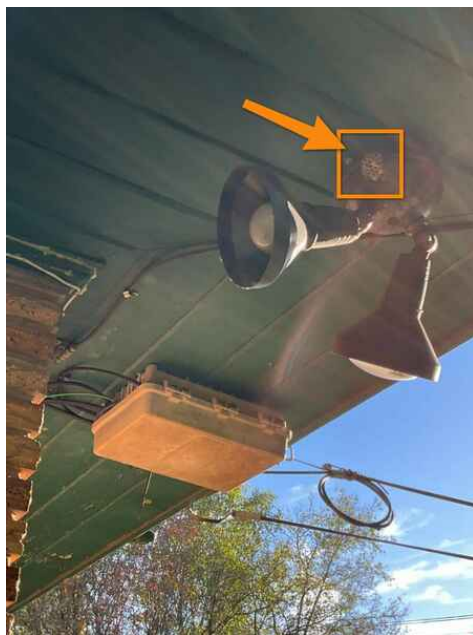
During the inspection, it was observed that there are insect nests present on the exterior of the house. Insect nests can pose both structural and aesthetic concerns, as well as potential health hazards. I recommend a licensed exterminator evaluate and remediate the concern.

Contact a qualified pest control specialist.

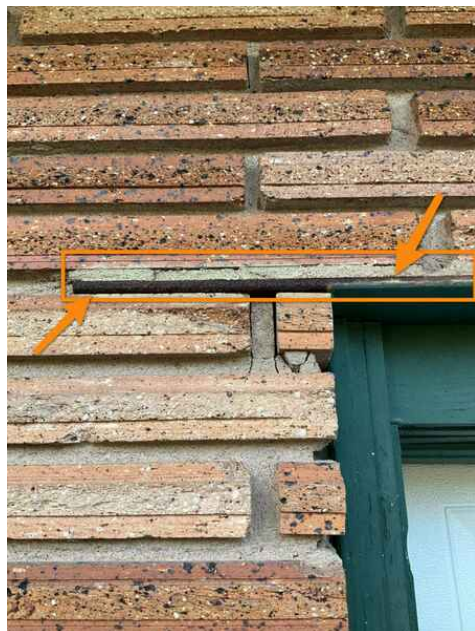
Lintel

One or more lintels are exposed and/ or damaged in various locations. A lintel is a structural element that spans the top of an opening in a building, providing support to the masonry or load above the opening. It acts as a horizontal beam, distributing the weight from above to the vertical supports (such as columns or walls) on either side of the opening. They are typically made of durable materials, such as steel, concrete, stone, or wood, depending on the structural requirements and the design of the building. Steel lintels shall be shop coated with a rust-inhibitive paint, except for lintels made of corrosion-resistant steel or steel treated with coatings to provide corrosion resistance. I recommend a qualified contractor evaluate and repair as needed.

Contact a qualified professional.

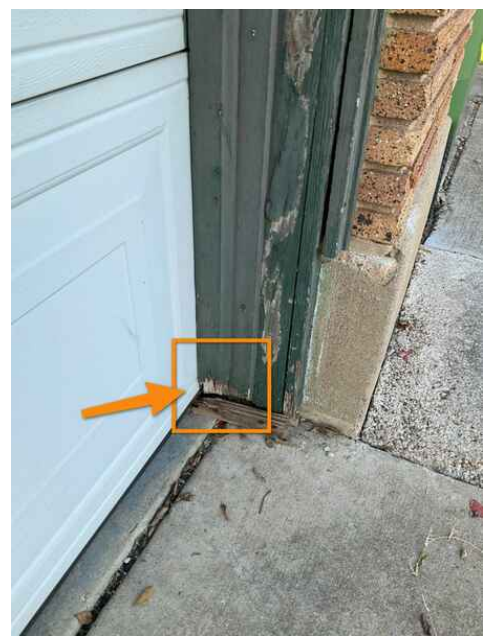
Garage

TRIM DAMAGED- EXTERIOR

During the inspection, it was noted that there was damage to the exterior trim in one or more areas. Exterior trim damage can result from exposure to the elements, pests, or general wear and tear. Neglecting to address exterior trim damage may lead to further deterioration, potential issues with water infiltration, and diminished curb appeal.

Recommendation
Contact a qualified professional.

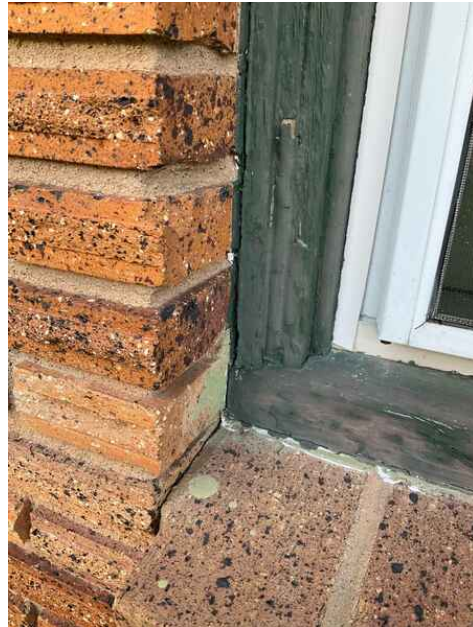
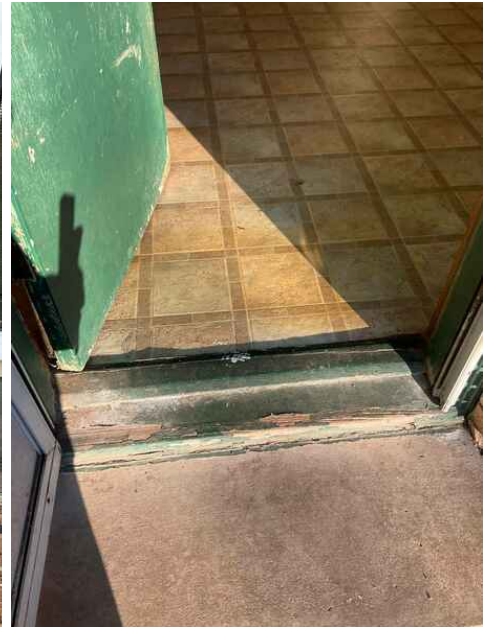
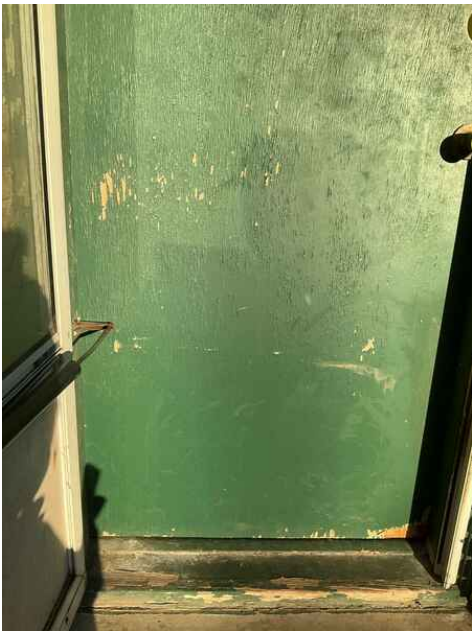
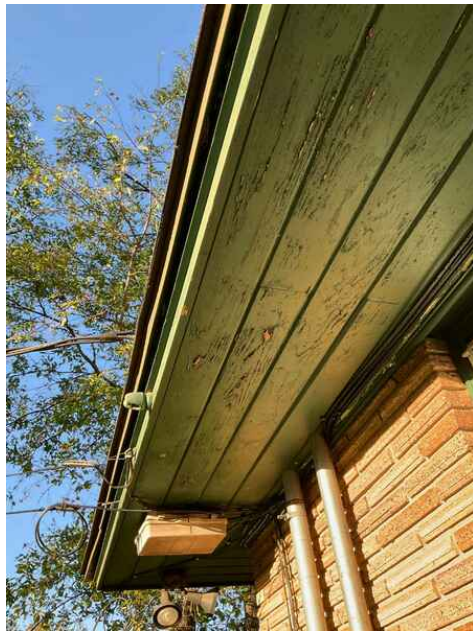
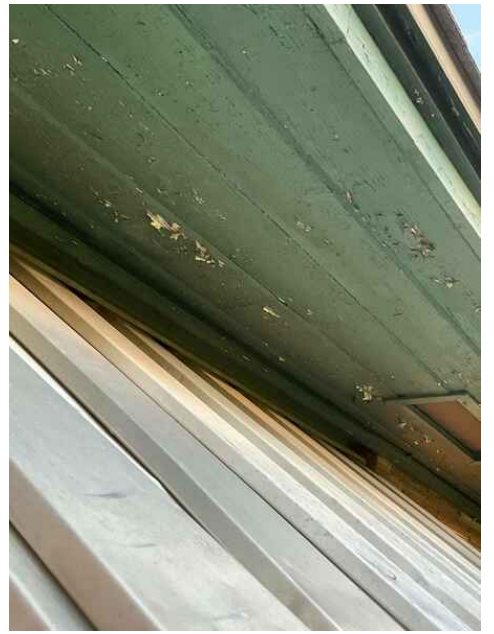
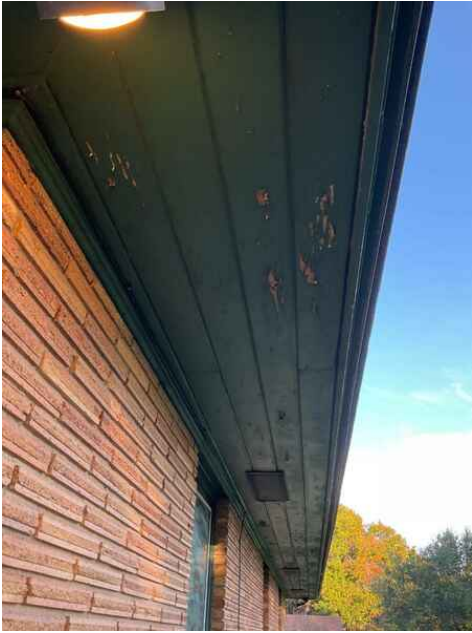
PAINT FAILING/ MISSING- EXTERIOR

During the inspection, it was noted that there are areas where the paint is failing or missing. The integrity of exterior paint is crucial for protecting surfaces from weathering, moisture, and UV damage. Neglecting to address failing or missing paint may result in further deterioration of surfaces, potential structural damage, and diminished aesthetic appeal. I recommend repainting exterior surfaces as soon as possible.

Recommendation
Contact a handyman or DIY project

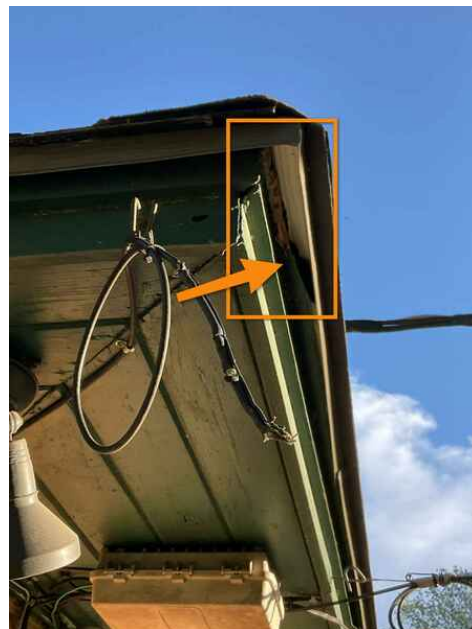
Fascia Board

FASCIA BOARD MISSING/ DAMAGED

During the inspection, it was observed that the fascia board was missing or damaged in one or more areas. The fascia board is a critical component for protecting the roof structure and enhancing the aesthetic appeal of the property. Neglecting to address missing or damaged fascia boards may lead to issues such as water infiltration, structural damage, and compromised roof integrity. I recommend a qualified contractor evaluate and repair as so soon as possible.

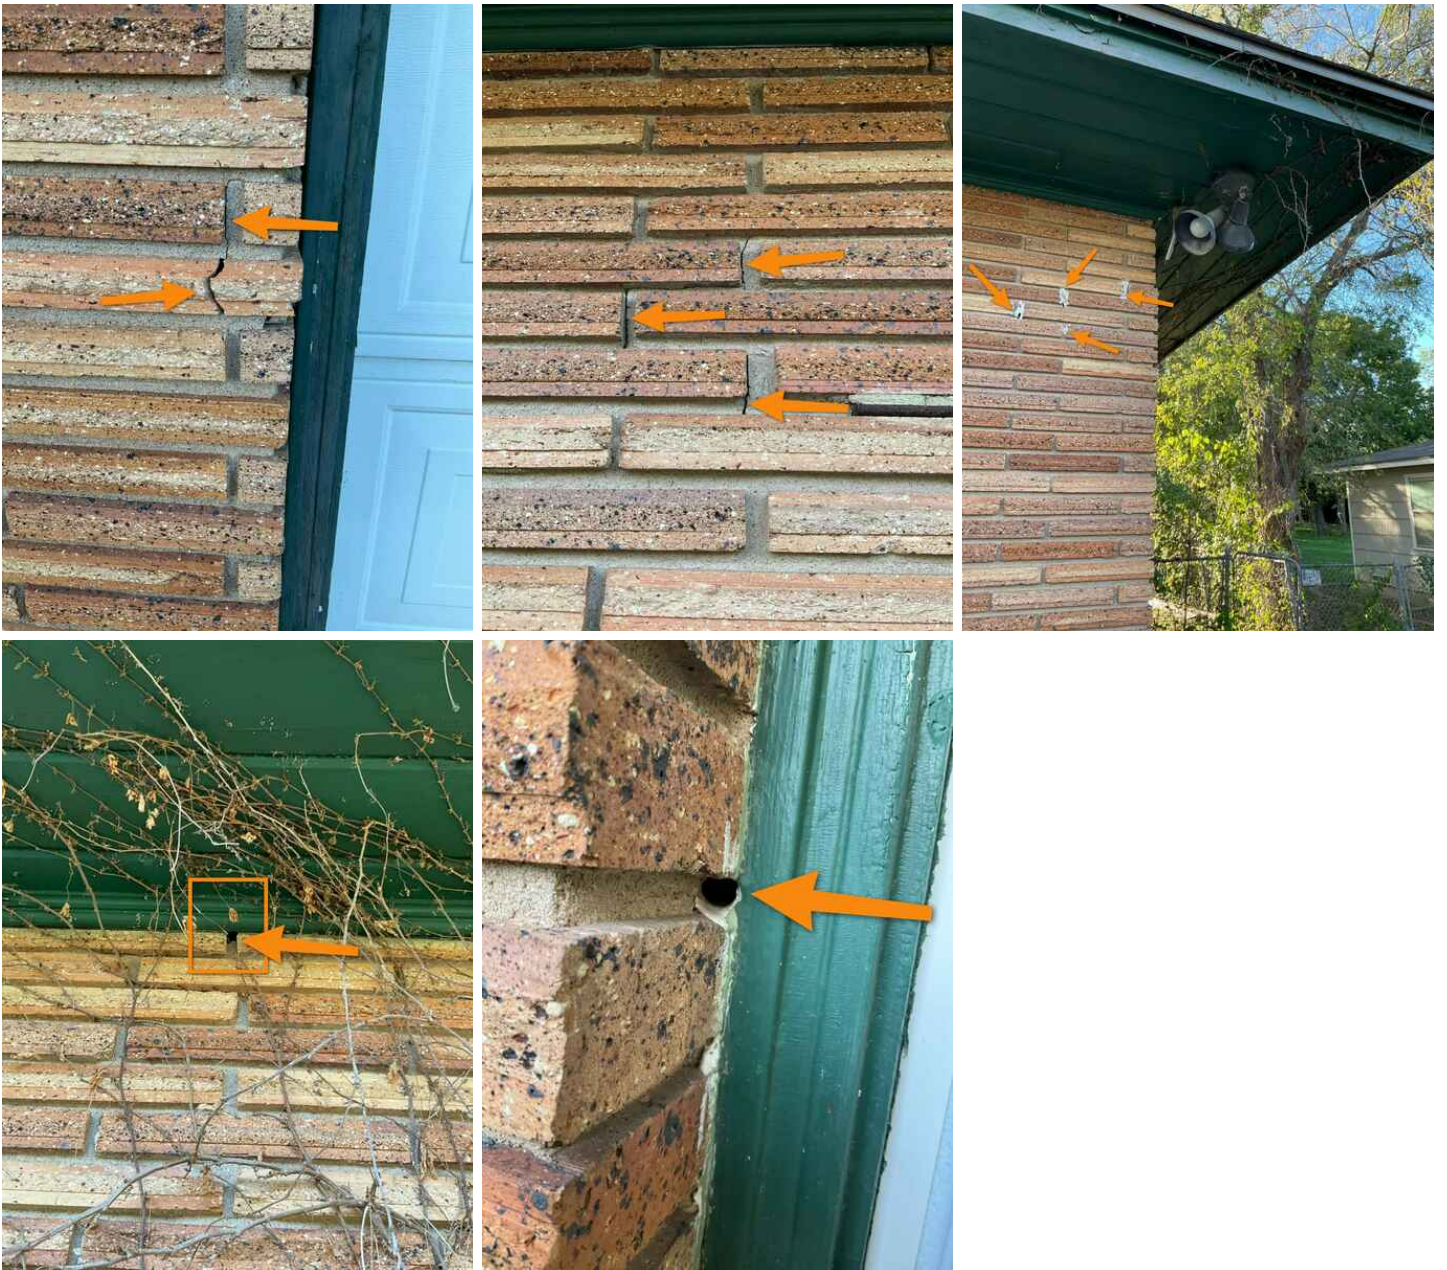
CRACKS IN BRICK/ MORTAR

During the inspection, cracks in the brick and mortar were identified in one or more areas. The presence of cracks in the brickwork and mortar joints can result from various factors, including settling, temperature fluctuations, or structural movement. Neglecting to address cracks in brick and mortar may lead to further deterioration, water penetration, and potential issues with structural stability. Cracks greater than 1/4 inch wide can indicate structural concerns. I recommend monitoring the cracks.

* If the cracks increase in size and width, contact a licensed structural professional for consultation.

Contact a qualified siding specialist.

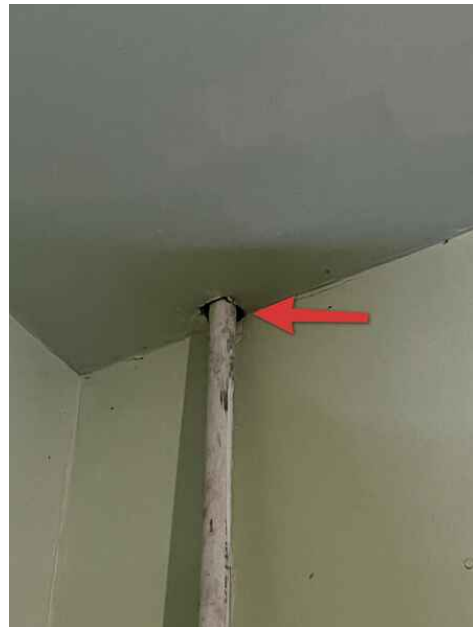
Ceiling Fire Separation

The firewall separation (gypsum board) between the habitual space and the second floor was observed to be missing in one or more locations. The firewall is intended to slow the spread of fire from the habitual space to the attic. The ceiling must be separated by a minimum of 1/2" drywall (gypsum board). I recommend a qualified professional evaluate and repair as needed.

Recommendation
Contact a qualified professional.

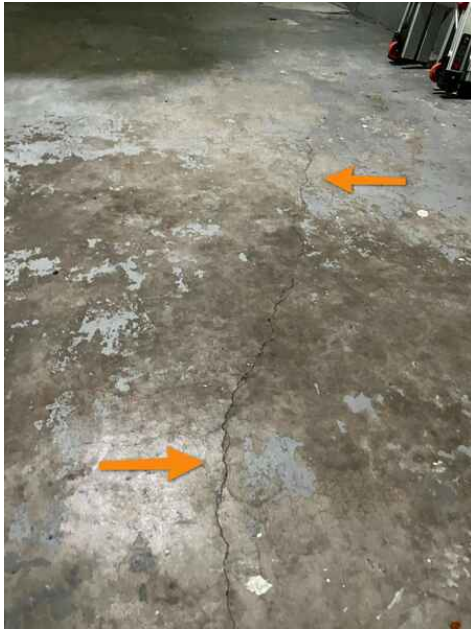
Garage Floor

2.6.3 F. Ceilings and Floors
GARAGE FLOOR- SETTLEMENT CRACKS

The concrete floor of the garage is cracked in areas. These cracks appear typical and do not seem significant. I recommend a qualified contractor be consulted for further evaluation and repair as needed.

Recommendation
Contact a qualified professional.

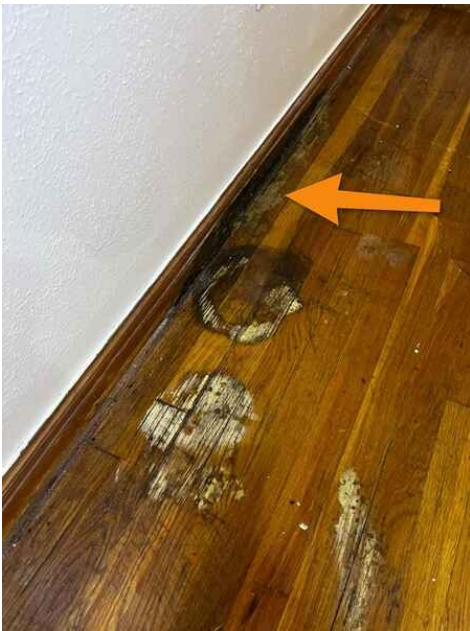
Bedroom 2

WATER STAINS- FLOORING

During the inspection, water stains were noted on the floor in one or more areas. Water stains not only detract from the aesthetic appeal of the flooring but may also indicate underlying issues such as leaks, plumbing problems, or improper drainage. Neglecting to address water stains promptly may lead to ongoing issues such as mold growth, deterioration of flooring materials, and potential structural damage. I recommend a qualified floor professional evaluate and repair as needed.

Recommendation
Contact a qualified flooring contractor

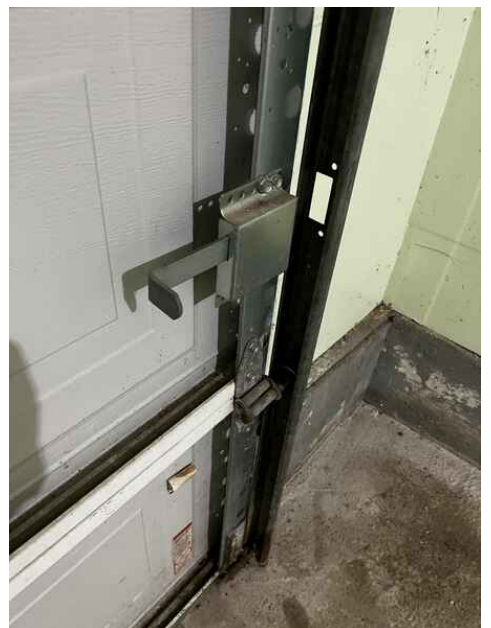
The garage door locks are observed to be present during the time of this inspection. While having garage door locks in place can provide an additional layer of security, forgetting to unlock them can severely damage the garage door. It is recommended that these locks be removed after installation of the garage door. This is for informational purposes and awareness only. The door locks at the time of the inspection do not hinder the operational or functionality of the garage door.

Recommendation
Contact a qualified professional.

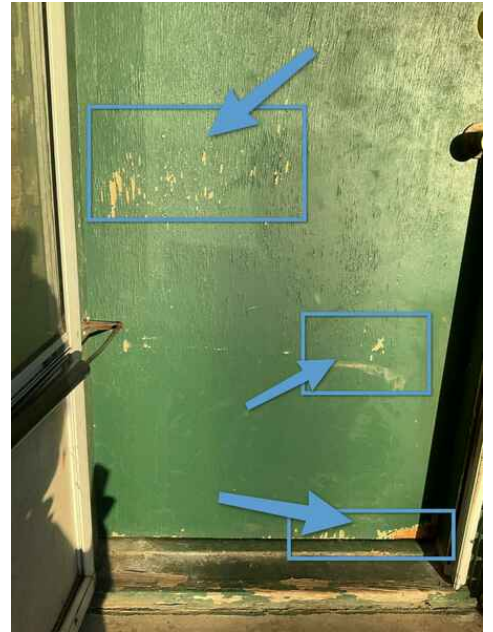
West- Back Door

DOOR PAINT FAILING/ DAMAGED

During the inspection, it was observed that the door was in need of repainting. The existing paint shows signs of wear, fading, or peeling, which not only affects the door's aesthetic appeal but also exposes it to potential damage from the elements. Neglecting to address the need for repainting may lead to accelerated wear and deterioration of the door. I recommend a qualified contractor evaluate and repair as needed.

Contact a qualified professional.

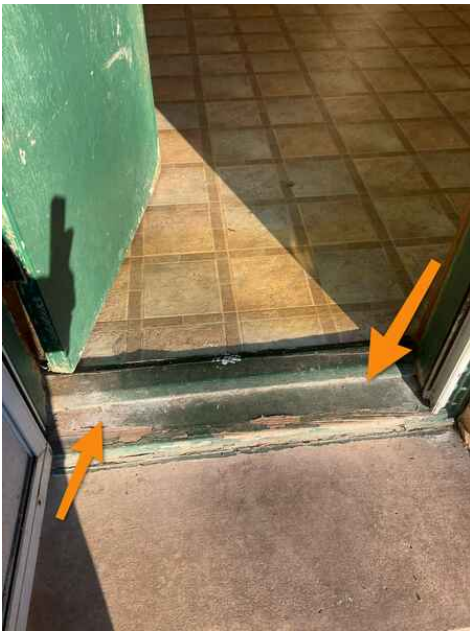
West- Back Door

DOOR WEATHER STRIP MISSING

During the inspection, it was noted that the weather stripping around one or more external doors is either missing or damaged. Weatherstripping is a crucial component for maintaining energy efficiency by sealing gaps and preventing drafts, moisture, and external elements from entering the home. I recommend replacing the weather stripping as soon as possible or contacting a qualified contractor to evaluate and repair as needed.

Contact a qualified professional.

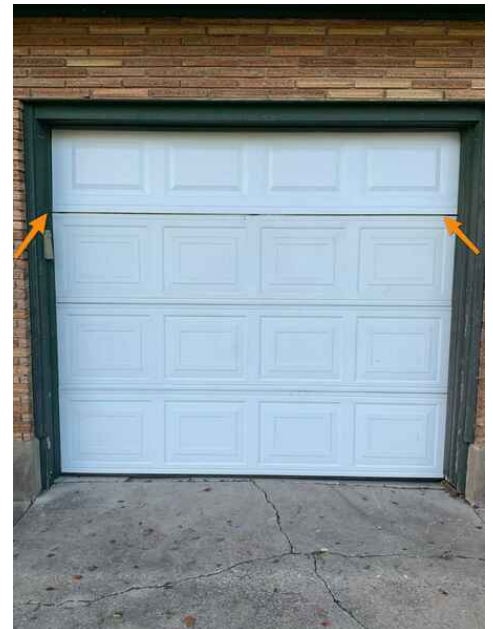
GARAGE DOOR DAMAGED/ MISALIGNED

During the inspection, it was observed that the garage door did not close completely. This could be due to the garage door being damaged or misaligned. A damaged or misaligned garage door not only impacts the aesthetic appeal of the property but also may compromise security, hinder smooth operation, and pose safety risks. I recommend a qualified contractor evaluate and repair as needed.

Recommendation
Contact a qualified professional.

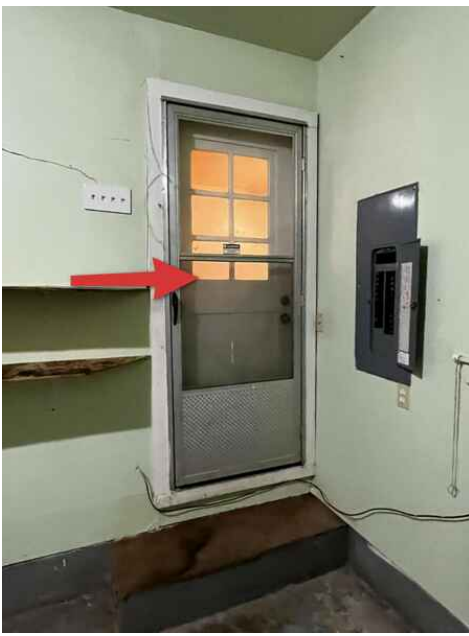
Door to Garage

DOOR TO GARAGE- INCORRECT

During the inspection, it was noted that the door leading to the garage appears to be inappropriate, potentially failing to meet current building code standards or safety requirements. The internal door leading to the garage should be a minimum of 1 3/8 inches thick – either a solid wood door, a solid or honeycomb-core steel door, or a 20-minute fire door, must not have openings or glazing, and is self-closing. This can pose a safety risk. I recommend a qualified contractor replace this door with a fire-rated door.

Recommendation
Contact a qualified professional.

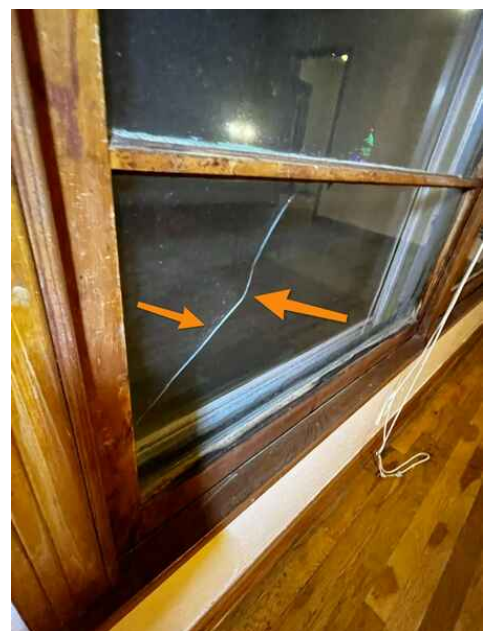
Living Room

GLAZING CRACKED/ DAMAGED

Contact a qualified professional.

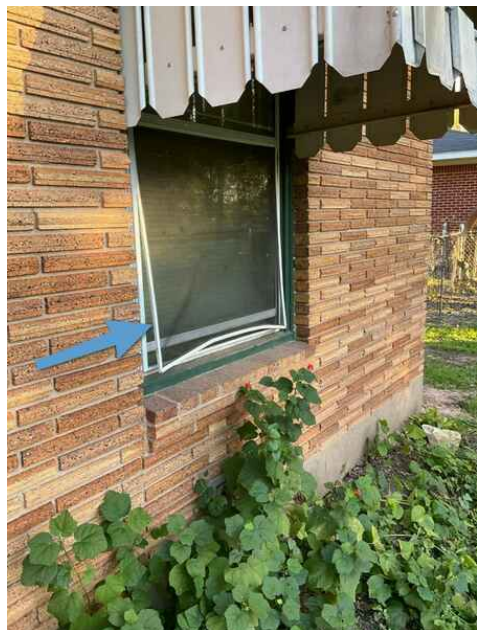
Window Screen

SCREEN DAMAGED

Contact a qualified professional.

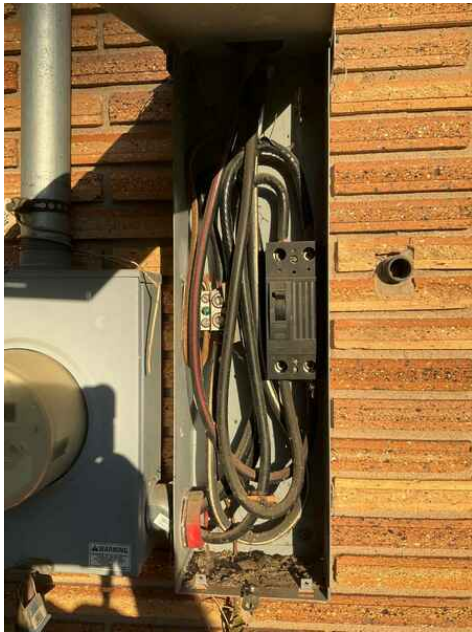
Main Panel

During the inspection, it was observed that there was a missing surge protector in the electrical panel. Surge protectors play a crucial role in safeguarding electronic devices and appliances from voltage spikes, helping prevent potential damage caused by power surges. The absence of a surge protector increases the vulnerability of sensitive electronic equipment to fluctuations in the electrical supply, which may occur due to lightning strikes, utility grid issues, or other electrical disturbances. I recommend a qualified electrician be consulted for further evaluation and repair.

Recommendation
Contact a qualified professional.

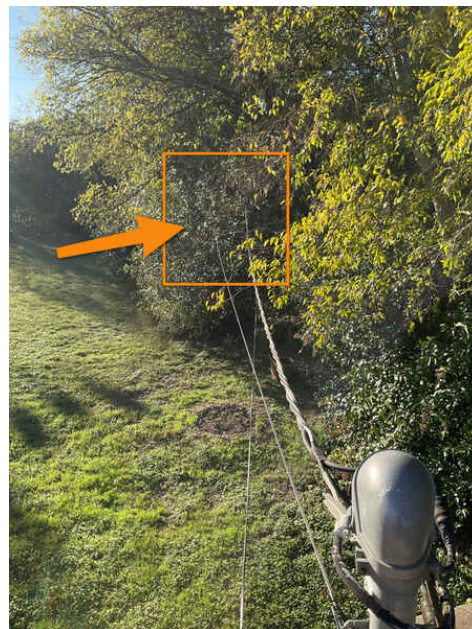
Overhead Mast Wiring

During the inspection, it was noted that electrical wires are in close proximity to trees and overhanging branches. This presents a notable safety concern as it increases the risk of potential hazards such as electrical fires, outages, or damage to the wiring due to contact with tree limbs. To address this issue, it is strongly recommended to engage the services of a qualified arborist and an electrician. The arborist can assess the trees in proximity to the wires, trim or remove branches as needed, and ensure a safe distance between the vegetation and the electrical lines. Simultaneously, the electrician can inspect the wiring for any damage and make necessary adjustments or repairs to enhance safety.

Recommendation
Contact a qualified professional.

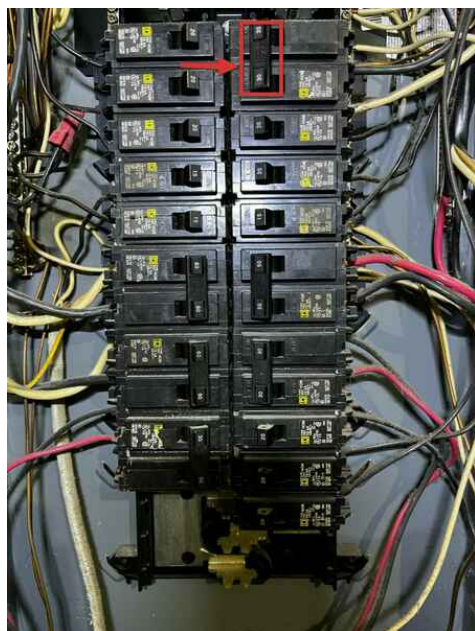
Subpanel

During the inspection, it was observed that oversized wires were connected to a breaker in the electrical panel. The use of oversized wires can pose significant safety risks, potentially leading to overheating, damage to the electrical panel, and increased fire hazards.

Recommendation
Contact a qualified professional.

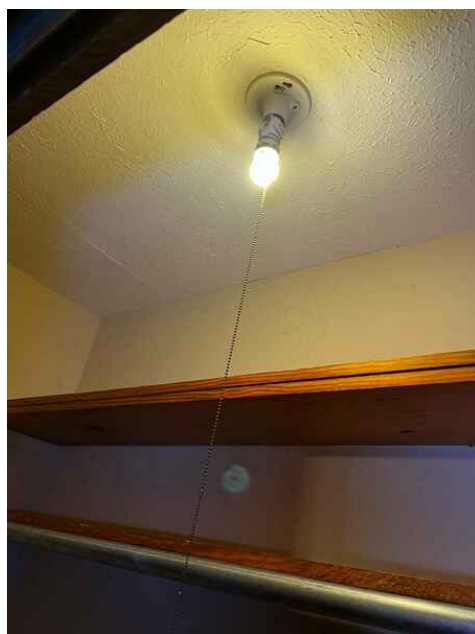
Closet Light

During the inspection, it was observed that one or more light fixtures were missing its protective cover. The protective cover serves as a crucial safety feature, preventing direct contact with the light bulb and reducing the risk of accidental breakage or exposure to electrical components.

Recommendation
Contact a qualified professional.

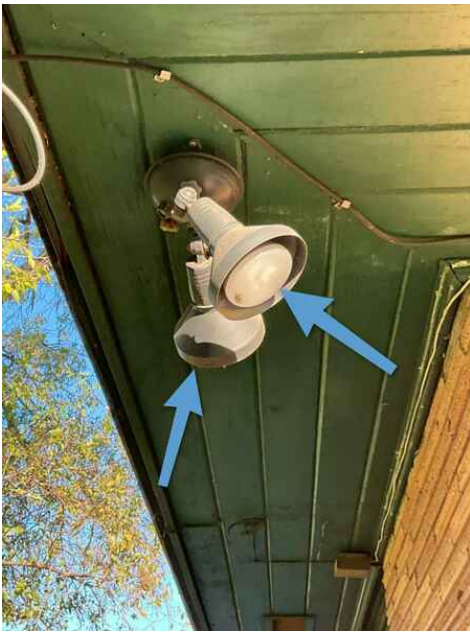
Southeast

One or more of the lights were inoperative at the time of the inspection. This condition can be caused by a blown light bulb or a bad circuit. Recommend further evaluation and replace as needed. If the bulbs are not blown, the circuit should be investigated.

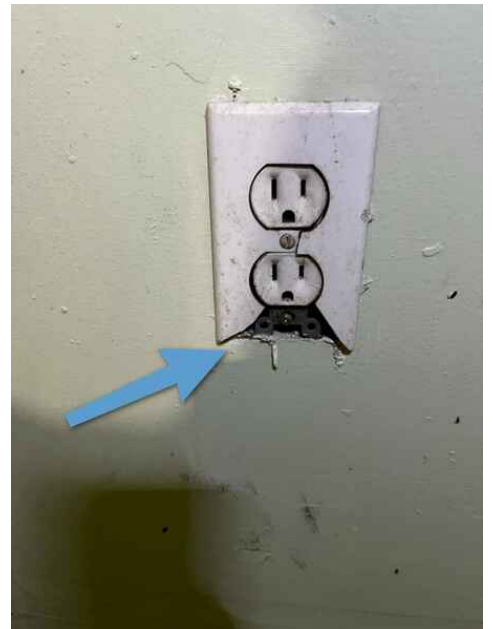
Receptacle Cover Plate

Some outlets have a damaged cover plate in some areas. I recommend replacing it with a new cover plate.

Recommendation
Recommended DIY Project

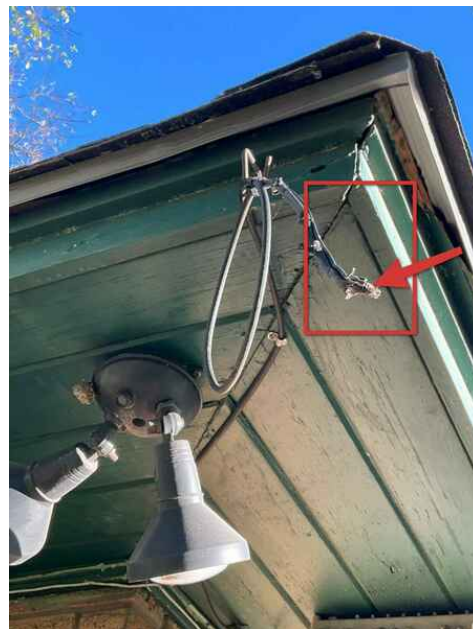
Exposed Wire

During the inspection, it was observed that there were exposed wires in one or more areas. Exposed wires pose a significant safety hazard, as they can lead to electrical shocks, fires, and other potential dangers. This is a safety concern. I recommend a licensed electrician evaluate and correct the concern.

Recommendation
Contact a qualified electrical contractor.

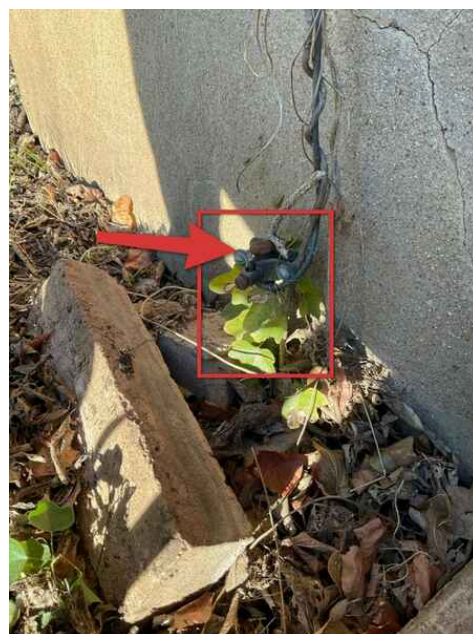
Grounding Rod

During the inspection, it was noted that there were concerns related to the grounding rod. Proper grounding is crucial for the safety and functionality of the electrical system. The grounding rod should be at least 8 ft long and fully submerged. An exposed grounding poses a tripping hazard and may not perform as intended. I recommend a licensed electrician evaluate and repair as needed.

Recommendation
Contact a qualified professional.

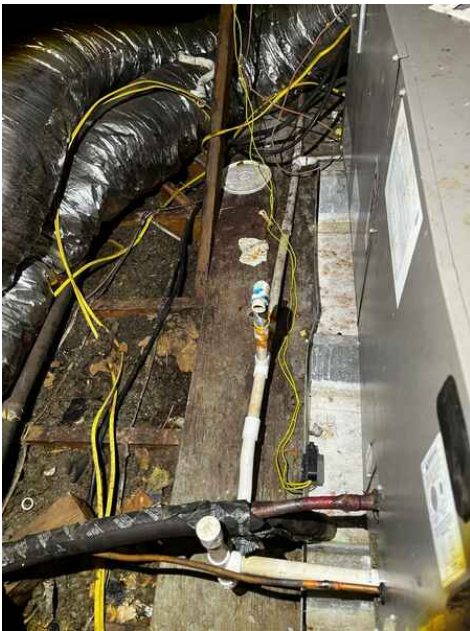
Attic

One or more furnaces do not have the appropriate clearance to be serviced and/ or inspected properly. A level service space at least 30 inches wide by 30 inches deep should be provided in front of all parts of the appliances that require service. I recommend a licensed HVAC contractor assess and provide solutions to resolve the clearance issue.

Recommendation
Contact a qualified HVAC professional.

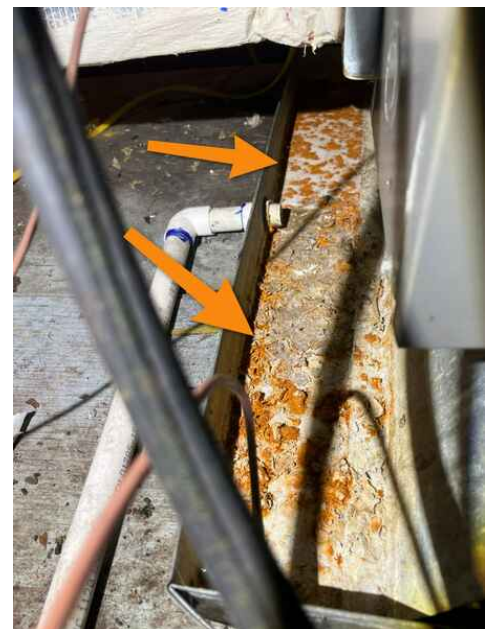
During the inspection, it was noted that the HVAC drain pan is exhibiting signs of rust. The presence of rust on the drain pan raises concerns about its structural integrity and potential for water leakage. A rusted drain pan may compromise the effectiveness of the HVAC system, leading to water damage and reduced indoor air quality. I recommend a licensed HVAC professional evaluate and replace the drain pan as needed.

Recommendation
Contact a qualified HVAC professional.

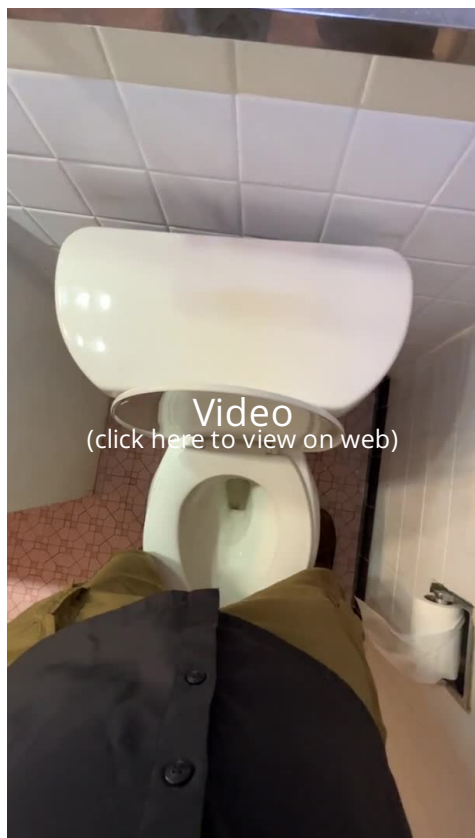
During the inspection, one or more toilets were observed to be loose. A loose toilet is a notable concern that requires attention to prevent potential issues such as leaks, instability, and damage to the flooring. A securely anchored toilet is essential for proper functioning and to avoid water leaks, which can lead to more extensive damage over time. The looseness may be attributed to issues with the toilet bolts, wax ring, or the flooring beneath. I recommend a qualified contractor be consulted for further evaluation and repair.

Recommendation
Contact a qualified plumbing contractor.

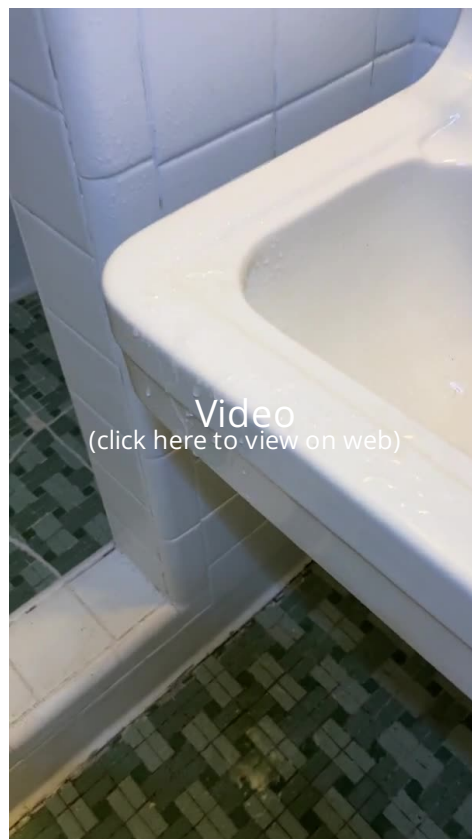
During the inspection, one or more sink faucets were observed to spray in excess. The faucet sprayed water outward beyond the containment of the sink. This could be remedied by simply replacing the aerator in the faucet end. If the issue continues, I recommend contacting a qualified plumbing professional to evaluate and repair as needed.

Recommendation
Contact a qualified plumbing contractor.

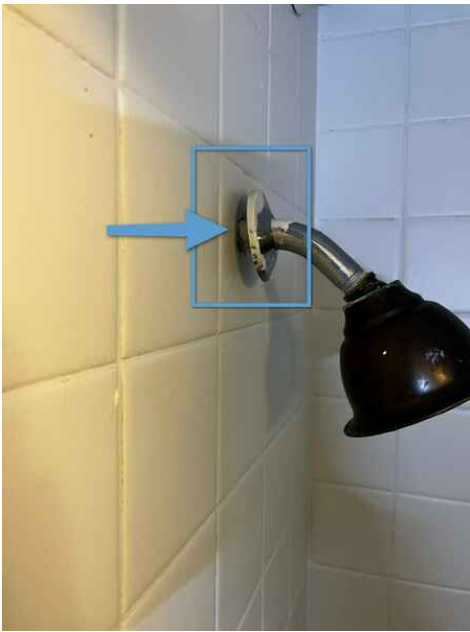
Bathroom

CAULK/ GROUT MISSING

Recommendation
Contact a qualified professional.

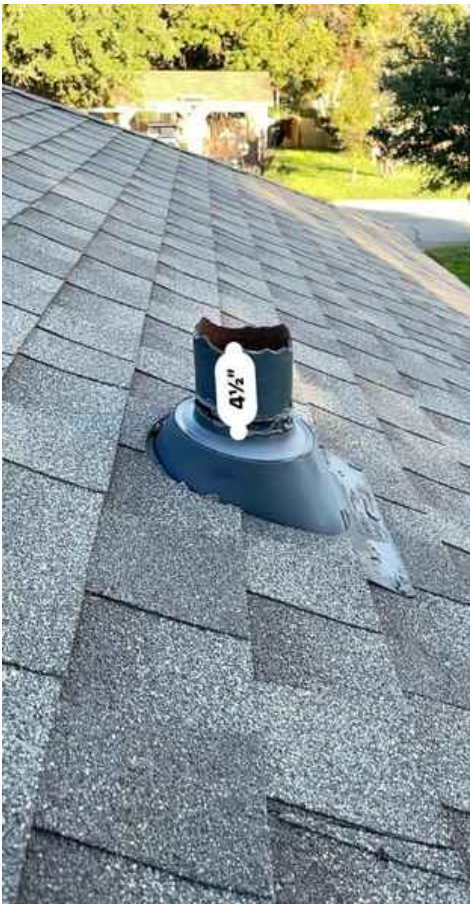
Vent Stack

One or more of the plumbing stacks do not appear to extend to the proper height above the rooftop. Plumbing stacks that penetrate the roof should extend at least 6 inches above the roof structure. I recommend I licensed roofer evaluate and repair as needed.

Recommendation
Contact a qualified professional.
