ROOK HOME INSPECTIONS LLC

RESIDENTIAL INSPECTION

333 Somewhere Dr
Waco, Texas 76712

PROPERTY INSPECTION REPORT FORM

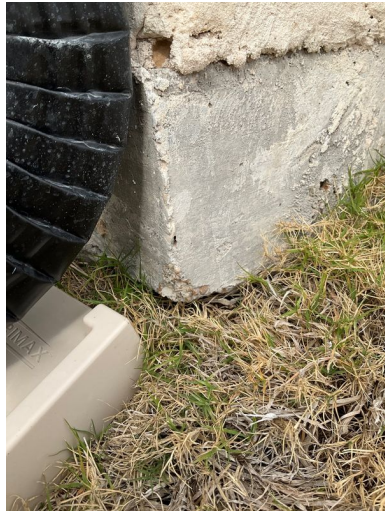
1: Foundation corner pops

The foundation has minor cracks in the corners (Corner pops). These are considered cosmetic. I recommend a qualified contractor repair as needed.

Recommendation: Contact a qualified professional.

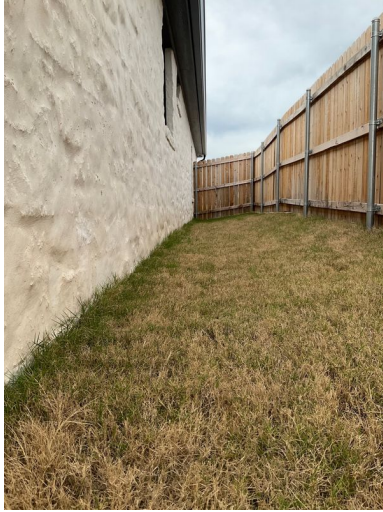
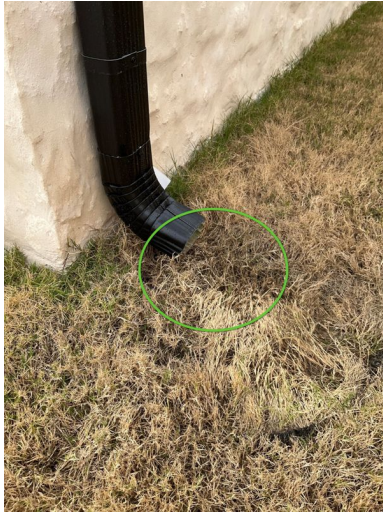
There is a negative slope in areas that does not appear to drain water away from the home. I recommend a qualified contractor be consulted for further evaluation and repair so that a minimum of 4 inches of concrete slab is visible.

Recommendation: Contact a qualified professional.

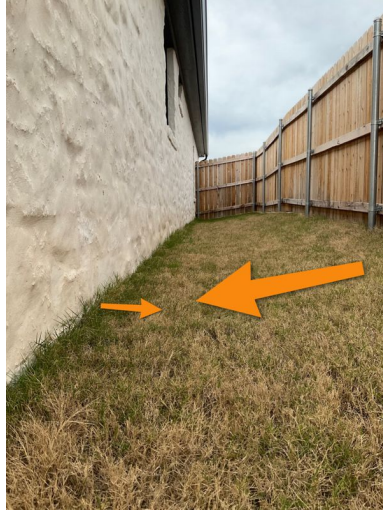
2: Missing Splash Blocks

Splash blocks are placed at the end of a downspout and used to divert water a minimum of 3-5 feet away from the foundation. This prevents excess water in the soil near the foundation which may cause foundation concerns. This is a simple correction that can be made by the homeowner.

Recommendation: Recommended DIY Project

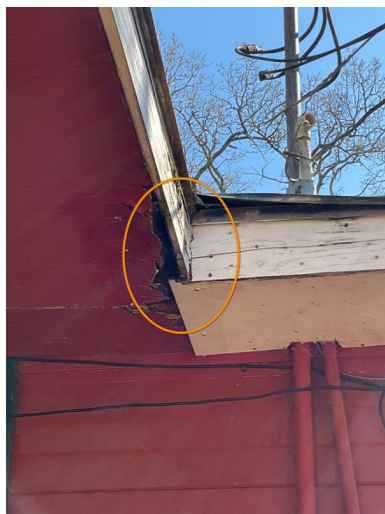
1: Roof covering is damaged

The roof covering is damaged in areas. This damage may need repair or replacement. I recommend a qualified roofing contractor be consulted for further evaluation and repair.

Recommendation: Contact a qualified professional.

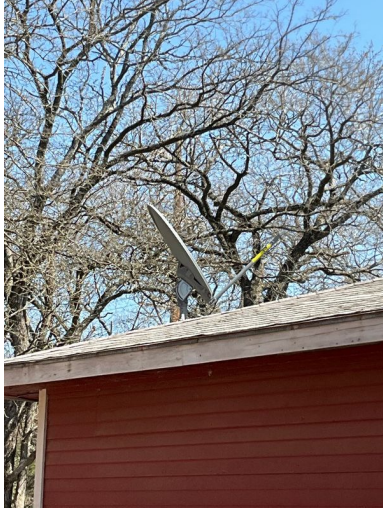
2: Satellite dish mounted on the roof

There is a satellite dish mounted on the roof in areas. This is not considered to be today's standard. I recommend a qualified roofing contractor be consulted to remove this unit and patch the roof surface as needed.

Recommendation: Contact a qualified professional.

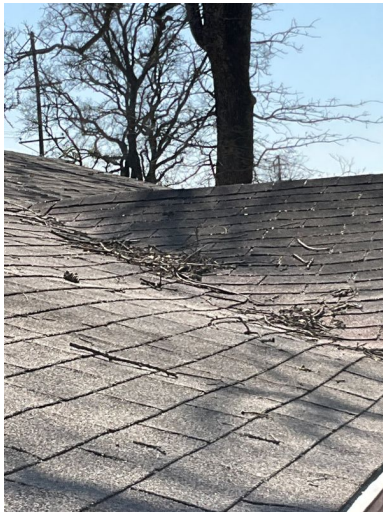
3: Debris observed on the roof surface

The roof surface has standing debris in areas. This can lead to damaged shingles and moisture intrusion if not corrected. I recommend a qualified contractor be consulted for further evaluation and repair as needed.

Recommendation: Contact a qualified professional.

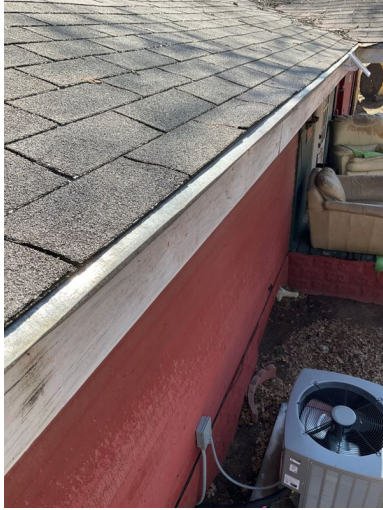
4: Drip edge flashing is not painted

The drip edge flashing is not painted. This is for your information. I recommend a qualified contractor be consulted for further evaluation and repair as needed.

Recommendation: Contact a qualified professional.

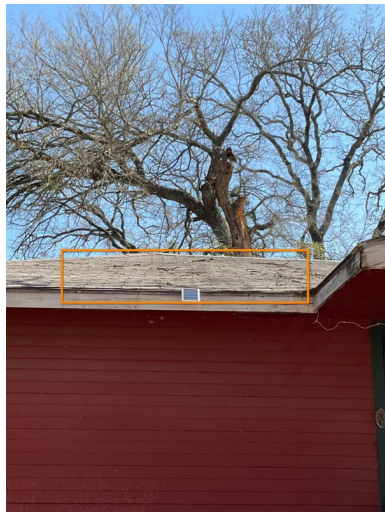
9: Roof is Uneven

The roof dips or sags in areas. This is most common with older construction homes when roof rafters were spaced too far apart to provide adequate support. I recommend a qualified roofing contractor be consulted for further evaluation and repair as needed.

Recommendation: Contact a qualified professional.

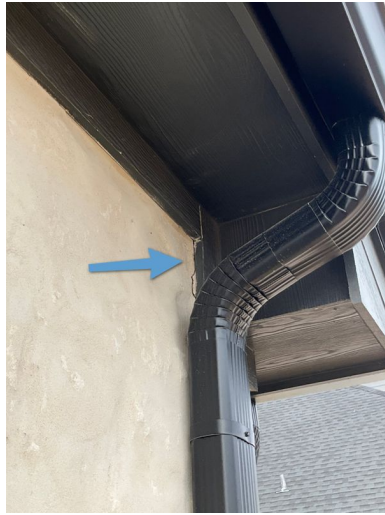
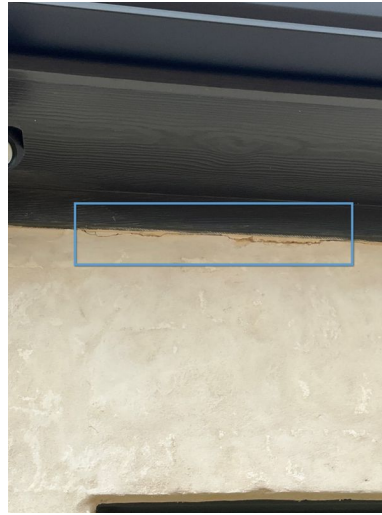
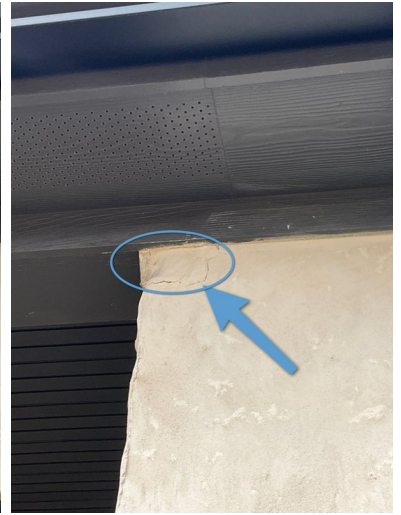
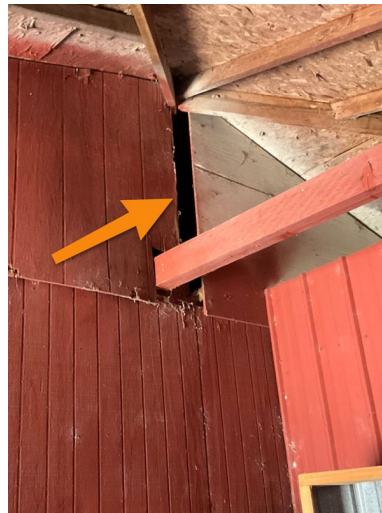
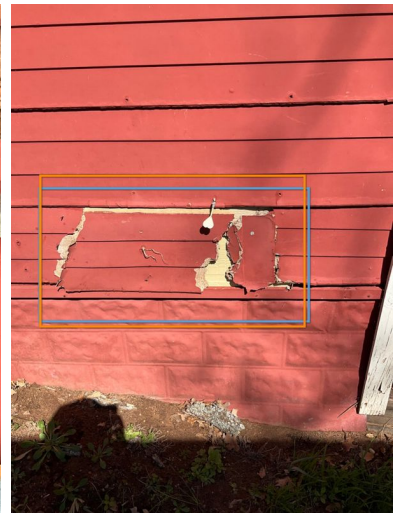
1: Exterior siding damaged in areas

The exterior siding is damaged in areas. I recommend a qualified contractor repair as needed.

Recommendation: Contact a qualified professional.

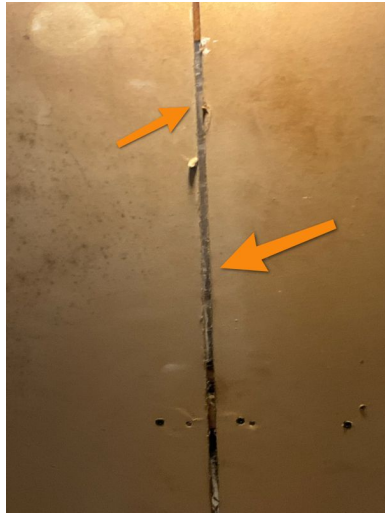
The drywall is unfinished in areas. This is for your information.

Recommendation: Contact a qualified professional.

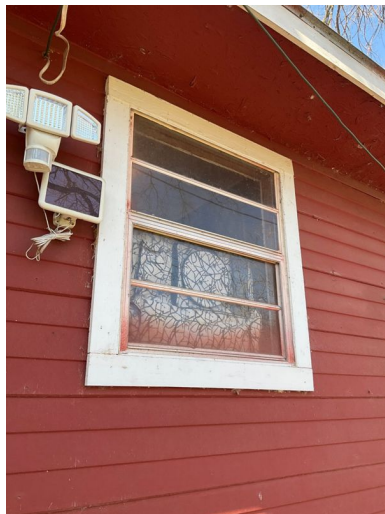
1: Missing window screen(s)

One or more windows are missing a screen. Recommend replacement.

Recommendation: Contact a qualified window repair/installation contractor.

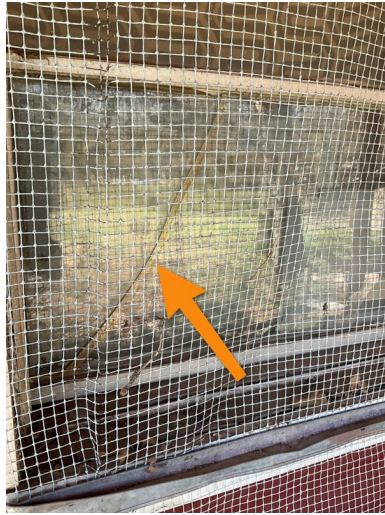
3: There is cracked/damaged glass in a window

The window is cracked in areas. I recommend a qualified contractor be consulted for further evaluation and repair or replace as needed.

Recommendation: Contact a qualified professional.

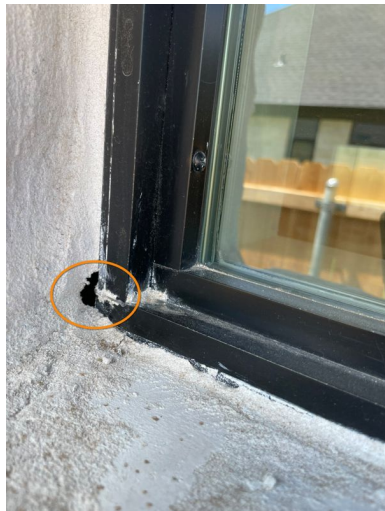
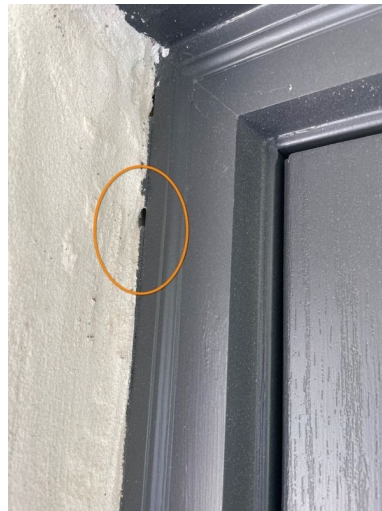
There are areas of the home that have grout or caulking that is missing or deteriorated. I recommend a qualified contractor be consulted for further evaluation and repair.

Recommendation: Contact a qualified professional.

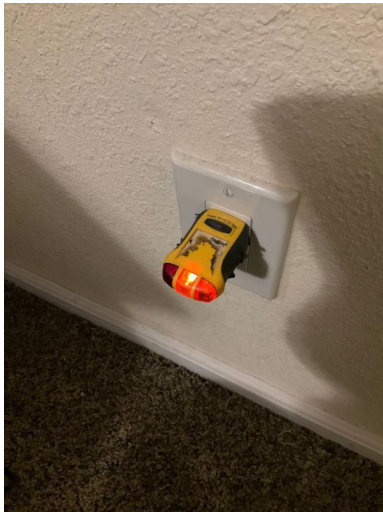
3: Improper Wiring

Improper wiring was observed at the time of inspection. Recommend a licensed electrician evaluate and repair.

Recommendation: Contact a qualified electrical contractor.

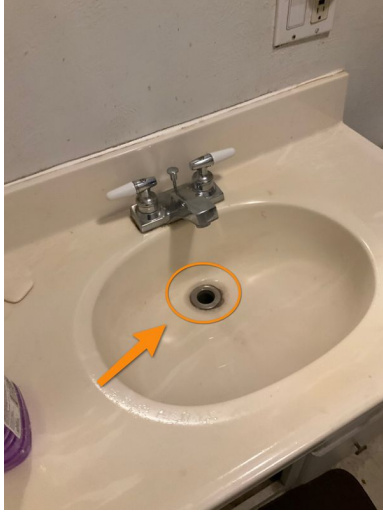
The sink stopper mechanism is not functioning properly in areas. I recommend a qualified person repair as needed.

Recommendation: Contact a qualified professional.

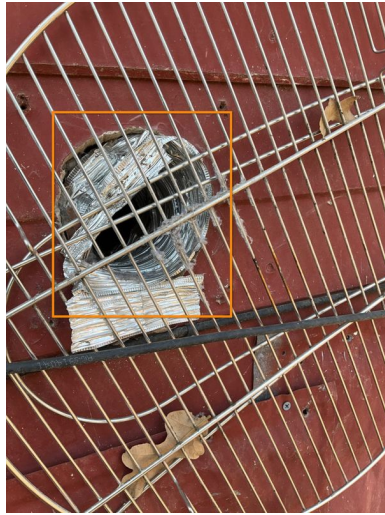
1: Improper Venting

Dryer vent is not terminating to the exterior, which can cause inefficient venting and/or a fire hazard. Recommend a qualified HVAC contractor or handyman vent to exterior.

Recommendation: Contact a qualified HVAC professional.

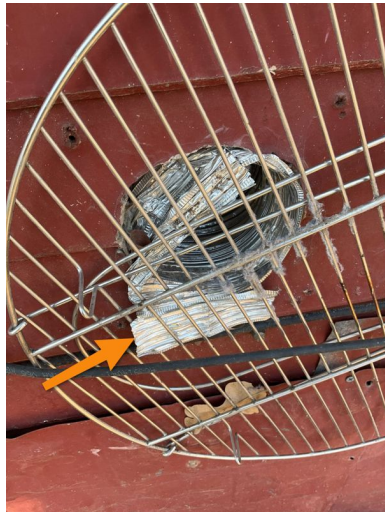
2: Improper material

The dryer vent piping is comprised of improper material for a gas dryer. I recommend a qualified contractor be consulted for further evaluation and repair.

Recommendation: Contact a qualified professional.
