ROOK HOME INSPECTION- RESIDENTIAL REPORT

1234 Main Street
Waco TX 76712

01/26/2024 9:00AM

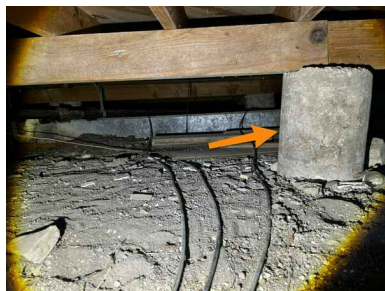
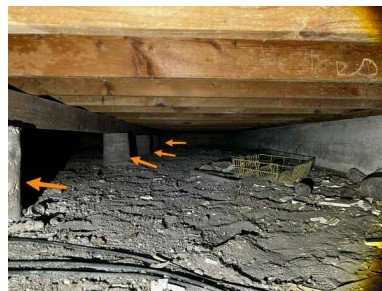
1: Crawlspace Access Inadequate

Access to the crawlspace is inadequate or unsafe. The minimum dimensions for access opening should be 18x24 inches (floor) or 16x24 inches (wall). This limits the inspector's ability to enter and view the components within the area of the crawlspace. Inspector's findings are based on limited access, visibility, and best judgment.

Recommendation: Contact a qualified professional.

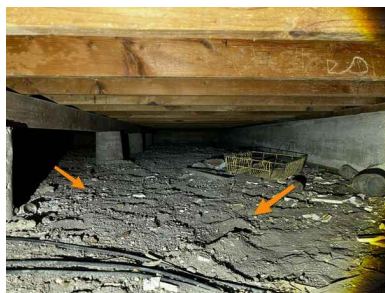
2: Crawlspace Vapor Retarder (Barrier) Missing

The vapor retarder is missing in the crawlspace. A vapor retarder, or waterproof sheeting, is typically installed in crawl spaces or attics and plays a crucial role in preventing moisture-related issues and ensuring the long-term structural integrity and energy efficiency of a home. The absence of a vapor retarder can lead to several potential problems, including increased humidity levels, condensation, and the risk of mold growth. Moisture intrusion can compromise the insulation's effectiveness, damage building materials, and contribute to indoor air quality issues. I recommend a qualified contractor evaluate and install vapor retarder as needed.

Recommendation: Contact a foundation contractor.

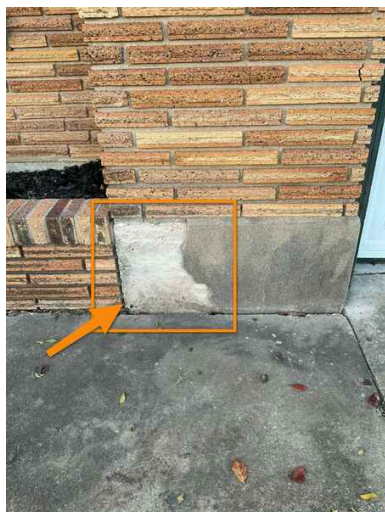
East- Garage

3: Spalling

The foundation is spalling at one or more areas. Spalling is the breakdown of concrete from natural weathering and/ or chemical reaction that results in sections of cement chipping off the main body; often

resulting in fractured, compromised concrete. This is considered a cosmetic issue. If you desire to correct the issue, I recommend a concrete specialist evaluate and repair it if needed.

Recommendation: Contact a qualified general contractor.

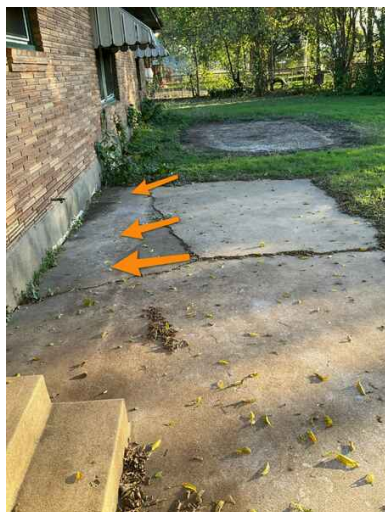
West

The grading does not appear to promote stormwater flow away from the house in one or more locations. The grading (ground) should slope away from the house at a rate of 6 inches for at least the first 10 feet or to a swale. Proper grading and drainage help prevent water from standing and/or ponding next to the foundation.

Corrective measures may be needed if the water stands within 10 feet of the foundation perimeter for more than 24 hours.

Recommendation: Contact a qualified professional.

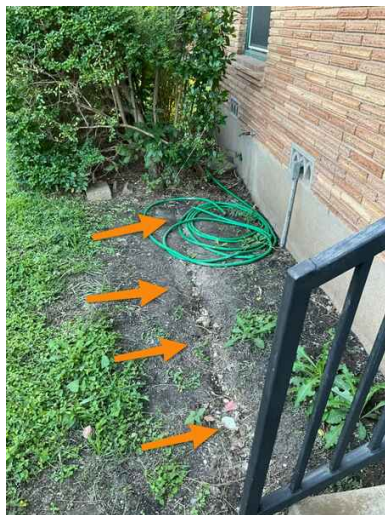
Southeast

There is evidence of soil erosion at various locations around the property. In this case, the lack of gutters and downspouts appears to be eroding the soil beneath the roof and creating a trough around the property. I recommend a qualified contractor evaluate and install gutters and downspouts. Backfill may be needed to replace the eroded soil.

Recommendation: Contact a qualified professional.

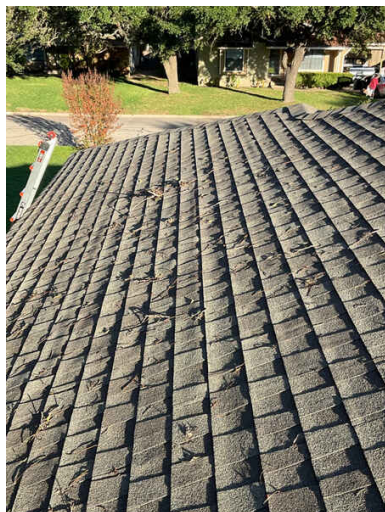
North Roof

The roof surface has standing debris in some areas. This can lead to damaged shingles and moisture intrusion if not corrected. I recommend clearing the debris to allow for water to be shed from the roof as intended.

Recommendation: Contact a qualified professional.

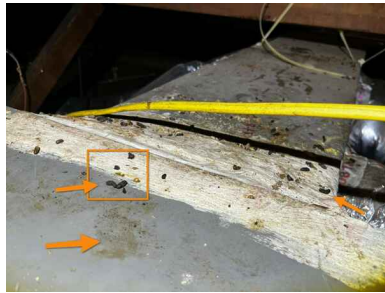
Attic

There is evidence such as droppings, gnaw marks, or nests may suggest the activity of rodents in this area. Rodents, such as mice and rats, can cause a range of problems in an attic. They may damage insulation, electrical wiring, and structural components while also posing health risks due to the spread of contaminants through their droppings and urine. I recommend a qualified pest control contractor evaluate and resolve the issue as needed.

Recommendation: Contact a qualified pest control specialist.

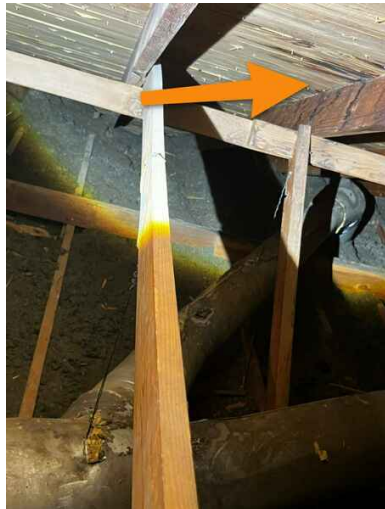
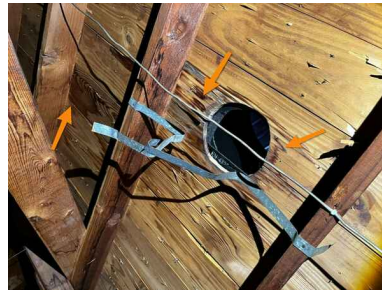
Attic

2: Evidence of Water Intrusion

There is evidence of water intrusion on the rafters in the attic space. Water stains are visible in several areas. These may have been from a previous problem that is now resolved or an ongoing issue. I recommend a licensed roofer evaluate and repair as needed.

Recommendation: Contact a qualified roofing professional.

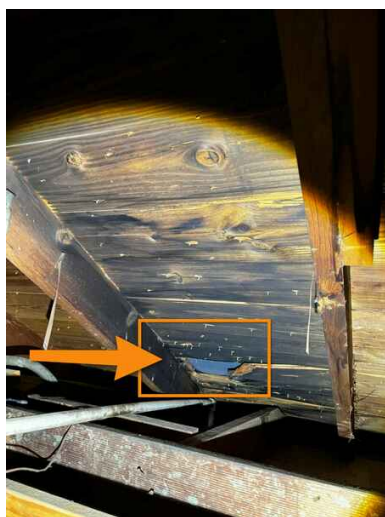
Attic

4: Roof Decking Damaged

The roof decking was observed to be damaged in one or more areas at the time of the inspection. The roof decking, a critical component of the roofing system, provides structural support and a base for roofing materials. Visible indicators of roof decking damage may include sagging, bowing, holes or missing parts, or areas of deterioration such as rot, water stains, or mold growth. Such damage can result from various factors, including water leaks, prolonged exposure to the elements, or inadequate ventilation. I recommend a licensed roofing contractor evaluate and repair as needed.

Recommendation: Contact a qualified roofing professional.

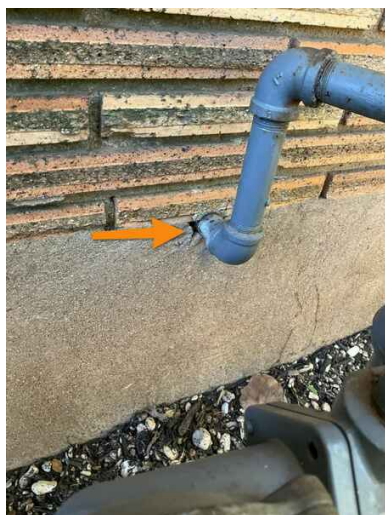
North

Caulk is deteriorated and/ or missing from exterior wall penetrations such as pipes, vents, or lights. This allows for water intrusion and access to wildlife. I recommend a qualified contractor evaluate and repair as needed.

Recommendation: Contact a qualified professional.

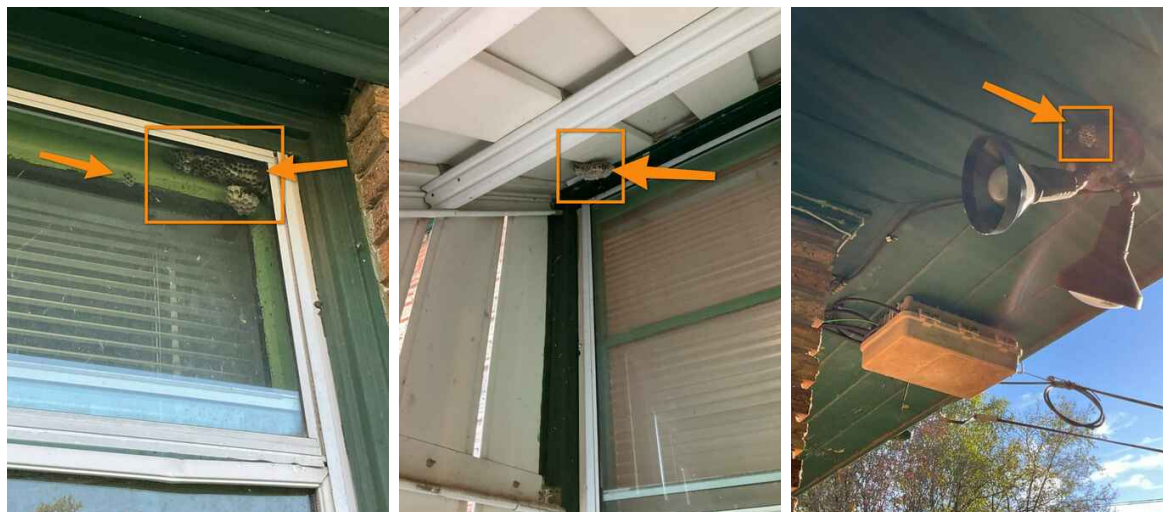
2: Insect Infestation

Recommendation: Contact a qualified pest control specialist.

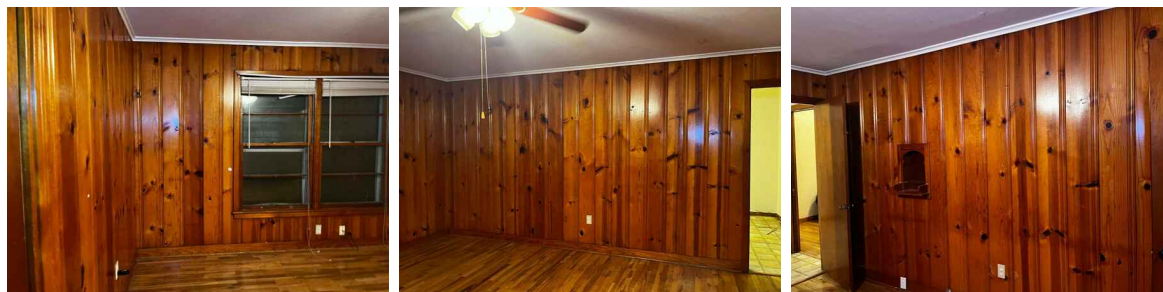
Extra Room/ Bedroom 3

3: Interior Wall- Combustable Material

One or more internal walls of the property were observed to be a combustible wall covering that separates the habitable space. This condition does not meet current building standards and poses a fire/ safety hazard. I recommend a qualified contractor with fire separation knowledge to evaluate and repair as needed.

Recommendation: Contact a qualified professional.

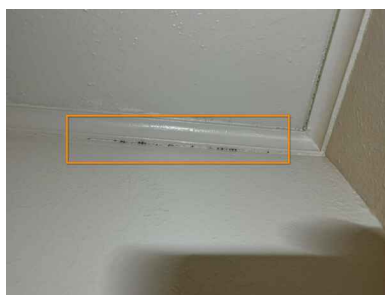
Kitchen

During the inspection, there were indications of possible mildew or moisture in one or more areas. The presence of mildew or moisture can result from various factors, including inadequate ventilation, water leaks, or high humidity levels. Neglecting to address possible mildew or moisture promptly may lead to further damage, compromised indoor air quality, and potential health risks. I recommend a qualified mold remediation contractor evaluate and provide possible solutions.

Recommendation: Contact a qualified mold remediation contractor

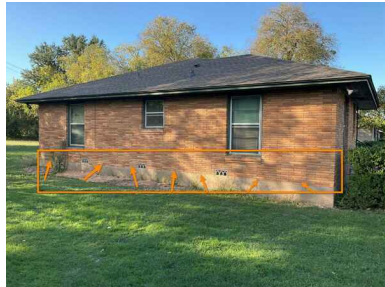
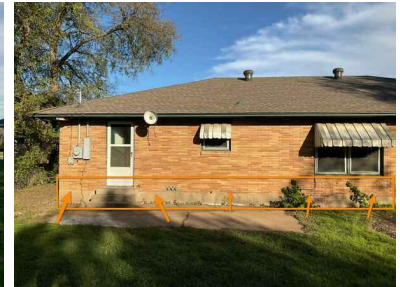
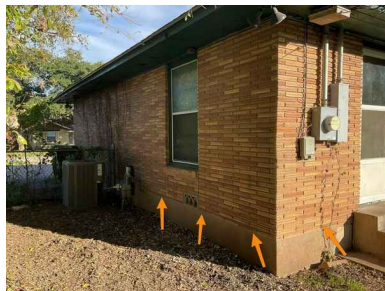
During the inspection, it was noted that there were missing weep holes in one or more areas. Weep holes play a crucial role in facilitating proper drainage, allowing water to exit from behind building components and preventing moisture buildup. Neglecting to address missing weep holes may lead to issues such as trapped moisture, potential water damage, and the risk of mold or mildew growth. I recommend a qualified siding contractor evaluate and repair as needed.

Recommendation: Contact a qualified siding specialist.

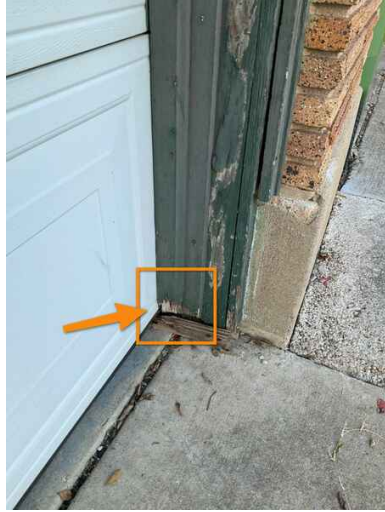
Garage

During the inspection, it was noted that there was damage to the exterior trim in one or more areas. Exterior trim damage can result from exposure to the elements, pests, or general wear and tear. Neglecting to address exterior trim damage may lead to further deterioration, potential issues with water infiltration, and diminished curb appeal.

Recommendation: Contact a qualified professional.

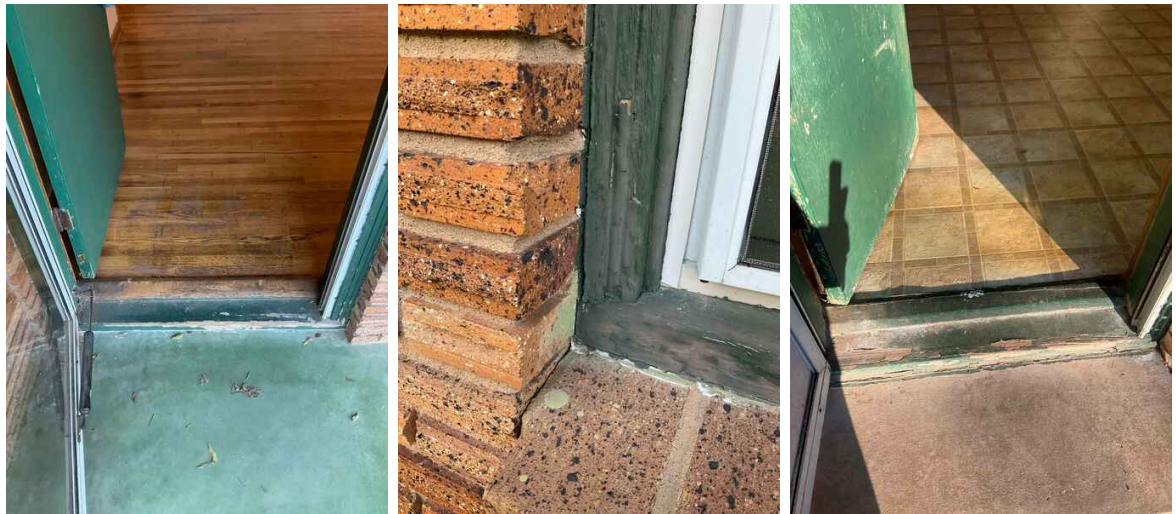
9: Paint Failing/ Missing- Exterior

During the inspection, it was noted that there are areas where the paint is failing or missing. The integrity of exterior paint is crucial for protecting surfaces from weathering, moisture, and UV damage. Neglecting to address failing or missing paint may result in further deterioration of surfaces, potential structural damage, and diminished aesthetic appeal. I recommend repainting exterior surfaces as soon as possible.

Recommendation: Contact a handyman or DIY project

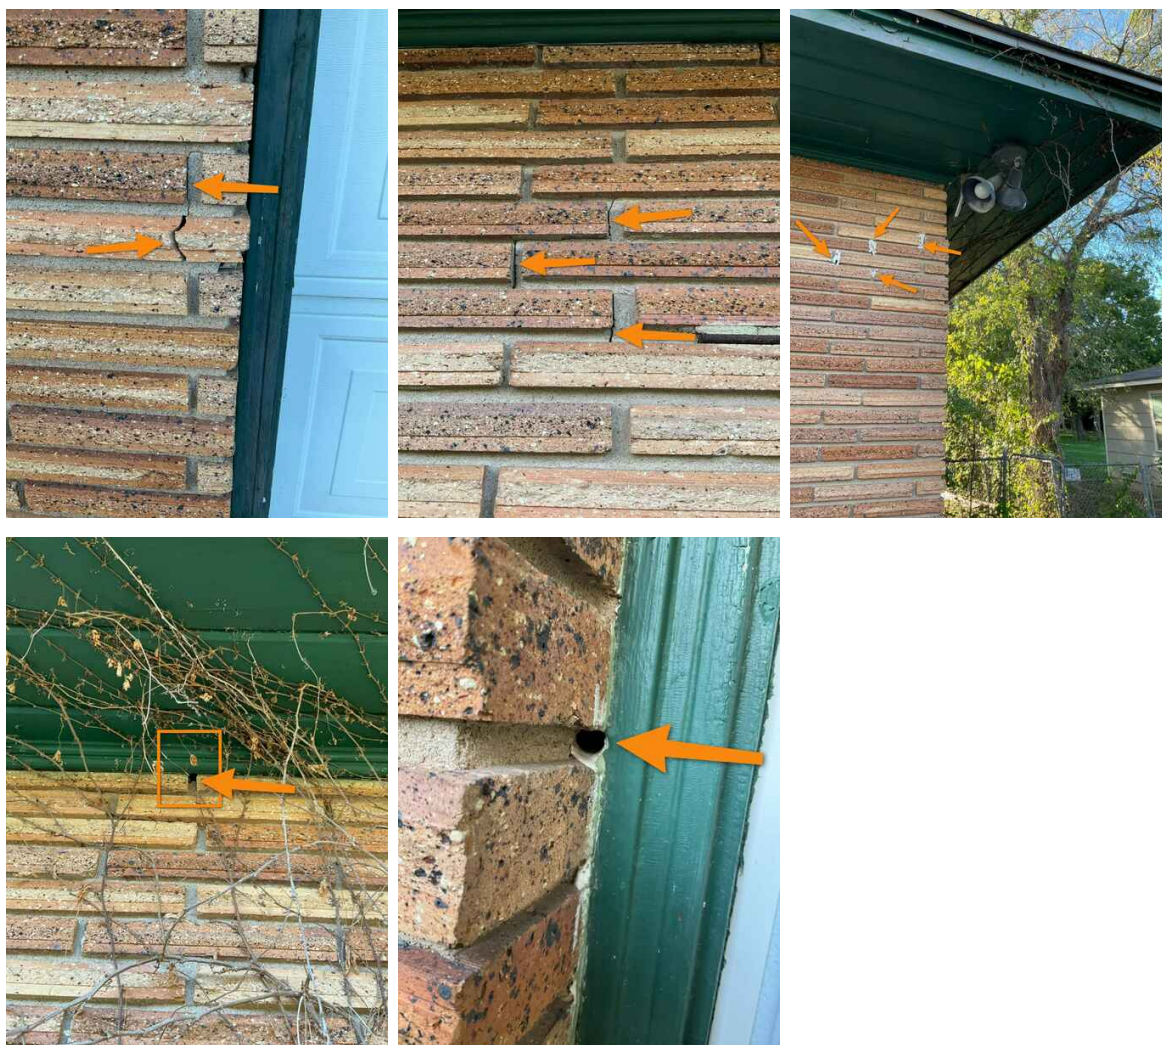
During the inspection, cracks in the brick and mortar were identified in one or more areas. The presence of cracks in the brickwork and mortar joints can result from various factors, including settling, temperature fluctuations, or structural movement. Neglecting to address cracks in brick and mortar may lead to further deterioration, water penetration, and potential issues with structural stability. Cracks greater than 1/4 inch wide can indicate structural concerns. I recommend monitoring the cracks.

* If the cracks increase in size and width, contact a licensed structural professional for consultation.

Recommendation: Contact a qualified siding specialist.

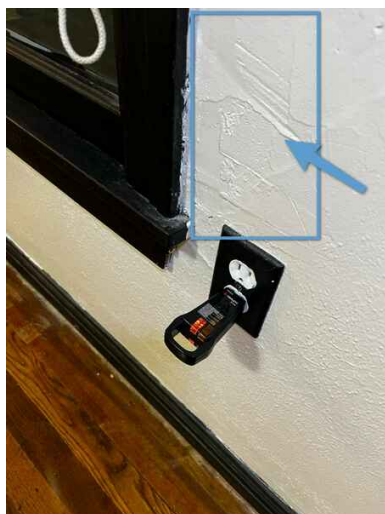
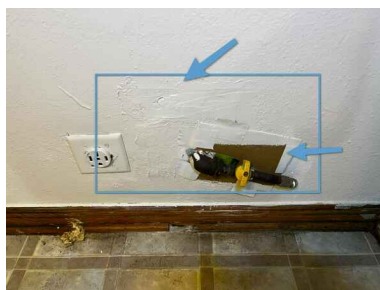
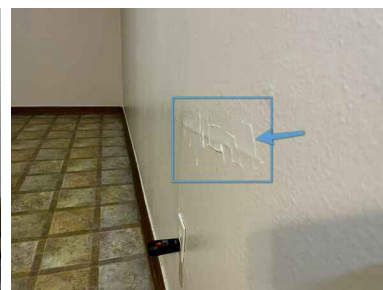
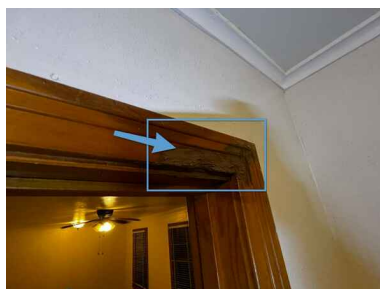
During the inspection, it was noted that certain interior walls had undergone previous repairs. The presence of repairs can indicate a proactive approach to addressing issues such as settling, cracks, or other underlying concerns. It is advisable to review any available documentation related to the repairs, such as invoices or reports, to gain insight into the nature of the repairs conducted. I recommend monitoring the repairs.

Recommendation: Contact a qualified professional.

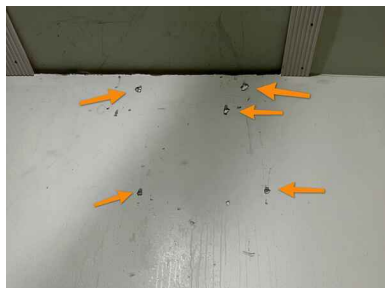
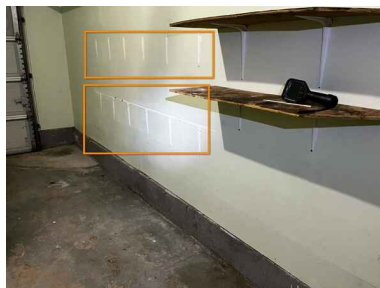
During the inspection, it was noted that one or more interior walls exhibited signs of damage. The nature of the damage may include holes, scrapes, scratches, and/or cracks. Neglecting to address damaged interior walls may lead to further deterioration, compromised structural integrity, and diminished overall visual appeal. I recommend a qualified contractor evaluate and repair as needed.

Recommendation: Contact a qualified professional.

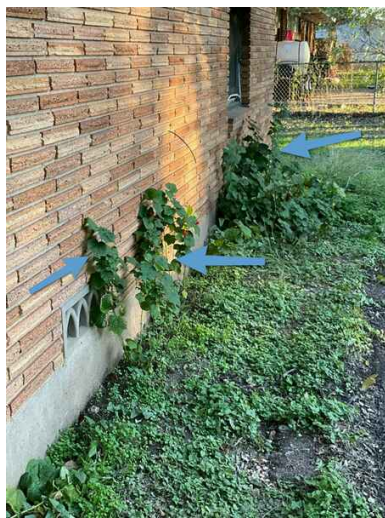
Vegetation

During the inspection, it was noted that vegetation was in direct contact with the house in one or more areas. The presence of vegetation in close proximity to the house can lead to various concerns, including moisture issues, pest access, and potential damage to the structure. I recommend trimming or removing the vegetation as soon as possible.

* If pest or insect concerns arise, consult with a licensed pest control professional.

Recommendation: Contact a handyman or DIY project

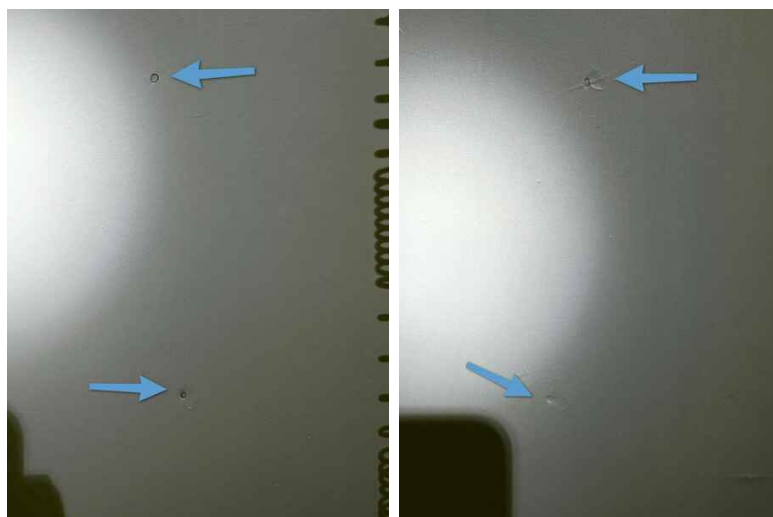
Garage Ceiling

The drywall on the ceiling has "Nail pops" in areas caused by settlement. This is considered cosmetic. I recommend a qualified contractor be consulted for further evaluation and repair as needed.

Recommendation: Contact a qualified professional.

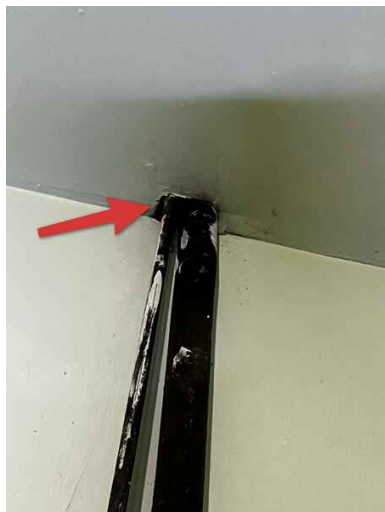
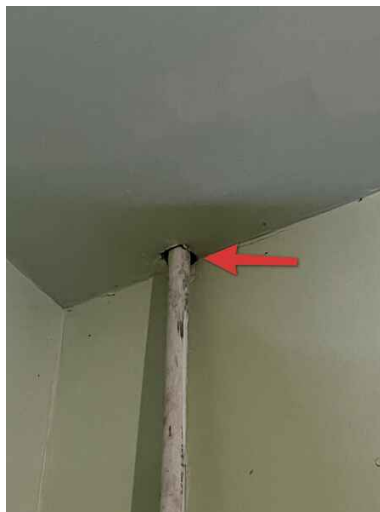
Ceiling Fire Separation

The firewall separation (gypsum board) between the habitual space and the second floor was observed to be missing in one or more locations. The firewall is intended to slow the spread of fire from the habitual space to the attic. The ceiling must be separated by a minimum of 1/2" drywall (gypsum board). I recommend a qualified professional contractor evaluate and repair as needed.

Recommendation: Contact a qualified professional.

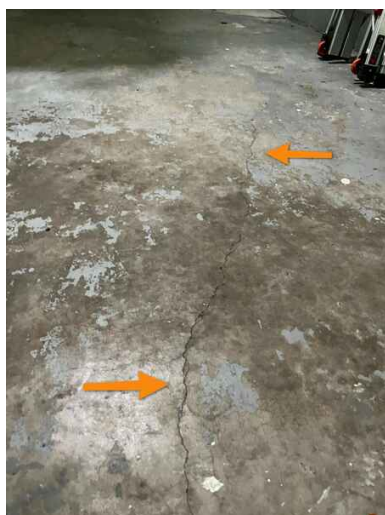
Garage Floor

The concrete floor of the garage is cracked in areas. These cracks appear typical and do not seem significant. I recommend a qualified contractor be consulted for further evaluation and repair as needed.

Recommendation: Contact a qualified professional.

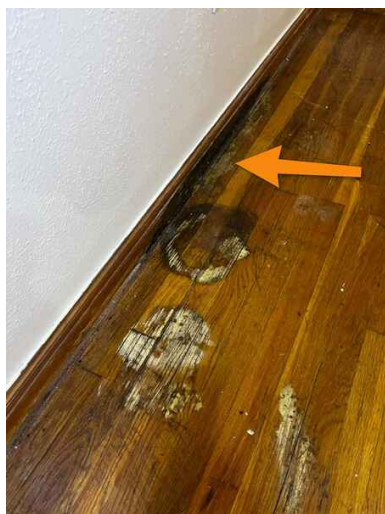
Bedroom 2

During the inspection, water stains were noted on the floor in one or more areas. Water stains not only detract from the aesthetic appeal of the flooring but may also indicate underlying issues such as leaks, plumbing problems, or improper drainage. Neglecting to address water stains promptly may lead to ongoing issues such as mold growth, deterioration of flooring materials, and potential structural damage. I recommend a qualified floor professional evaluate and repair as needed

Recommendation: Contact a qualified flooring contractor

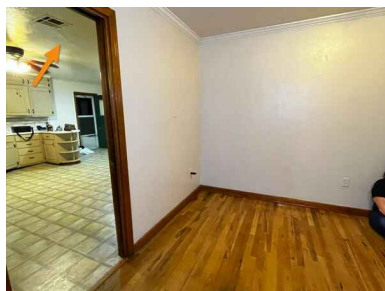
Kitchen

various sources such as roof leaks, plumbing issues, or condensation problems. Thermal imaging showed no evidence of a current concern. I recommend a qualified professional evaluate and repair as needed.

Recommendation: Contact a qualified professional.

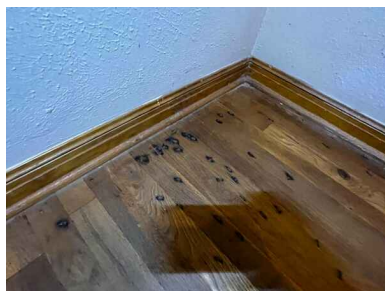
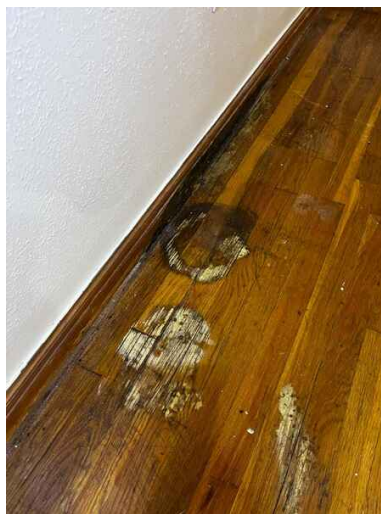
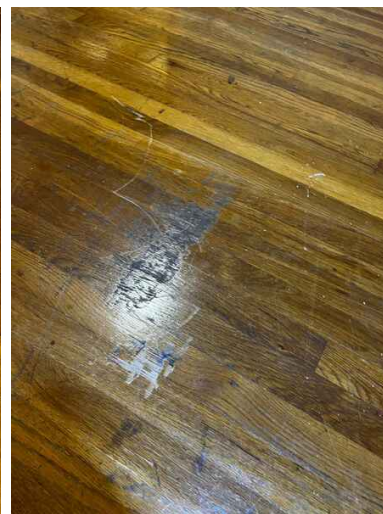
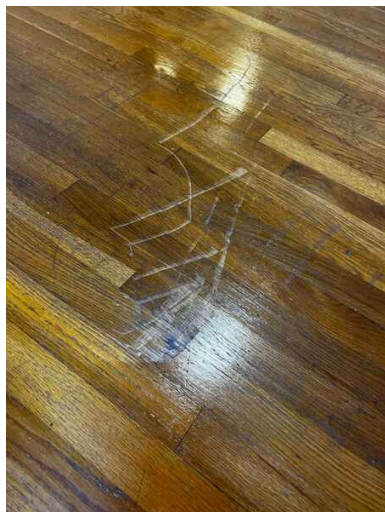
During the inspection, it was observed that the surface of the floor in one or more areas was damaged. Floor damage can detract from the aesthetic appeal of the space and may indicate issues such as wear and tear, impact damage, or underlying structural concerns. I recommend a qualified floor professional evaluate and repair as needed.

Recommendation: Contact a qualified flooring contractor

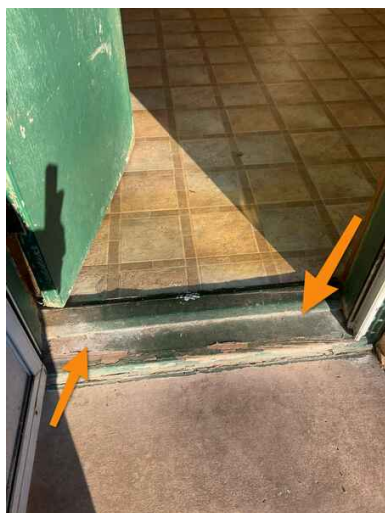
West- Back Door

4: Door Weather Strip Missing

During the inspection, it was noted that the weather stripping around one or more external doors is either missing or damaged. Weatherstripping is a crucial component for maintaining energy efficiency by sealing gaps and preventing drafts, moisture, and external elements from entering the home. I recommend replacing the weather stripping as soon as possible or contacting a qualified contractor to evaluate and repair as needed.

Recommendation: Contact a qualified professional.

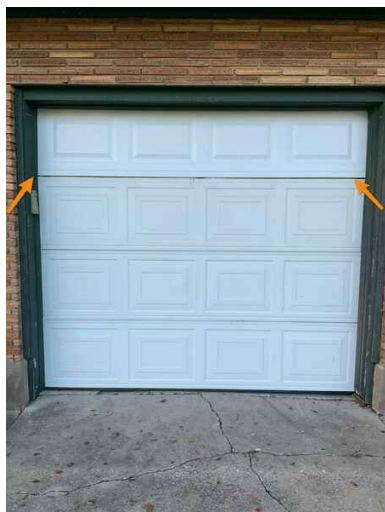
During the inspection, it was observed that the garage door did not close completely. This could be due to the garage door being damaged or misaligned. A damaged or misaligned garage door not only impacts the aesthetic appeal of the property but also may compromise security, hinder smooth operation, and pose safety risks. I recommend a qualified contractor evaluate and repair as needed.

Recommendation: Contact a qualified professional.

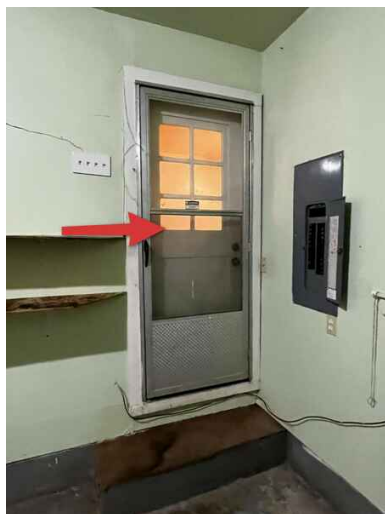
Door to Garage

6: Door to Garage- Incorrect

During the inspection, it was noted that the door leading to the garage appears to be inappropriate, potentially failing to meet current building code standards or safety requirements. The internal door leading to the garage should be a minimum of 1 3/8 inches thick – either a solid wood door, a solid or honeycomb-core steel door, or a 20-minute fire door, must not have openings or glazing, and is self-closing. This can pose a safety risk. I recommend a qualified contractor replace this door with a fire-rated door.

Recommendation: Contact a qualified professional.

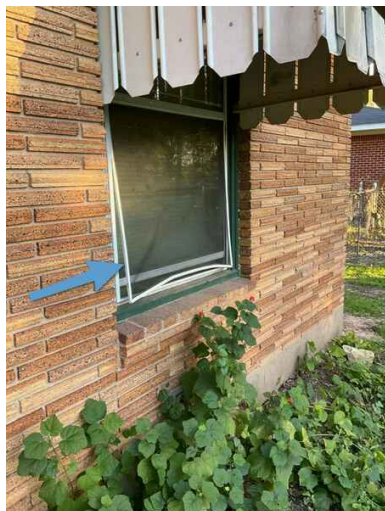
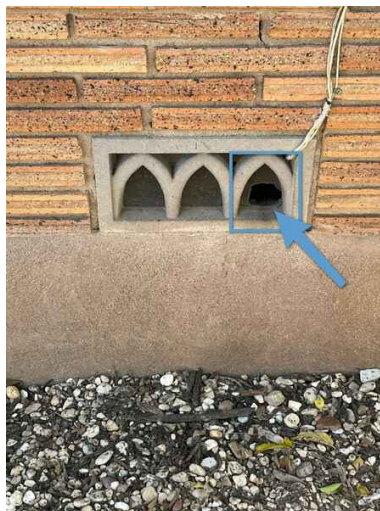
During the inspection, it was noted that one or more window screens exhibited damage. Window screens are essential for maintaining a comfortable and insect-free indoor environment while allowing for ventilation. I recommend replacing the screen as needed.

Recommendation: Contact a qualified professional.

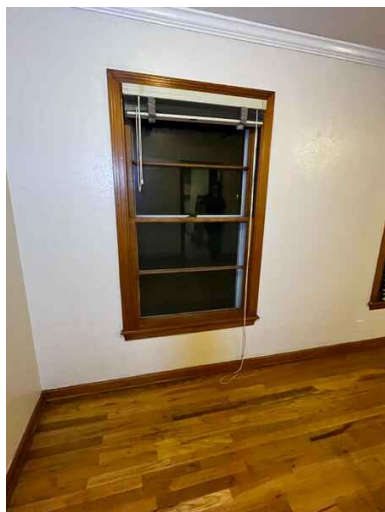
Living Room

not only limit these essential aspects but also pose potential safety concerns. I recommend a qualified window contractor evaluate and repair windows so that they are functional.

Recommendation: Contact a qualified window repair/installation contractor.

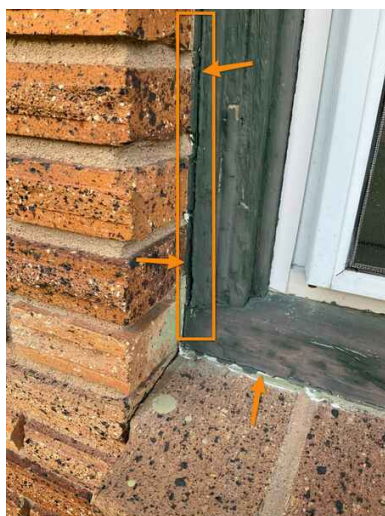
External Window

5: Caulking Missing/ Deteriorated

During the inspection, it was observed that caulking was missing or deteriorated around one or more external windows. Caulking is a crucial component for weatherproofing and sealing gaps, preventing water infiltration, and maintaining energy efficiency. Neglecting to replace missing caulking around an external window may lead to issues such as water penetration, drafts, and potential damage to the surrounding structure. I recommend replacing the missing or deteriorated caulk as soon as possible.

Recommendation: Contact a handyman or DIY project

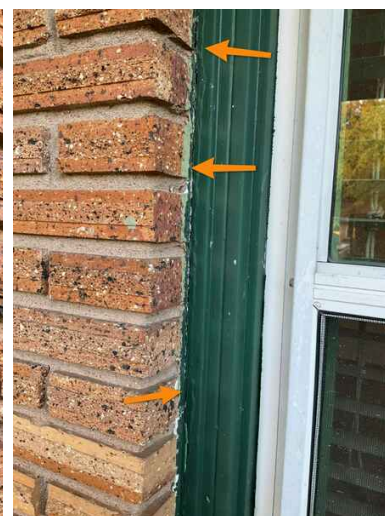
External Window

6: Window Unable to Lock Properly

During the inspection, it was noted that one or more window locks were not functioning properly. Window locks are integral to home security, providing a barrier against unauthorized access and enhancing the overall safety of the property. I recommend a qualified person evaluate and repair as needed.

Recommendation: Contact a qualified professional.

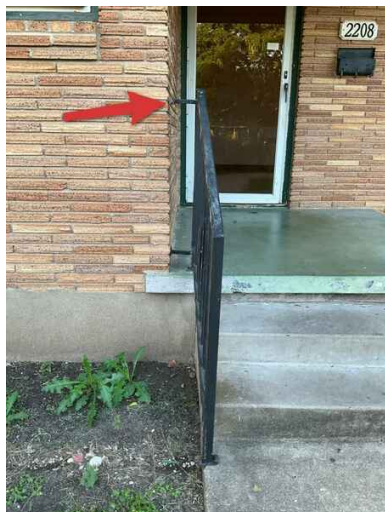
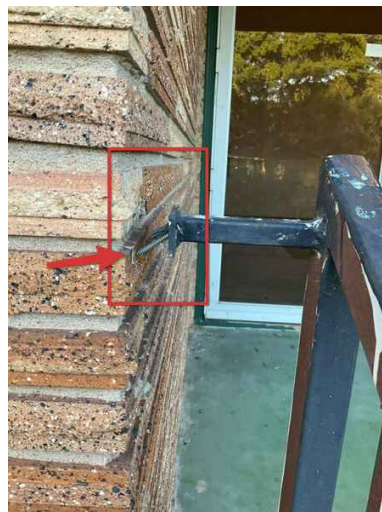
East

1: Handrail Loose

During the inspection, it was observed that the handrail was loose at one or more locations. A loose handrail poses a safety hazard, as it may fail to provide adequate support and stability for individuals using it, increasing the risk of accidents, slips, or falls. I recommend a qualified contractor evaluate and repair immediately.

Recommendation: Contact a qualified professional.

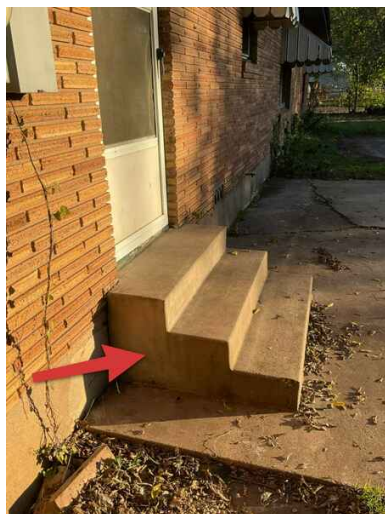
West

Handrails are missing in one or more staircases on the property, posing a safety hazard of falling. Handrails are horizontal or sloping railings that provide support and guidance for individuals while ascending or descending stairs, ramps, or other elevated surfaces. They are an essential safety feature in buildings and outdoor spaces, helping to prevent falls, provide stability, and assist with balance. Handrails are typically installed on one or both sides of a stairway, ramp, or elevated surface. They are positioned at a height that allows individuals to comfortably reach and grasp them (roughly 34-38 inches). I recommend a qualified contractor assess and provide solutions to resolve the hazard.

Recommendation: Contact a qualified professional.

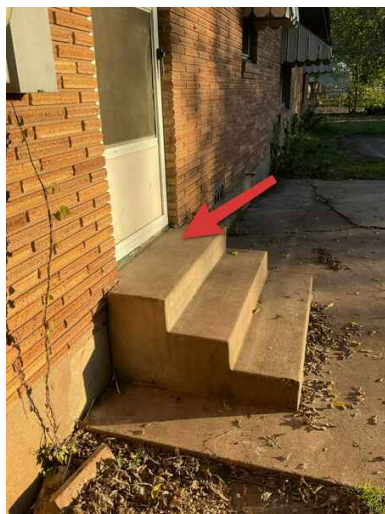
West

3: Landing/ Platform Insufficient

The landing/ platform at the top of the stairs is insufficient or nonexistent. When steps lead to an entry door, the platform at the top should be large enough to stand on (3' minimum) while opening an outward swinging door. When the platform is too small or a person has to stand on the steps, it can cause an individual to be knocked down by someone exiting the property. This is a safety hazard. I recommend a qualified contractor assess the situation and provide solutions to resolve the hazard.

Recommendation: Contact a qualified professional.

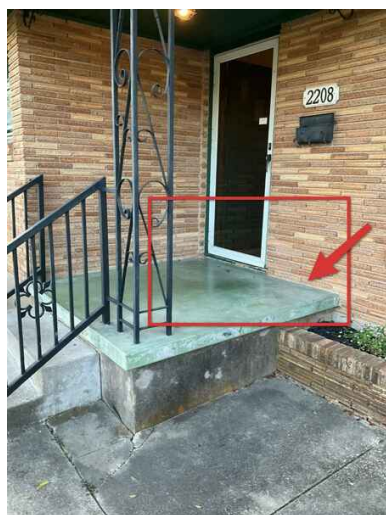
During the inspection, it was observed that the porch/ stoop is missing guardrails, presenting a safety concern for individuals accessing or descending from this elevated platform. Stoops are commonly characterized by a few steps leading up to a raised platform or porch, providing a transitional space between the exterior and interior of a home. Guardrails are essential safety features, providing a barrier to prevent accidental falls and ensuring the well-being of residents and visitors. I recommend a qualified contractor evaluate and repair as needed.

Recommendation: Contact a qualified professional.

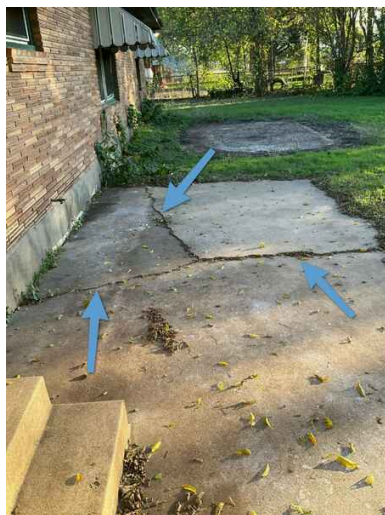
2: Patio Cracked

During the inspection, it was observed that the concrete patio exhibits visible cracking. Cracks in concrete surfaces can occur due to a variety of factors, including weather conditions, settling, or improper installation. This does not affect the affect integrity of the property's foundation. This is for your information.

* If you want to fix the problem, I recommend consulting with a qualified landscape professional who specializes in concrete patios.

Recommendation: Contact a qualified professional.

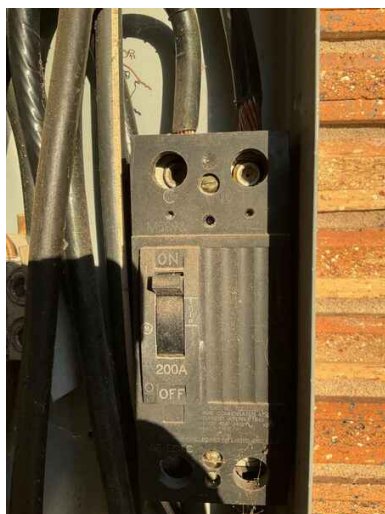
200 AMP Main Breaker

Main Panel Capacity: 200 AMP
West- Outside

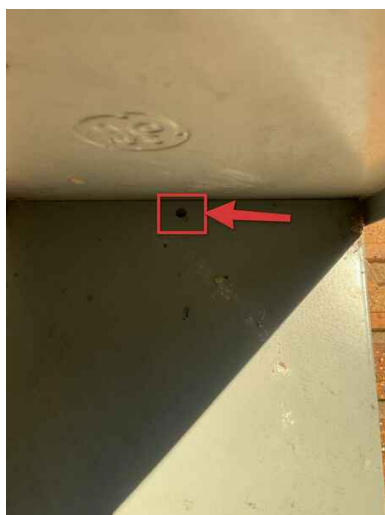
Main Panel

The panel is missing cover screws for the front cover. This is a safety issue that needs correcting. I recommend a qualified electrician be consulted for further evaluation and repair.

Recommendation: Contact a qualified professional.

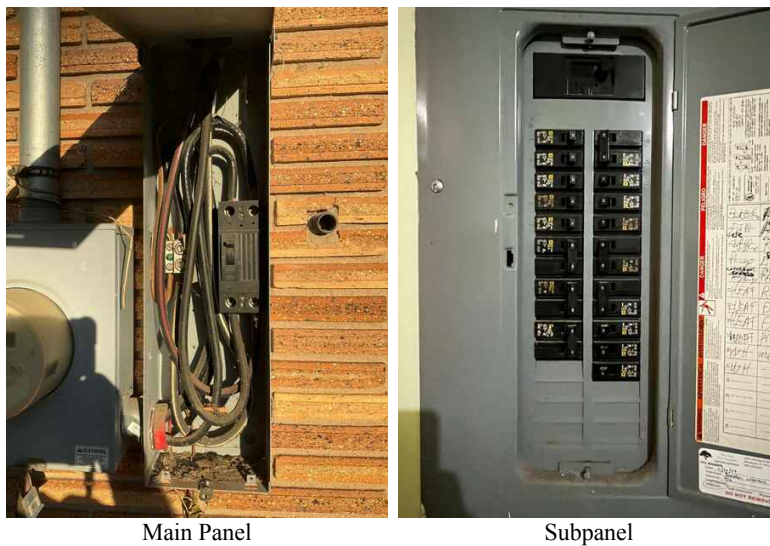
6: Surge Protector Missing

During the inspection, it was observed that there was a missing surge protector in the electrical panel. Surge protectors play a crucial role in safeguarding electronic devices and appliances from voltage spikes, helping prevent potential damage caused by power surges. The absence of a surge protector increases the vulnerability of sensitive electronic equipment to fluctuations in the electrical supply, which may occur due to lightning strikes, utility grid issues, or other electrical disturbances. I recommend a qualified electrician be consulted for further evaluation and repair.

Recommendation: Contact a qualified professional.

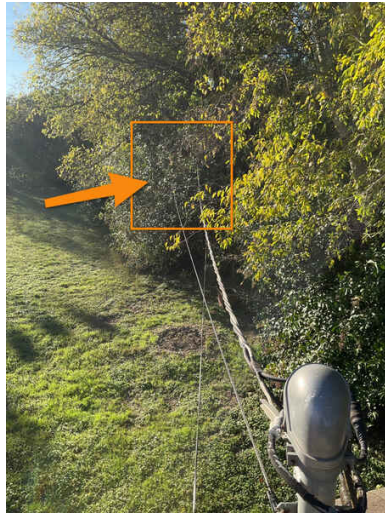
Overhead Mast Wiring

During the inspection, it was noted that electrical wires are in close proximity to trees and overhanging branches. This presents a notable safety concern as it increases the risk of potential hazards such as electrical fires, outages, or damage to the wiring due to contact with tree limbs. To address this issue, it is strongly recommended to engage the services of a qualified arborist and an electrician. The arborist can assess the trees in proximity to the wires, trim or remove branches as needed, and ensure a safe distance between the vegetation and the electrical lines. Simultaneously, the electrician can inspect the wiring for any damage and make necessary adjustments or repairs to enhance safety.

Recommendation: Contact a qualified professional.

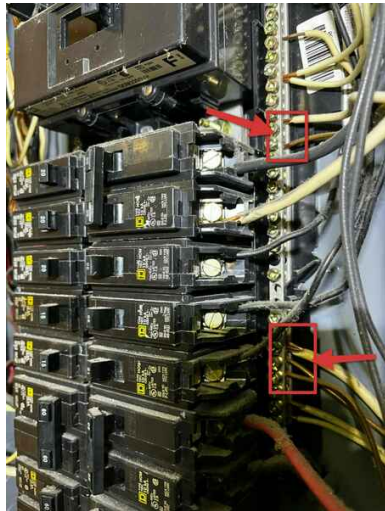
Subpanel

The electrical sub-panel was observed to have neutral and ground wires on the same bus bar. Combining neutral and ground wires on the same bus bar in an electrical sub-panel raises concerns about proper grounding practices and potential safety hazards. The neutral and ground wires serve distinct purposes in an electrical system, and keeping them separate is essential for maintaining a safe and effective electrical installation. The neutral wire returns the current from the electrical load to the source, typically the utility transformer. On the other hand, the ground wire is a safety feature that provides a path for fault currents to safely flow into the ground, preventing electrical shock hazards. I recommend a licensed electrician evaluate and repair the deficiency as needed.

Recommendation: Contact a qualified electrical contractor.

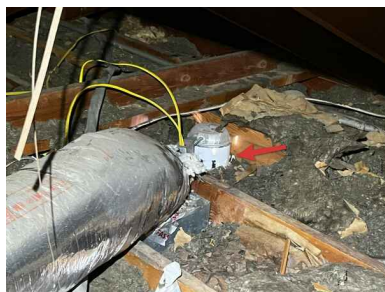
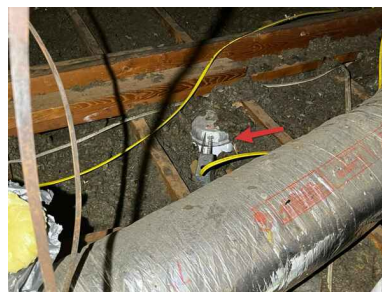
3: Light Fixture Touching Insulation

Recommendation: Contact a qualified professional.

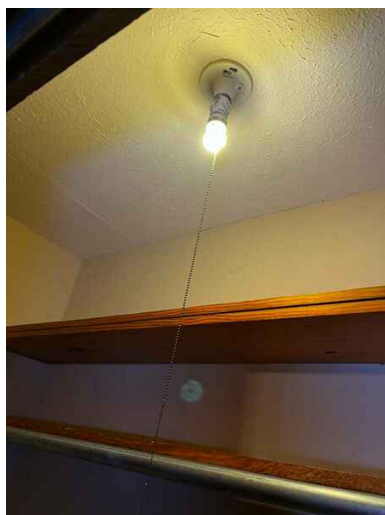
Closet Light

During the inspection, it was observed that one or more light fixtures were missing its protective cover. The protective cover serves as a crucial safety feature, preventing direct contact with the light bulb and reducing the risk of accidental breakage or exposure to electrical components.

Recommendation: Contact a qualified professional.

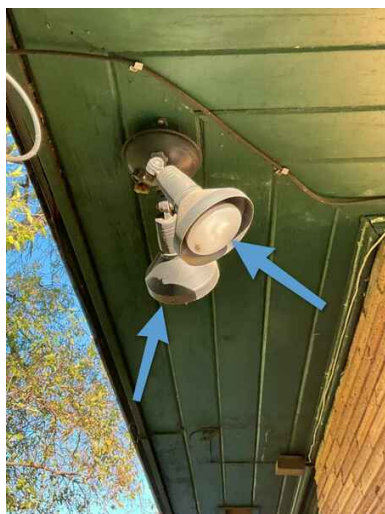
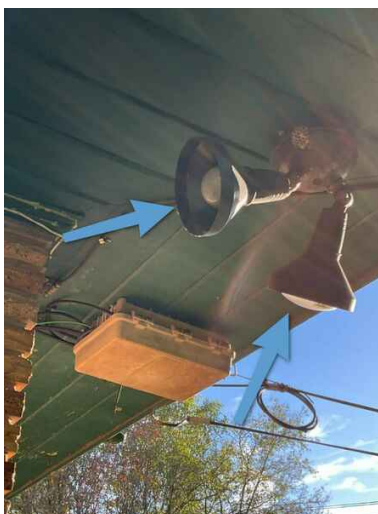
5: Light Inoperable

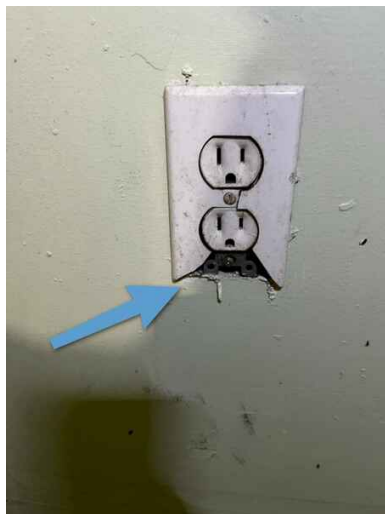
Receptacle Cover Plate

6: Receptacle- Cover Plates Damaged

Some outlets have a damaged cover plate in some areas. I recommend replacing it with a new cover plate.

Recommendation: Recommended DIY Project

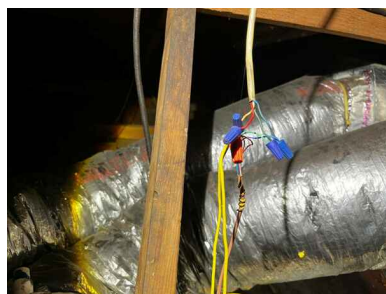
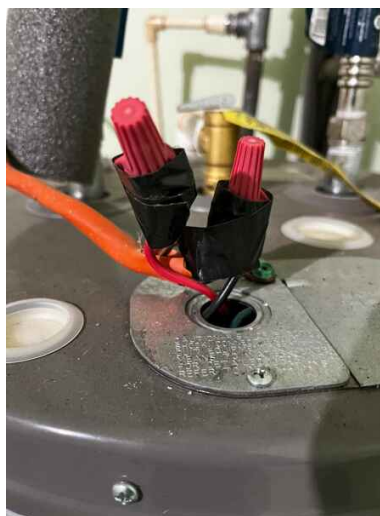
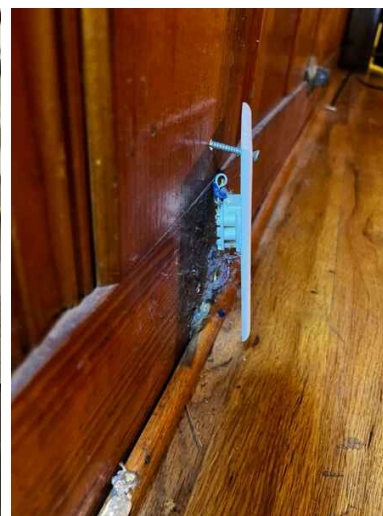
During the inspection, it was observed that there are missing junction boxes in the electrical system. Junction boxes are critical components in electrical installations, providing protective enclosures for wire connections and contributing to the overall safety and organization of the wiring. The absence of junction boxes raises significant concerns as it increases the risk of exposed wires, potential electrical hazards, and difficulties in identifying or resolving electrical issues. I recommend a licensed electrician evaluate and repair as needed.

Recommendation: Contact a qualified electrical contractor.

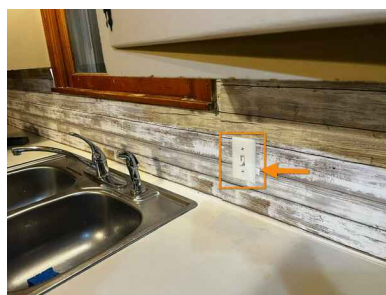
Kitchen

11: Light Switch Inoperable

During the inspection, it was observed that one or more light switches were inoperable. A non-functioning light switch can be indicative of electrical issues, faulty wiring, a malfunctioning switch, or a switch that is not connected. I recommend a licensed electrician evaluate and correct the problem.

Recommendation: Contact a qualified electrical contractor.

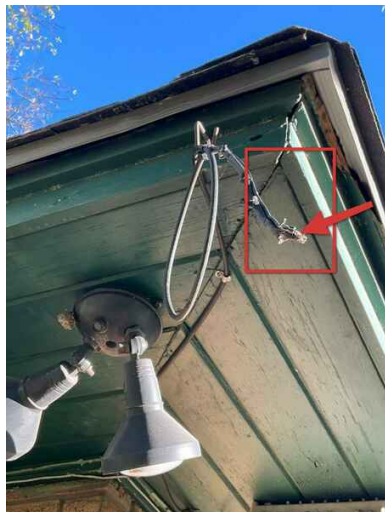
Exposed Wire

12: Wire Exposed

During the inspection, it was observed that there were exposed wires in one or more areas. Exposed wires pose a significant safety hazard, as they can lead to electrical shocks, fires, and other potential dangers. This is a safety concern. I recommend a licensed electrician evaluate and correct the concern.

Recommendation: Contact a qualified electrical contractor.

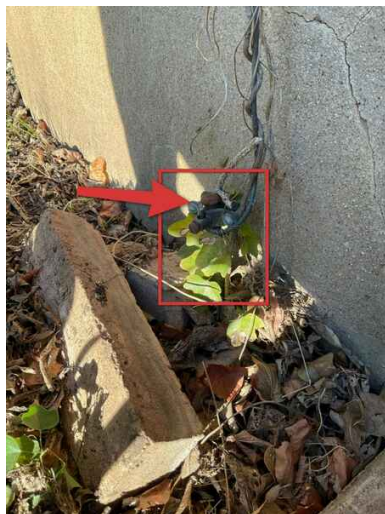
Grounding Rod

13: Ground Rod Improper Install

During the inspection, it was noted that there were concerns related to the grounding rod. Proper grounding is crucial for the safety and functionality of the electrical system. The grounding rod should be at least 8 ft long and fully submerged. An exposed grounding poses a tripping hazard and may not perform as intended. I recommend a licensed electrician evaluate and repair as needed.

Recommendation: Contact a qualified professional.

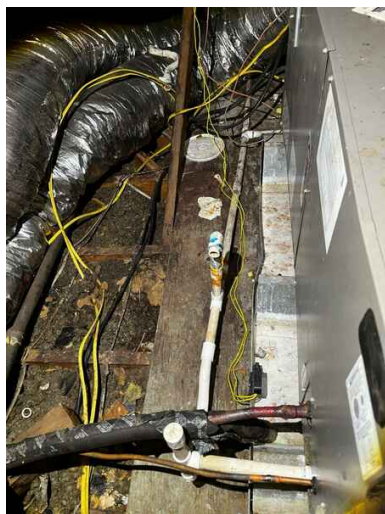
Attic

One or more furnaces do not have the appropriate clearance to be serviced and/ or inspected properly. A level service space at least 30 inches wide by 30 inches deep should be provided in front of all parts of the appliances that require service. I recommend a licensed HVAC contractor assess and provide solutions to resolve the clearance issue.

Recommendation: Contact a qualified HVAC professional.

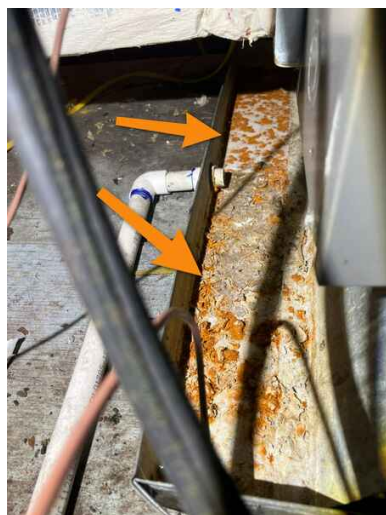
During the inspection, it was noted that the HVAC drain pan is exhibiting signs of rust. The presence of rust on the drain pan raises concerns about its structural integrity and potential for water leakage. A rusted drain pan may compromise the effectiveness of the HVAC system, leading to water damage and reduced indoor air quality. I recommend a licensed HVAC professional evaluate and replace the drain pan as needed.

Recommendation: Contact a qualified HVAC professional.

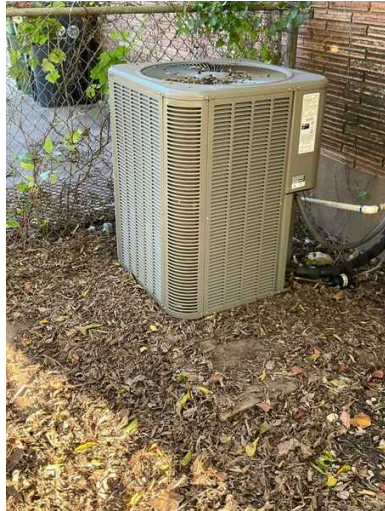
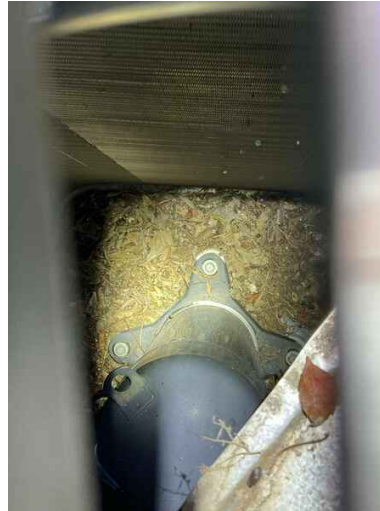
Condenser Unit

1: Condenser- Debris

efficiency and causing it to work harder to achieve desired temperatures. This may lead to increased energy consumption, higher utility costs, and potential strain on the HVAC components. I recommend cleaning out the debris in and around the unit to ensure the equipment is working efficiently. If there are any concerns in the future, contact a licensed HVAC professional for evaluation.

Recommendation: Contact a qualified HVAC professional.

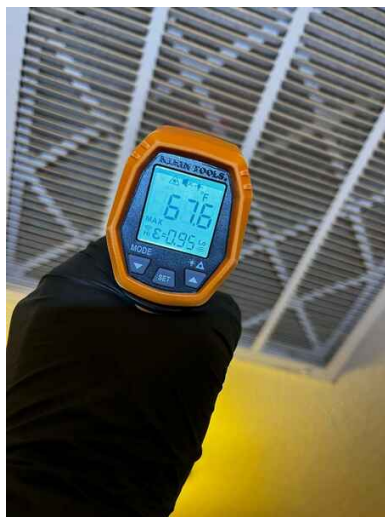
Hallway

2: Tested and Not Working Properly

The air at the supply and return air vents were measured using a laser thermometer and/or thermal imaging equipment. The differential between the supply and the return air is used to determine the performance of the cooling system. At the time of the inspection the system failed to achieve a 15 to 22 degrees Fahrenheit (F) temperature differential. Recommend evaluation by a licensed HVAC technician.

Recommendation: Contact a qualified professional.
