ROOK HOME INSPECTION- RESIDENTIAL REPORT

1234 Main Street
Waco TX 76712

01/26/2024 9:00AM

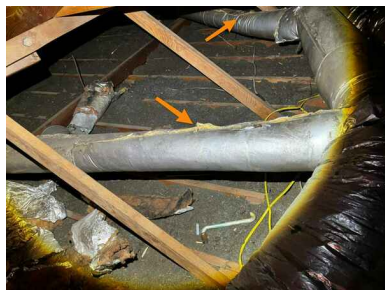
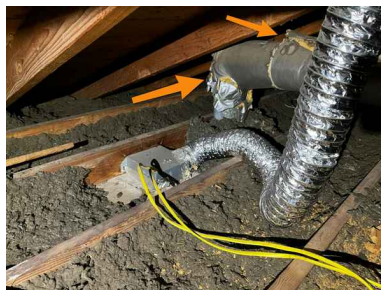
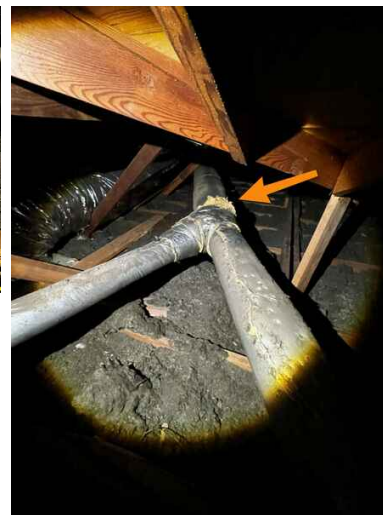
Ductwork

One or more of the insulated ducts were observed to be damaged and/or not properly sealed at the time of this inspection. This issue can lead to uneven heating or cooling, increased energy consumption, and reduced overall system effectiveness. Additionally, damaged ducts may contribute to the infiltration of contaminants, affecting indoor air quality. I recommend further evaluation and repair as needed to ensure optimum efficiency.

Recommendation: Contact a qualified HVAC professional.

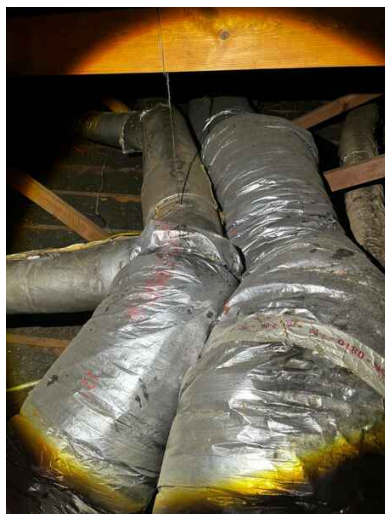
2: Ductwork in Contact with Other Ductwork

During the inspection, one or more ductwork were touching. Properly spaced and supported ductwork is essential for maintaining optimal airflow, reducing energy consumption, and prolonging the lifespan of the HVAC system. Neglecting to address ductwork contact may lead to increased operational costs, reduced system efficiency, the development of condensation, and potential discomfort for occupants. I recommend a licensed HVAC technician be consulted for further evaluation and repair.

Recommendation: Contact a qualified HVAC professional.

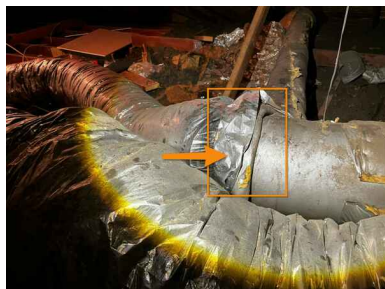
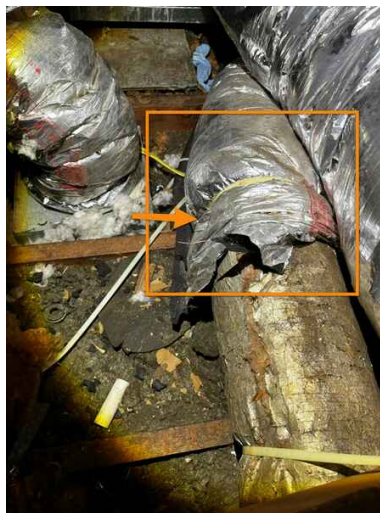
Attic

3: Ductwork Not Installed Properly

During the inspection of the ductwork in the attic, it was observed that one or more components were improperly installed. Common problems associated with improperly installed ductwork include air leaks, inadequate insulation, or improper connections. These issues can lead to uneven heating or cooling, increased energy consumption, and reduced overall system effectiveness. Additionally, poorly installed ducts may contribute to the infiltration of contaminants, affecting indoor air quality. I recommend a licensed HVAC contractor evaluate and repair as needed.

Recommendation: Contact a qualified HVAC professional.

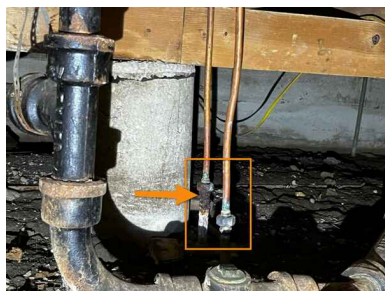
Crawlspace- Copper Pipe

1: Galvanic Corrosion Observed

Galvanic corrosion was observed in one or more areas. Galvanic corrosion, also known as bimetallic corrosion or dissimilar metal corrosion, is an electrochemical process that occurs when two different metals are in contact with each other in the presence of an electrolyte (such as water or moisture). Galvanic corrosion can lead to structural damage and reduced functionality in metal components, especially in marine environments or when dissimilar metals are used together in plumbing systems or construction applications. I recommend a licensed plumbing contractor evaluate and repair as needed.

Recommendation: Contact a qualified plumbing contractor.

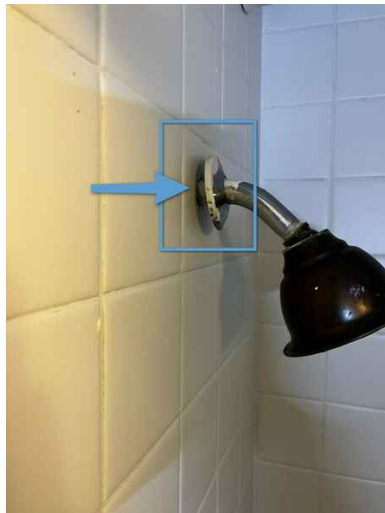
Bathroom

5: Caulk/ Grout Missing

During the inspection, one or more areas were observed to be missing caulk/ grout. Adequate caulking/ grouting plays a crucial role in maintaining the integrity of the building envelope, preventing water intrusion, and ensuring energy efficiency. The absence of caulking can lead to various issues, including air leaks, moisture penetration, and potential damage to structural components. I recommend a qualified professional evaluate and repair as needed.

Recommendation: Contact a qualified professional.

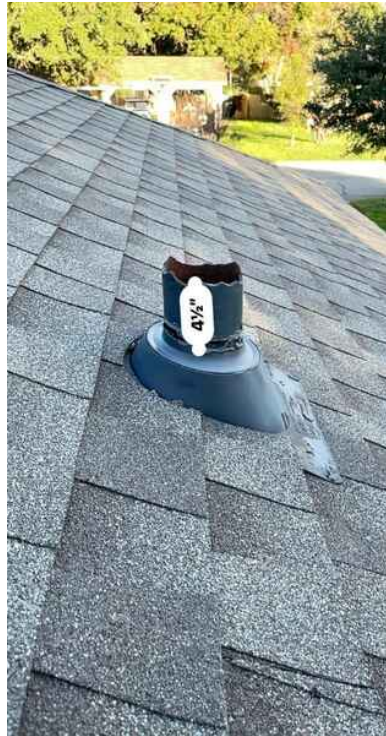
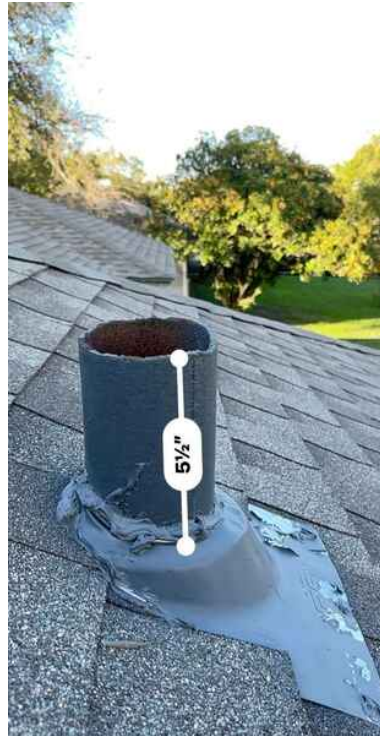
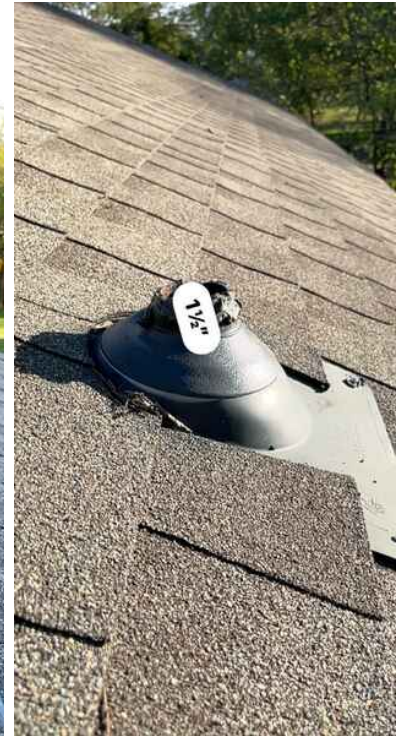
Vent Stack

1: Plumbing Stack Too Short

One or more of the plumbing stacks do not appear to extend to the proper height above the rooftop. Plumbing stacks that penetrate the roof should extend at least 6 inches above the roof structure. I recommend I licensed roofer evaluate and repair as needed.

Recommendation: Contact a qualified professional.

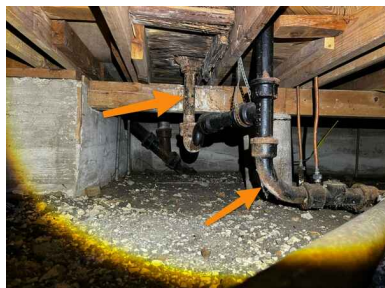
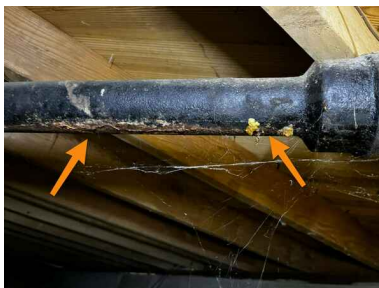
3: DWV Pipe Corroded

During the inspection, it was noted that the DWV (Drain, Waste, Vent) pipe is exhibiting signs of corrosion. Corrosion on DWV pipes is a concerning issue that can compromise the integrity and functionality of the plumbing system. Corroded pipes may lead to leaks, blockages, or reduced drainage efficiency, posing potential water damage risks and impacting the overall plumbing performance. I recommend a licensed plumbing professional evaluate and repair as needed.

Recommendation: Contact a qualified plumbing contractor.

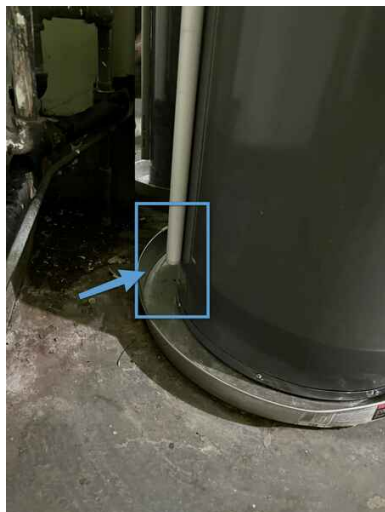
Garage- Water Heater TPR Valve

One or more of the temperature and pressure relief valve discharge pipes were terminated in a location that may cause damage or personal injury. It is recommended that the discharge pipe run downward to the exterior of the structure, turn downward, and terminate within 6- inches of the ground. I recommend a licensed plumber be consulted for further evaluation and repairs.

Recommendation: Contact a qualified plumbing contractor.

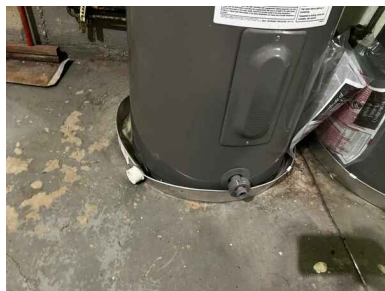
Garage- Water Heater Overflow Pan Discharge

2: Overflow Pan Discharges Inside

During the inspection, the water heaters overflow pan was observed to discharge inside of the property. This could cause water to accumulate and cause damage to structural components of the property. It is recommended that the discharge be evacuated to the outside of the property. I recommend a qualified plumbing professional evaluate and repair as needed.

Recommendation: Contact a qualified plumbing contractor.

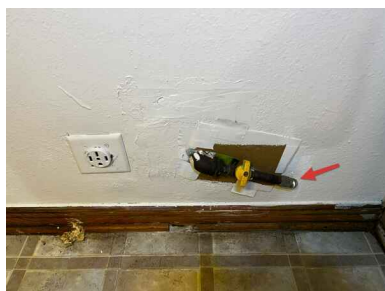
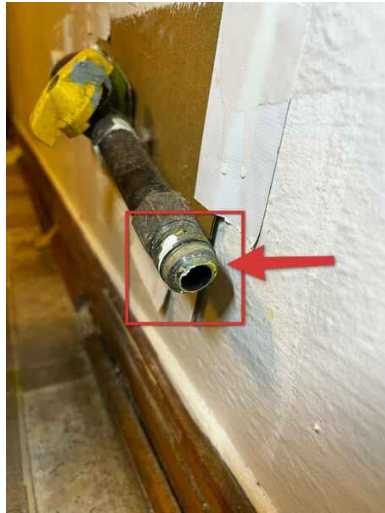
Kitchen- Gas Pipe

During the inspection, the gas distribution pipe was observed to not be capped. Though the gas shut-off lever was in the off position, this could still pose a possible safety concern. The area around the meter and the pipe was tested using a gas detection meter and it was determined that there was no concern at the time. I recommend a certified plumbing professional evaluate and cap the gas pipe as soon as possible.

Recommendation: Contact a qualified professional.

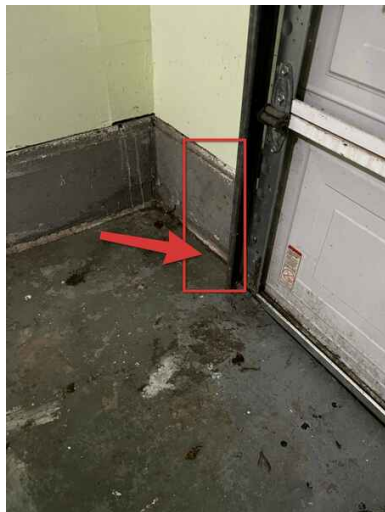
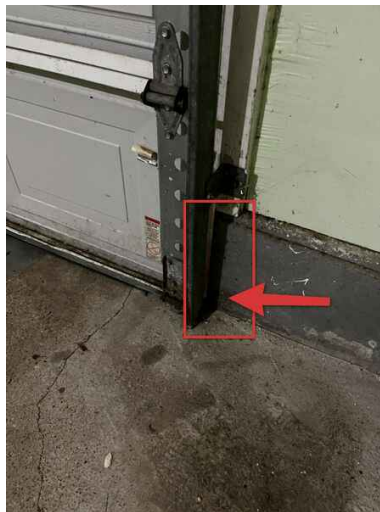
Garage

1: Auto Reverse Sensor Not Working

No safety reversing sensors were observed at the time of inspection. Photo sensors should be placed on either side of the garage door opening and at a height of at least 6 inches from the surface of the floor. This is a safety issue that needs correcting. I recommend a qualified contractor be consulted for installing needed safety sensors.

Recommendation: Contact a qualified professional.

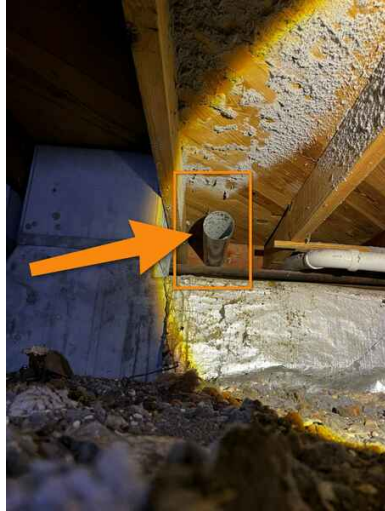
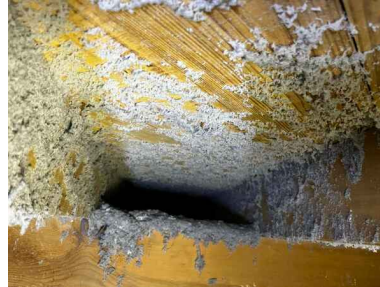
North Crawlspace

Dryer vent is not terminating to the exterior, which can cause inefficient venting and/or a fire hazard. Recommend a qualified HVAC contractor or handyman vent to exterior.

Recommendation: Contact a qualified HVAC professional.
