SUMMARY
1234 Main Street Waco TX 76712
Buyer Name
01/26/2024 9:00AM

Jose Caraballo
TREC #25913
Rook Home Inspections LLC
(254) 856-3371
rookinpections@gmail.com

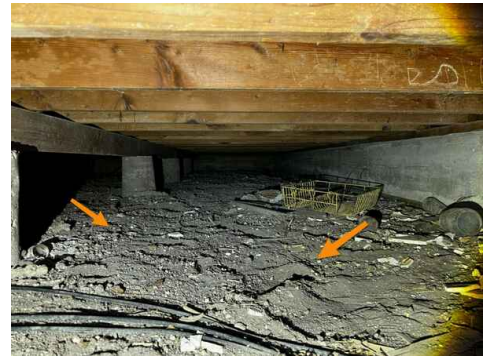
Crawlspace

CRAWLSPACE VAPOR RETARDER (BARRIER) MISSING

The vapor retarder is missing in the crawlspace. A vapor retarder, or waterproof sheeting, is typically installed in crawl spaces or attics and plays a crucial role in preventing moisture-related issues and ensuring the long-term structural integrity and energy efficiency of a home. The absence of a vapor retarder can lead to several potential problems, including increased humidity levels, condensation, and the risk of mold growth. Moisture intrusion can compromise the insulation's effectiveness, damage building materials, and contribute to indoor air quality issues. I recommend a qualified contractor evaluate and install vapor retarder as needed.

Contact a foundation contractor.

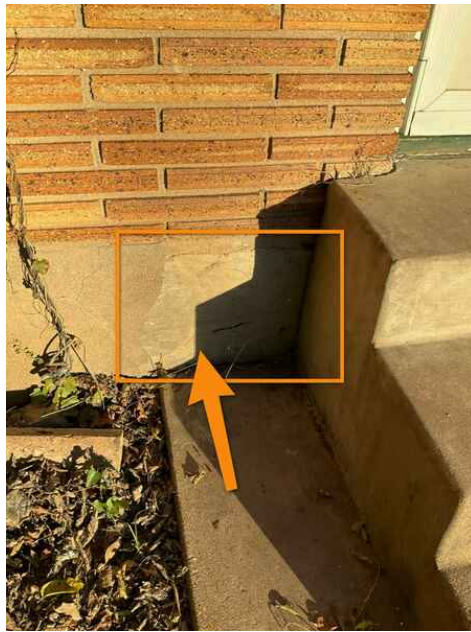
West- Stairs

SPALLING

The foundation is spalling at one or more areas. Spalling is the breakdown of concrete from natural weathering and/or chemical reaction that results in sections of cement chipping off the main body; often resulting in fractured, compromised concrete. This is considered a cosmetic issue. If you desire to correct the issue, I recommend a concrete specialist evaluate and repair it if needed.

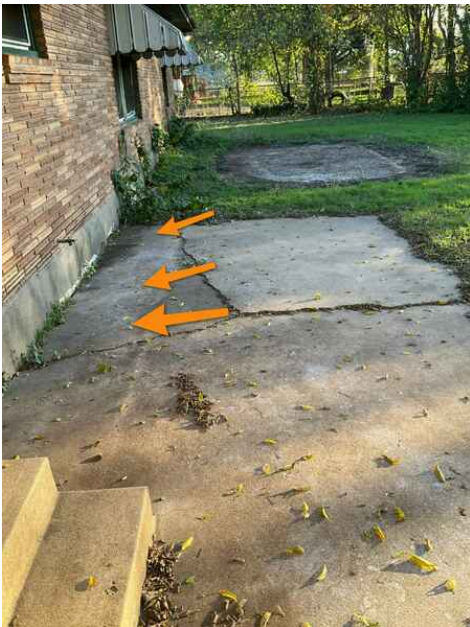
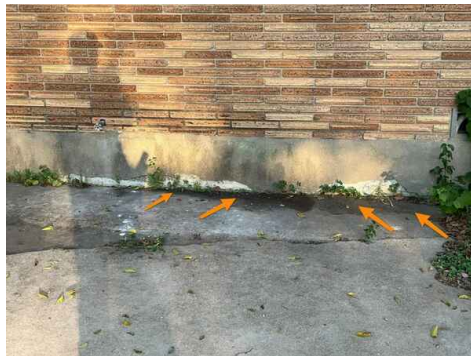
The grading does not appear to promote stormwater flow away from the house in one or more locations. The grading (ground) should slope away from the house at a rate of 6 inches for at least the first 10 feet or to a swale. Proper grading and drainage help prevent water from standing and/or ponding next to the foundation. Corrective measures may be needed if the water stands within 10 feet of the foundation perimeter for more than 24 hours.

Contact a qualified professional.

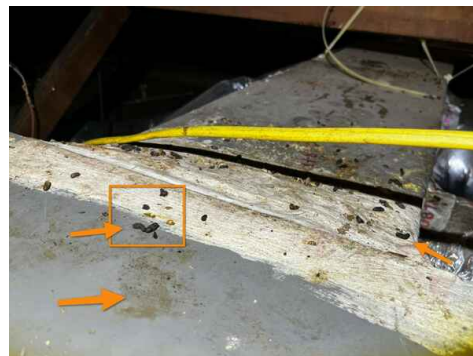
Attic

There is evidence such as droppings, gnaw marks, or nests may suggest the activity of rodents in this area. Rodents, such as mice and rats, can cause a range of problems in an attic. They may damage insulation, electrical wiring, and structural components while also posing health risks due to the spread of contaminants through their droppings and urine. I recommend a qualified pest control contractor evaluate and resolve the issue as needed.

Contact a qualified pest control specialist.

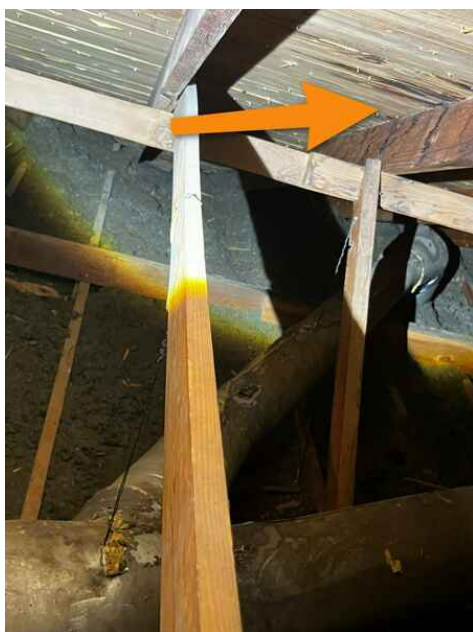
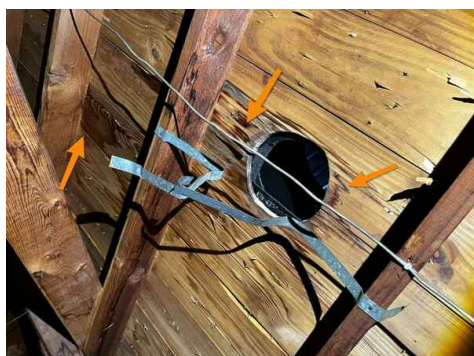
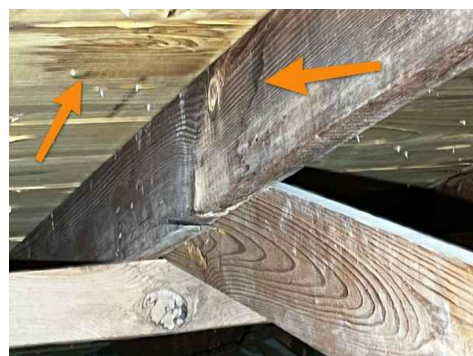
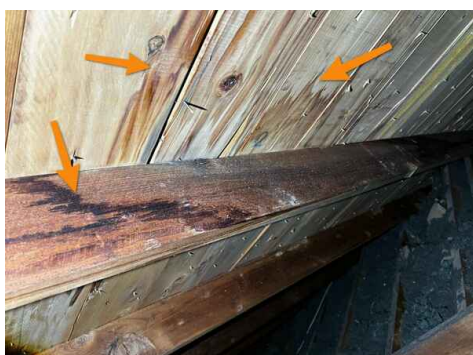
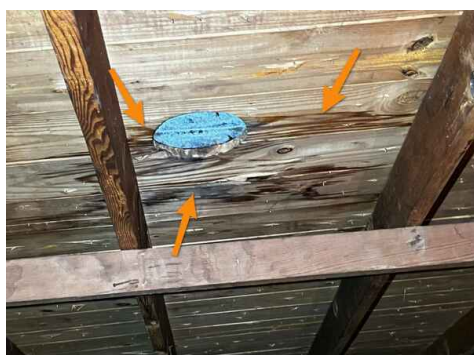
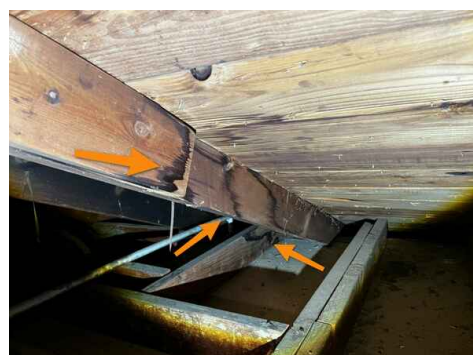
2.4.2 D. Roof Structures and Attics
EVIDENCE OF WATER INTRUSION

There is evidence of water intrusion on the rafters in the attic space. Water stains are visible in several areas. These may have been from a previous problem that is now resolved or an ongoing issue. I recommend a licensed roofer evaluate and repair as needed.

Contact a qualified roofing professional.

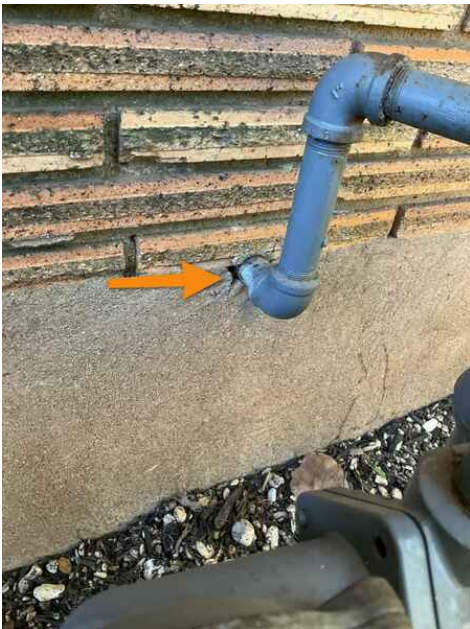
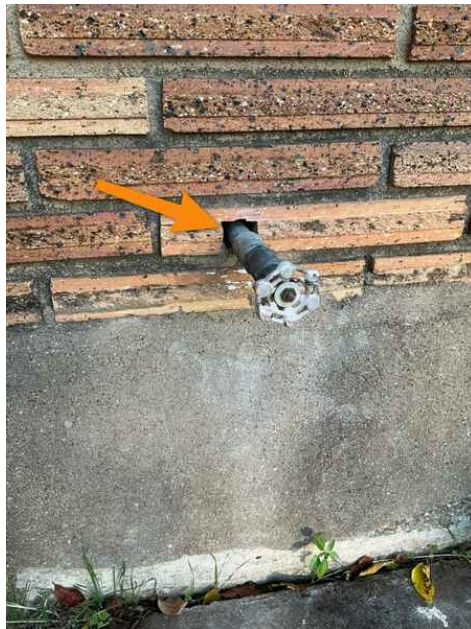
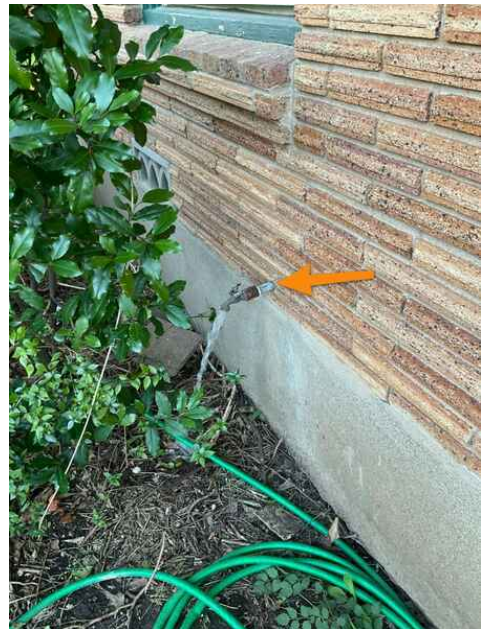
CAULKING ON EXTERIOR WALL PENETRATION MISSING

Caulk is deteriorated and/ or missing from exterior wall penetrations such as pipes, vents, or lights. This allows for water intrusion and access to wildlife. I recommend a qualified contractor evaluate and repair as needed.

Contact a qualified professional.

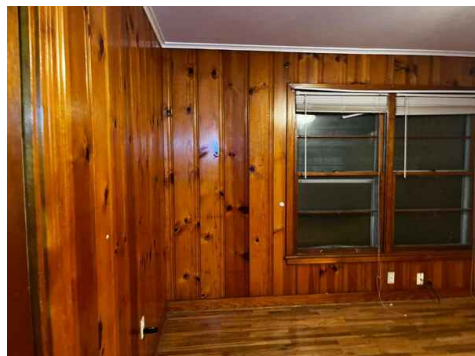
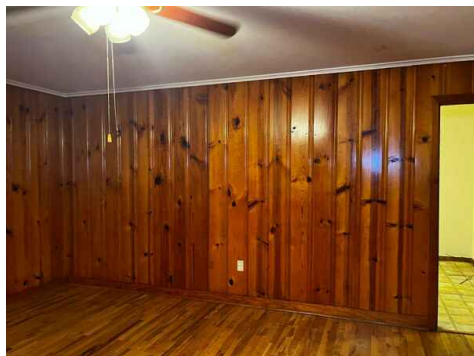
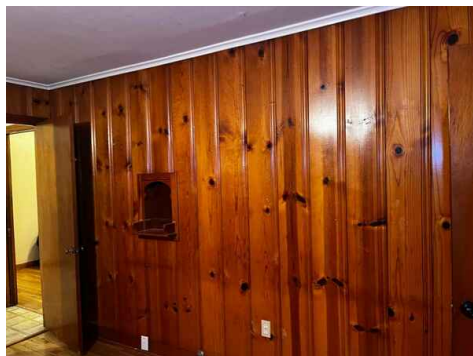
One or more internal walls of the property were observed to be a combustible wall covering that separates the habitable space. This condition does not meet current building standards and poses a fire/ safety hazard. I recommend a qualified contractor with fire separation knowledge to evaluate and repair as needed.

Contact a qualified professional.

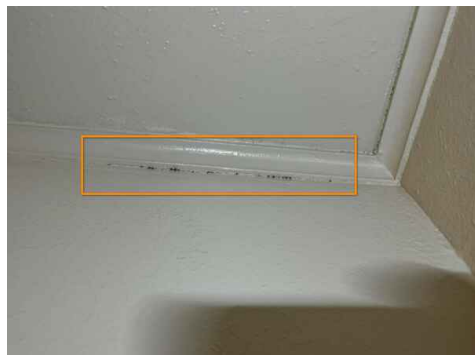
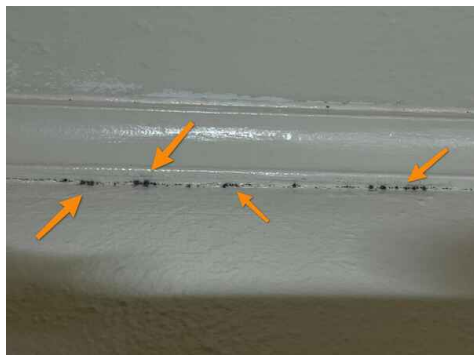
EVIDENCE OF MILDEW/ MOISTURE

Contact a qualified mold remediation contractor

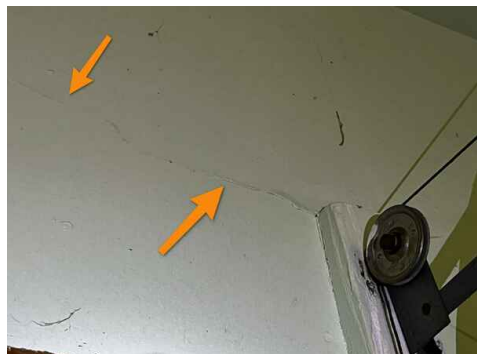
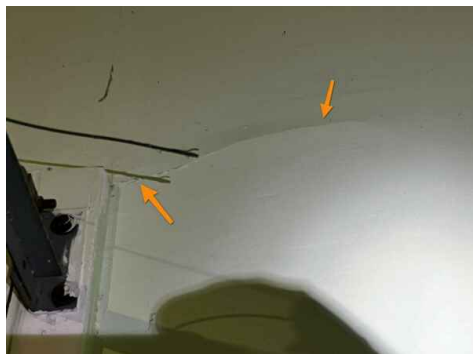
INTERIOR WALL- CRACKED/ DAMAGED

Contact a qualified professional.

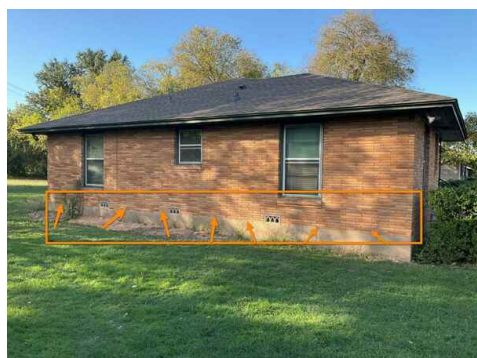
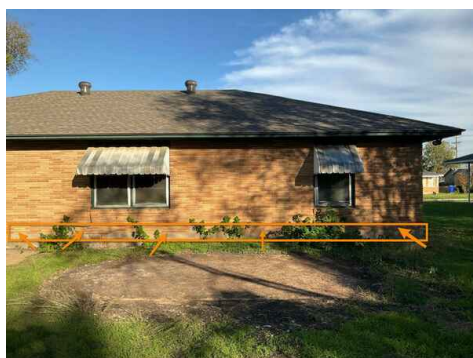
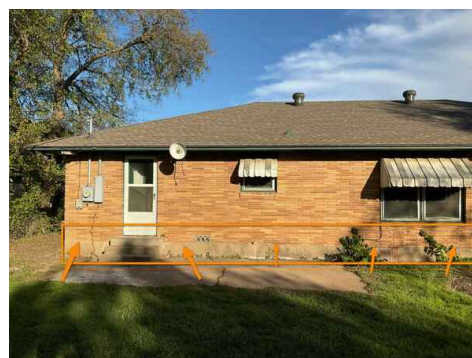
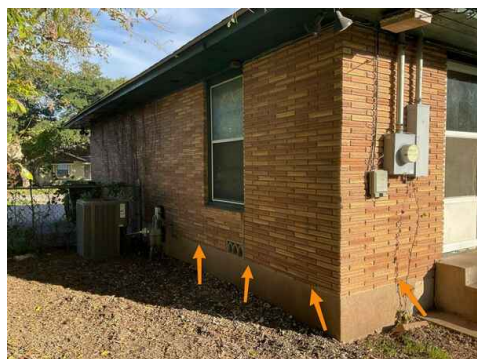
WEEP HOLE MISSING

Contact a qualified siding specialist.

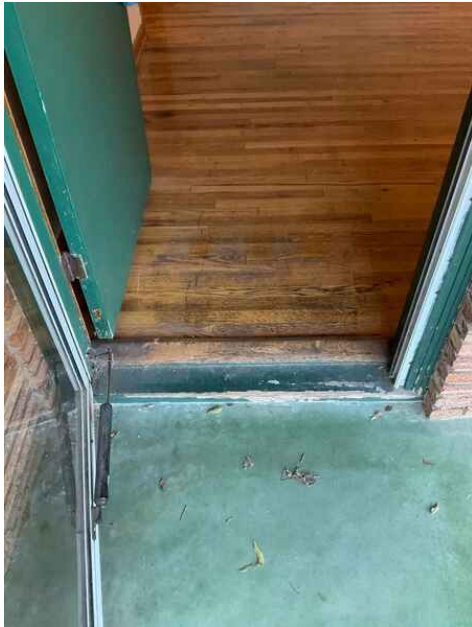
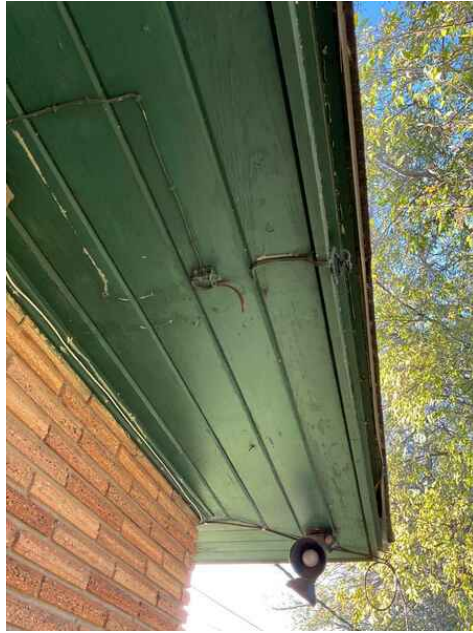
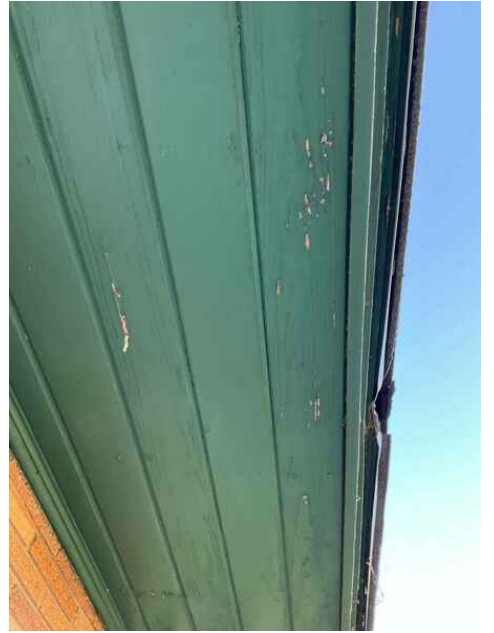
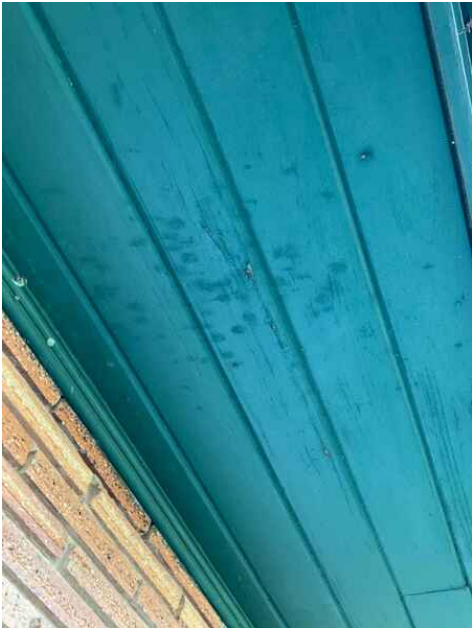
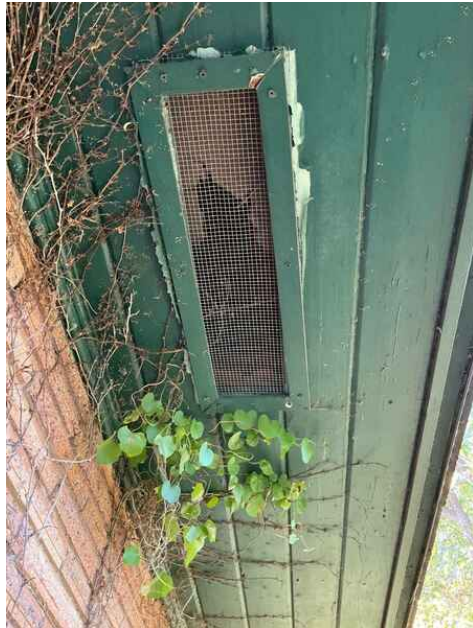
During the inspection, it was noted that there are areas where the paint is failing or missing. The integrity of exterior paint is crucial for protecting surfaces from weathering, moisture, and UV damage. Neglecting to address failing or missing paint may result in further deterioration of surfaces, potential structural damage, and diminished aesthetic appeal. I recommend repainting exterior surfaces as soon as possible.

Recommendation
Contact a handyman or DIY project

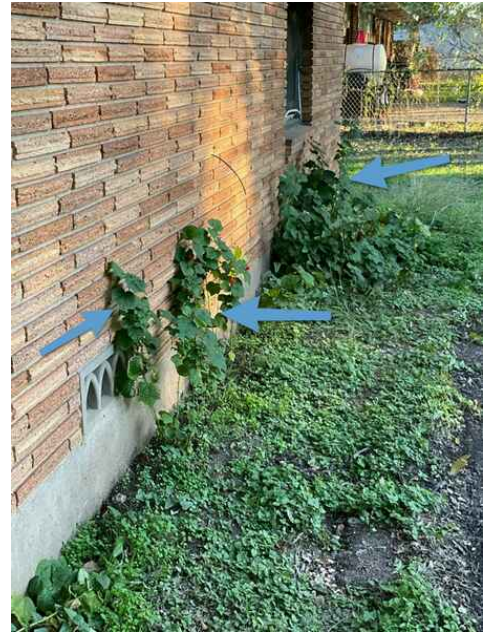
Vegetation

2.5.14 E. Walls (Interior and Exterior) **VEGETATION IN CONTACT WITH PROPERTY**

During the inspection, it was noted that vegetation was in direct contact with the house in one or more areas. The presence of vegetation in close proximity to the house can lead to various concerns, including moisture issues, pest access, and potential damage to the structure. I recommend trimming or removing the vegetation as soon as possible.

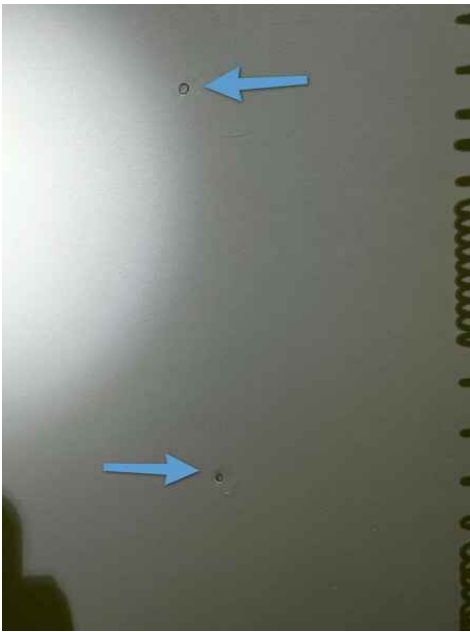
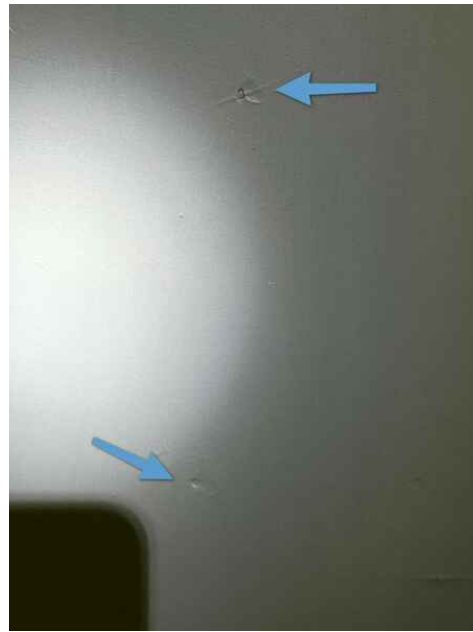
Garage Ceiling

2.6.1 F. Ceilings and Floors

The drywall on the ceiling has "Nail pops" in areas caused by settlement. This is considered cosmetic. I recommend a qualified contractor be consulted for further evaluation and repair as needed.

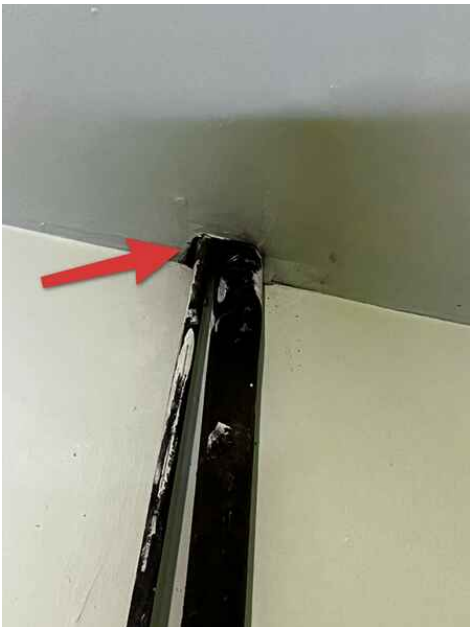
Ceiling Fire Separation

2.6.2 F. Ceilings and Floors
FIREWALL SEPARATION

The firewall separation (gypsum board) between the habitual space and the second floor was observed to be missing in one or more locations. The firewall is intended to slow the spread of fire from the habitual space to the attic. The ceiling must be separated by a minimum of 1/2" drywall (gypsum board). I recommend a qualified professional evaluate and repair as needed.

Recommendation
Contact a qualified professional.

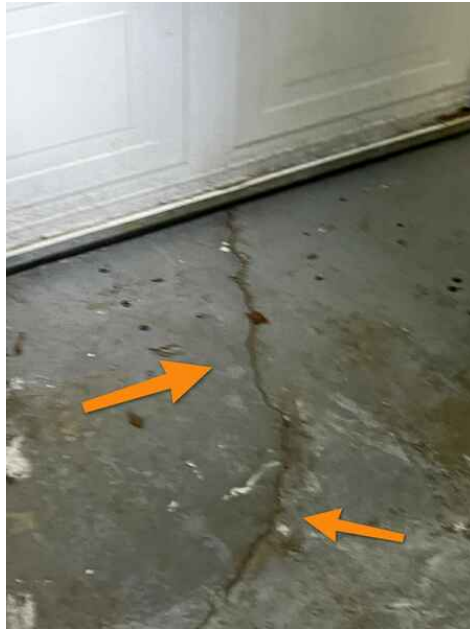
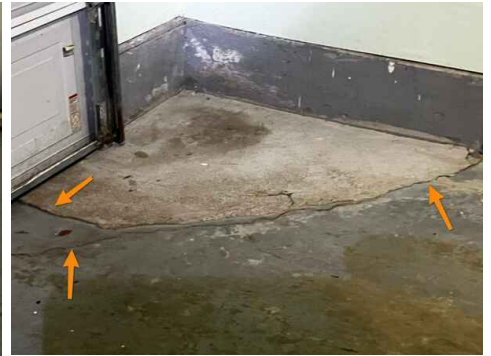
Garage Floor

2.6.3 F. Ceilings and Floors
GARAGE FLOOR- SETTLEMENT CRACKS

The concrete floor of the garage is cracked in areas. These cracks appear typical and do not seem significant. I recommend a qualified contractor be consulted for further evaluation and repair as needed.

Recommendation
Contact a qualified professional.

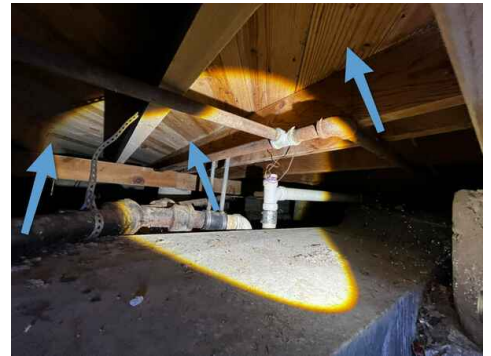
Flooring

INSULATION MISSING- PIER AND BEAM HOUSE

During the inspection, it was noted that there is missing insulation in the flooring of the pier and beam house. Adequate insulation is crucial for maintaining energy efficiency, temperature regulation, and preventing issues such as drafts and moisture infiltration. I recommend a qualified contractor be consulted for further evaluation.

Recommendation
Contact a qualified professional.

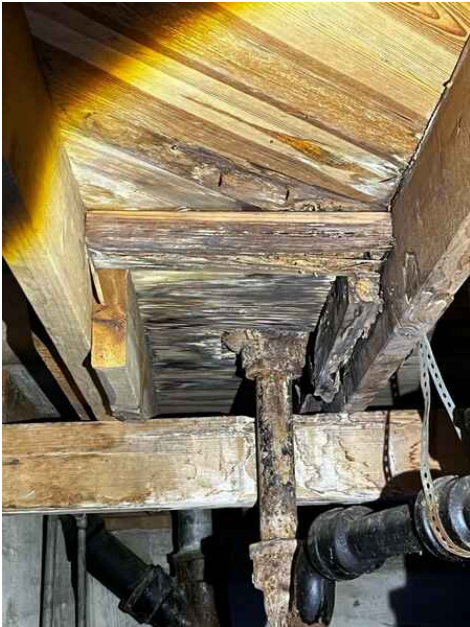
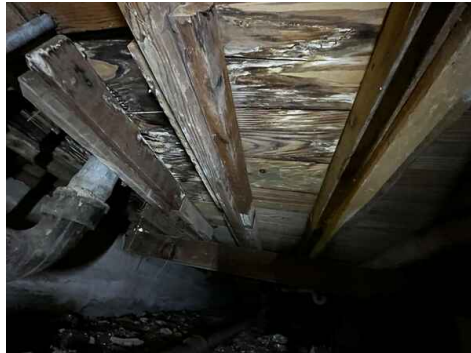
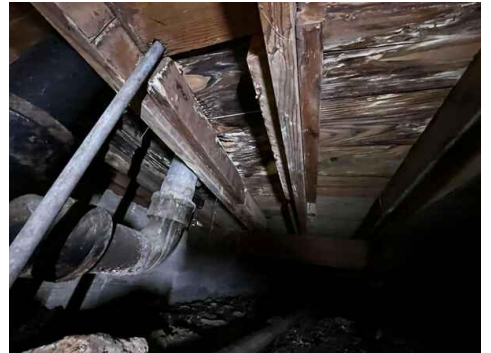
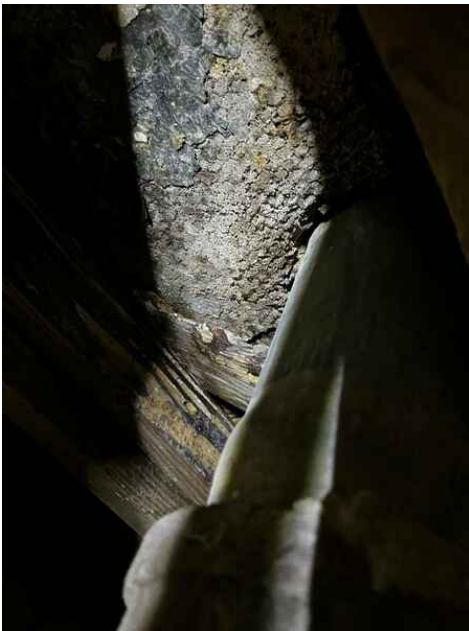
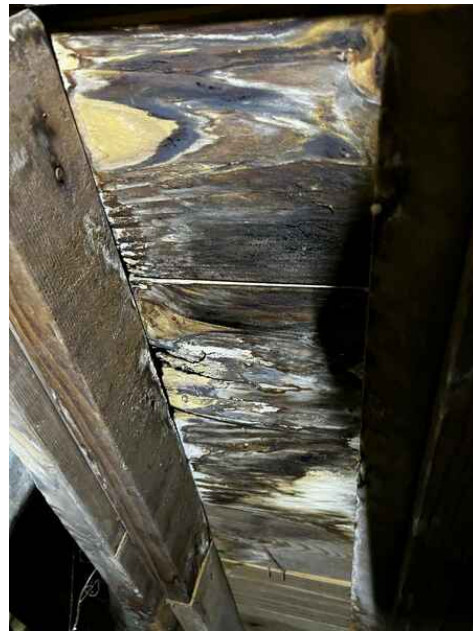
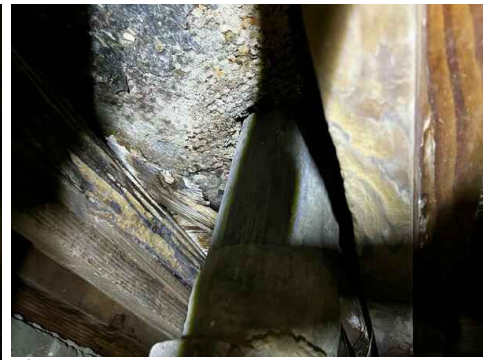
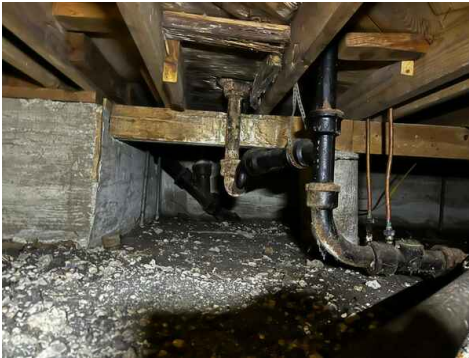
Floor

FLOORING- WATER DAMAGE

During the inspection, it was observed that there was water damage to the floor in one or more areas. Water damage to flooring can have serious consequences, including compromised structural integrity, mold growth, and potential hazards. Neglecting to address water damage promptly may lead to more extensive and costly repairs, as well as potential health risks associated with mold growth. I recommend a qualified floor professional evaluate and repair as needed.

Contact a qualified flooring contractor

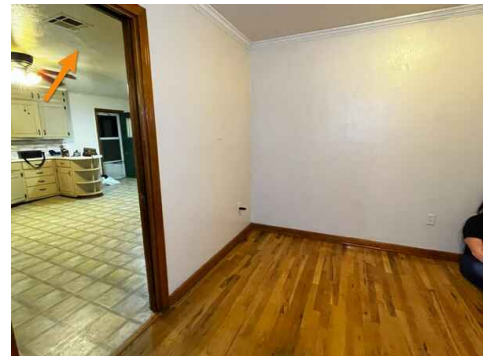
Kitchen

CEILING- POSSIBLE PREVIOUS WATER DAMAGE

During the inspection, evidence of possible previous water damage to the ceiling in one or more areas was observed. There was a bulge in the painted ceiling in the kitchen. Water damage to ceilings can result from various sources such as roof leaks, plumbing issues, or condensation problems. Thermal imaging showed no evidence of a current concern. I recommend a qualified professional evaluate and repair as needed.

Recommendation
Contact a qualified professional.

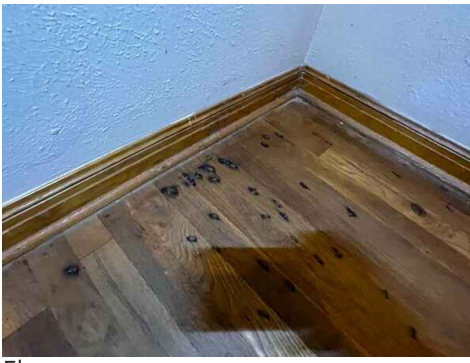
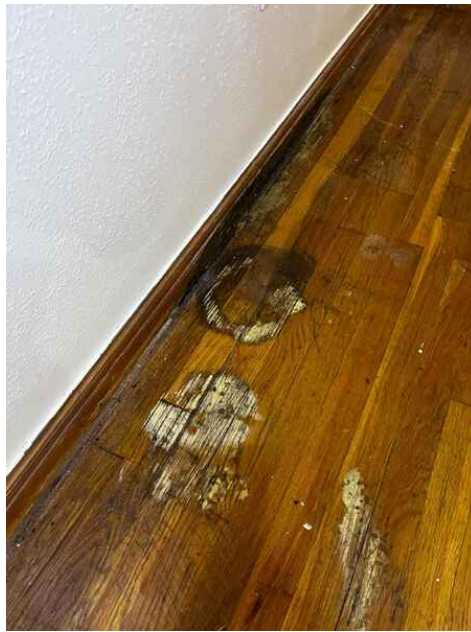
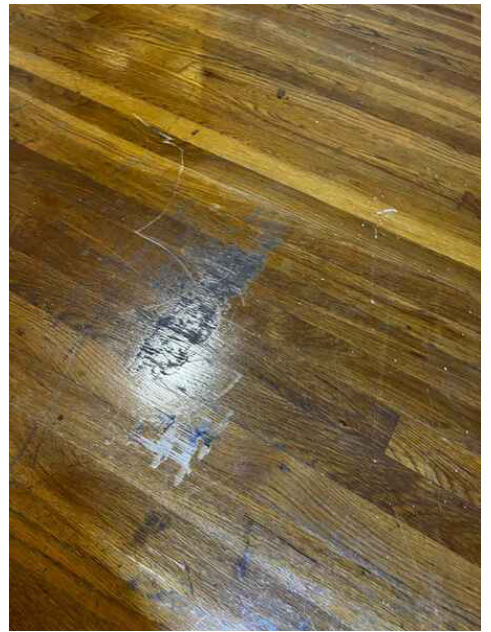
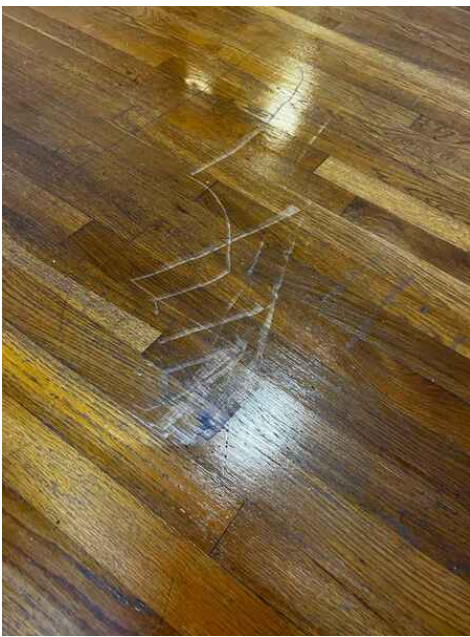
FLOOR SURFACE DAMAGED

During the inspection, it was observed that the surface of the floor in one or more areas was damaged. Floor damage can detract from the aesthetic appeal of the space and may indicate issues such as wear and tear, impact damage, or underlying structural concerns. I recommend a qualified floor professional evaluate and repair as needed.

Recommendation
Contact a qualified flooring contractor

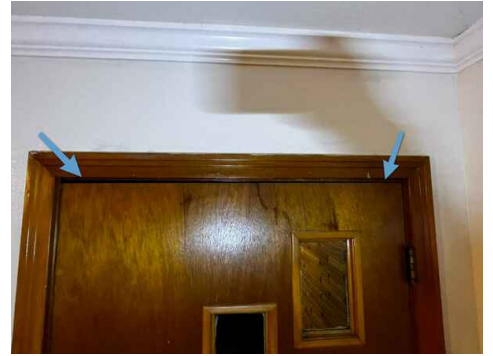
During the inspection, it was observed that the door was not plumb (square). A plumb door is crucial for proper functionality, alignment, and efficient operation. A misaligned door can lead to issues such as difficulty in closing, improper sealing, and potential energy inefficiencies. I recommend a qualified contractor evaluate and repair as needed.

Contact a qualified professional.

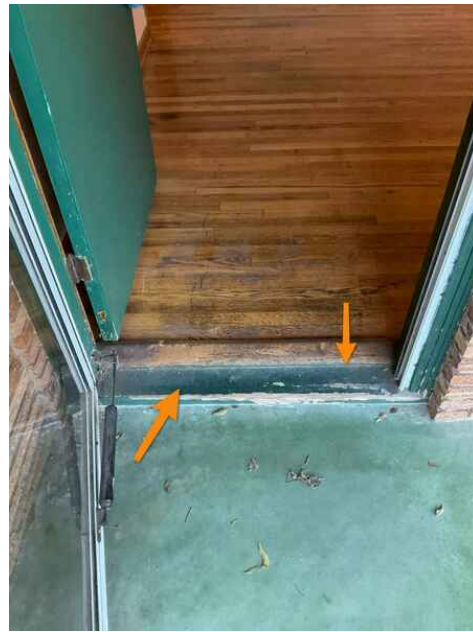
East- Front Door

DOOR WEATHER STRIP MISSING

During the inspection, it was noted that the weather stripping around one or more external doors is either missing or damaged. Weatherstripping is a crucial component for maintaining energy efficiency by sealing gaps and preventing drafts, moisture, and external elements from entering the home. I recommend replacing the weather stripping as soon as possible or contacting a qualified contractor to evaluate and repair as needed.

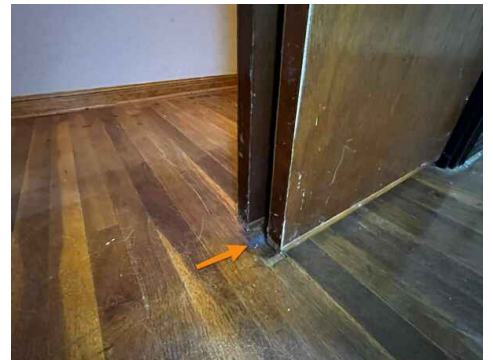
Sliding Door

DOOR RAIL MISSING

During the inspection, it was observed that one or more closet sliding door was loose. This may be caused by missing components or misalignment. A loose sliding door can impact both functionality and aesthetics, leading to difficulties in operation and potential safety concerns. Neglecting to address a loose sliding door may result in continued difficulties in opening and closing, potential damage to the door or tracks, and diminished overall functionality. I recommend a qualified contractor evaluate and repair as needed.

Contact a qualified professional.

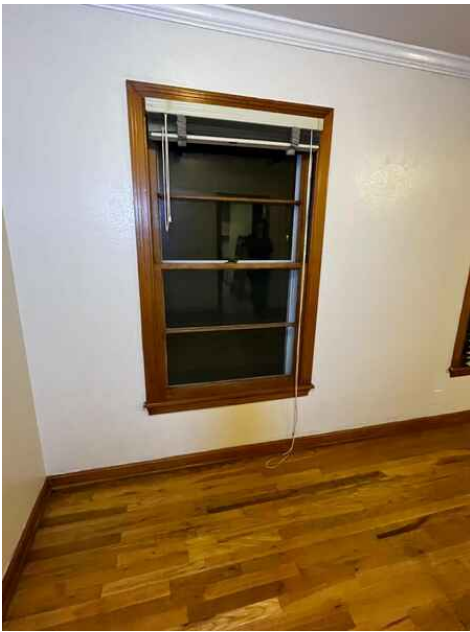
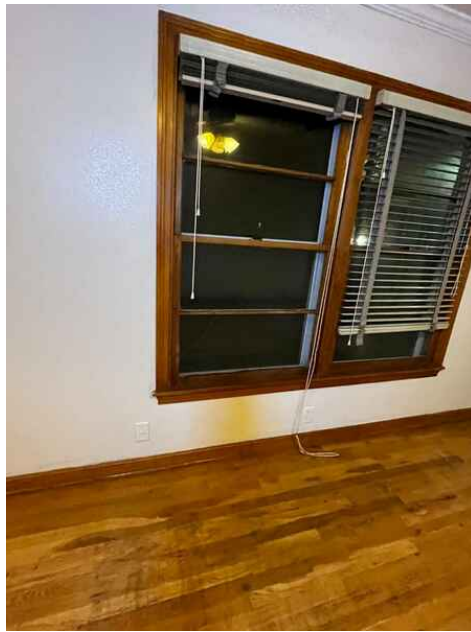
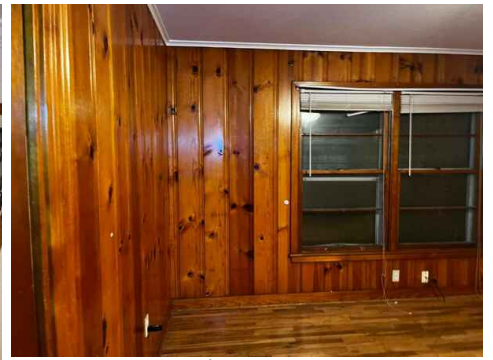
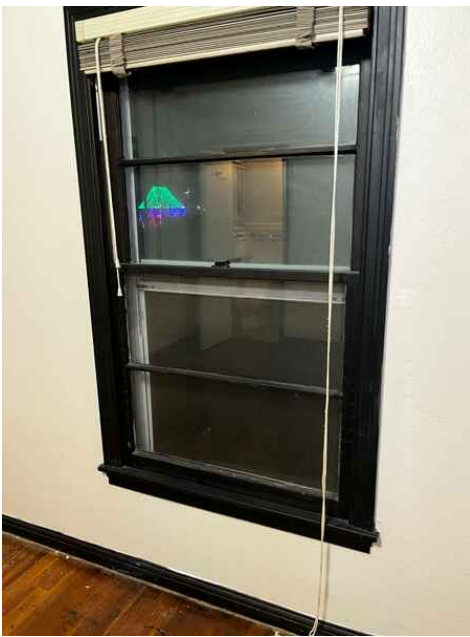
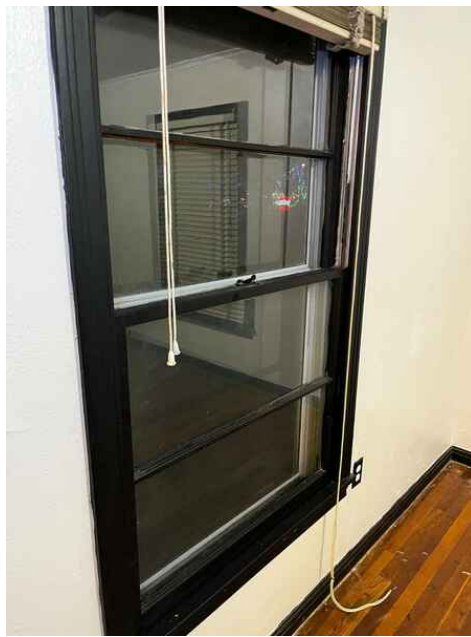
WINDOW INOPERABLE

Contact a qualified window repair/installation contractor.

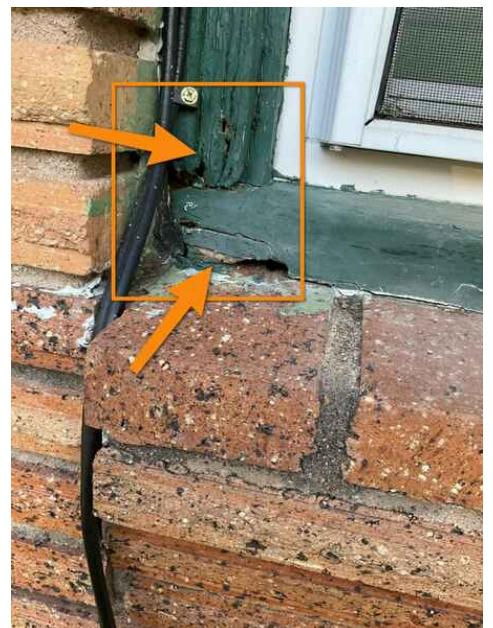
WINDOW TRIM DAMAGE/ DETERIORATED

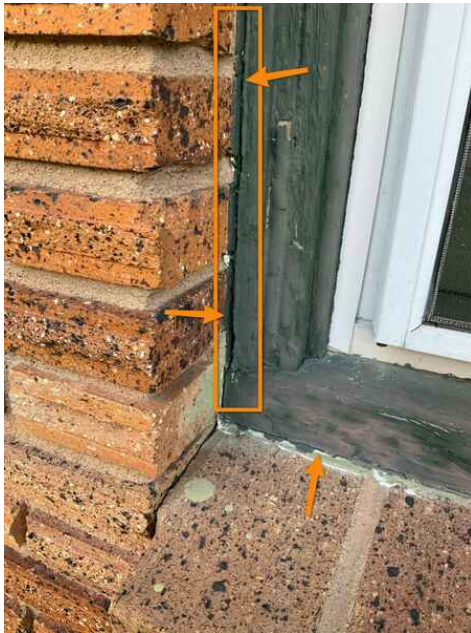
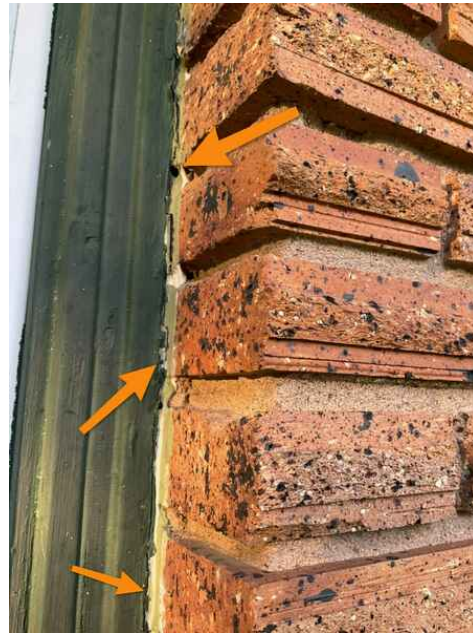
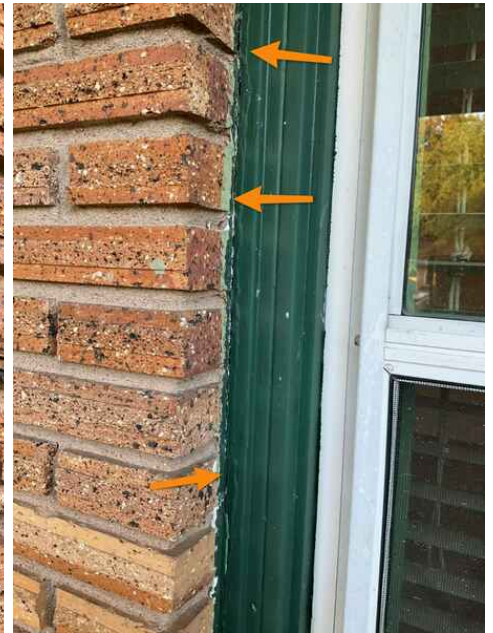
External Window

CAULKING MISSING/ DETERIORATED

Contact a handyman or DIY project

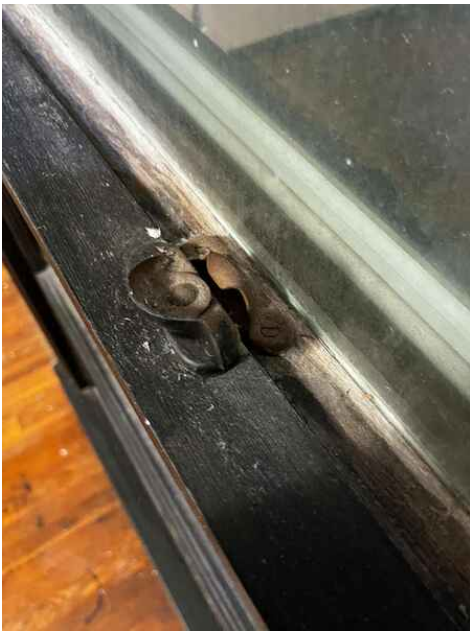
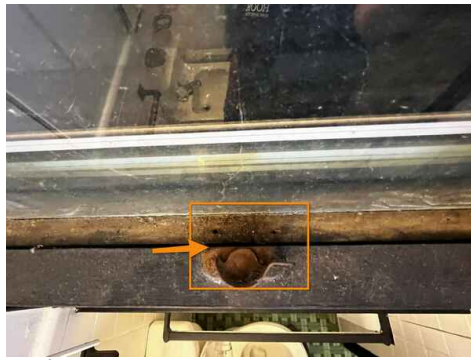
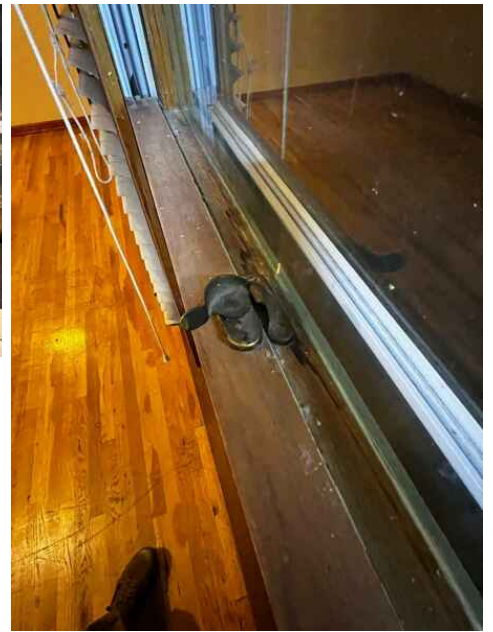
2.8.6 H. Windows

Contact a qualified professional.

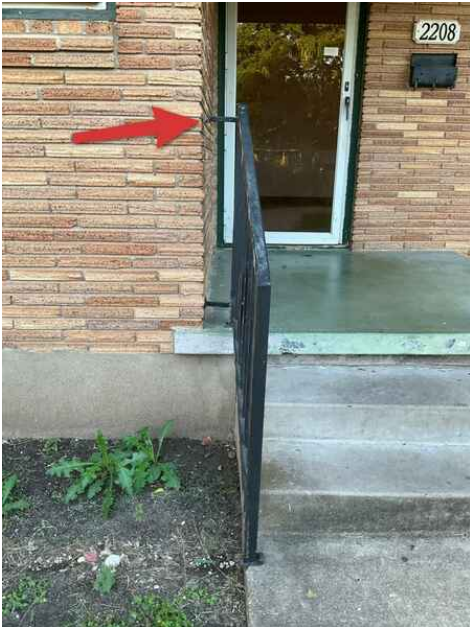
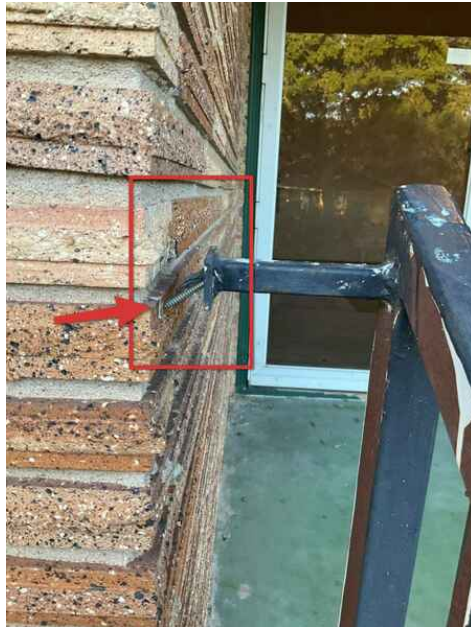
East

2.9.1 I. Stairways (Interior and Exterior)

Contact a qualified professional.

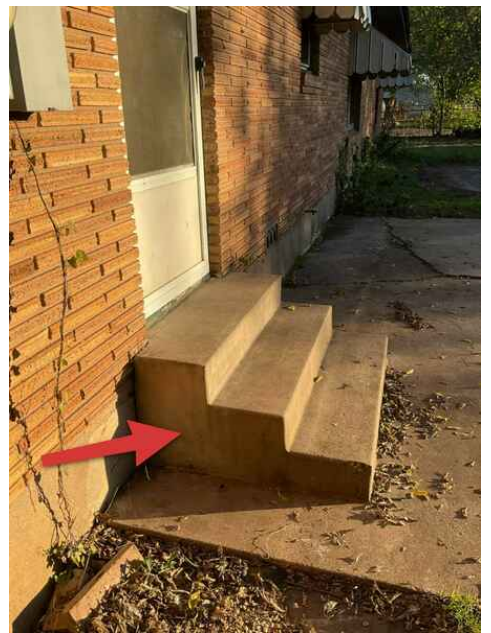
West

2.9.2 I. Stairways (Interior and Exterior)

Contact a qualified professional.

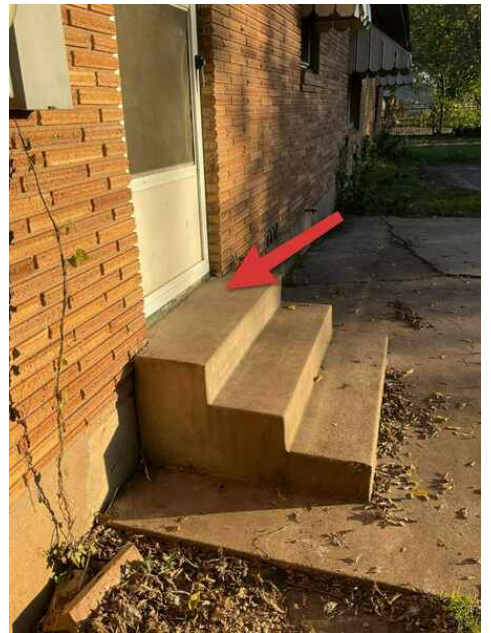
West

2.9.3 I. Stairways (Interior and Exterior)

Contact a qualified professional.

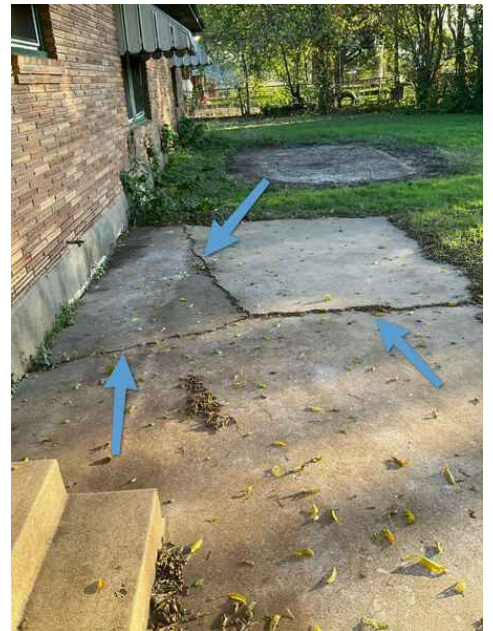
Patio

PATIO CRACKED

During the inspection, it was observed that the concrete patio exhibits visible cracking. Cracks in concrete surfaces can occur due to a variety of factors, including weather conditions, settling, or improper installation. This does not affect the affect integrity of the property's foundation. This is for your information.

* If you want to fix the problem, I recommend consulting with a qualified landscape professional who specializes in concrete patios.

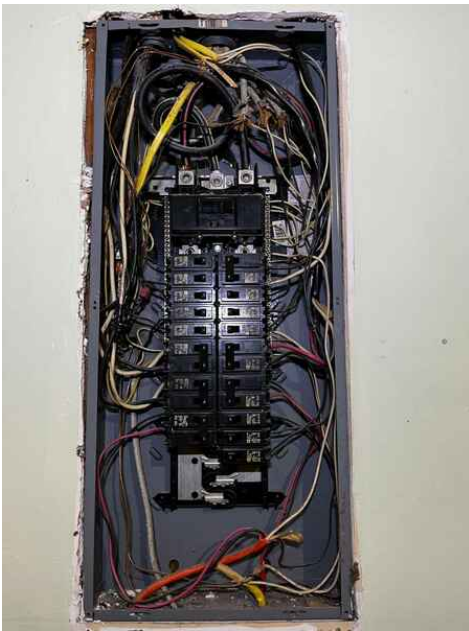
Circuit Breakers

AFCI MISSING

Arc Fault Circuit Interrupter (AFCI) breakers are missing in the service panel. AFCIs are intended to protect structures from fire caused during an arcing fault condition of the wiring within the wall, the installed switches and outlets, and the equipment plugged in. AFCIs are required in all living spaces except where GFCIs are required. I recommend a licensed electrician evaluate and repair as needed.

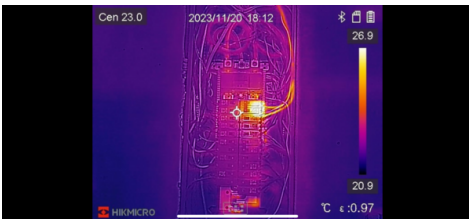
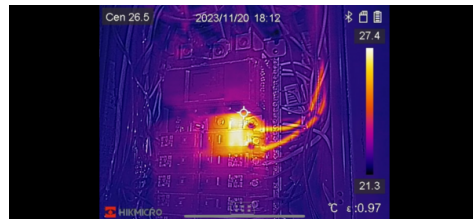
Subpanel Breaker

3.1.2 A. Service Entrance and Panels **BREAKER- HOT/ OVERHEATING**

During the inspection, one or more circuit breakers were observed to be hot/ overheating. A hot breaker is a serious concern as it may indicate issues such as overloading, poor connections, or potential electrical faults. This may cause the breaker to fail and could cause a fire in the future. This situation poses a significant fire hazard and requires immediate attention from a qualified electrician. I recommend a licensed electrician evaluate and repair as needed.

Contact a qualified electrical contractor.

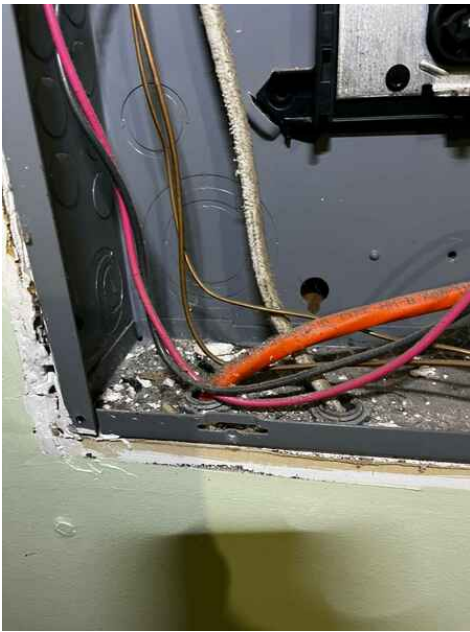
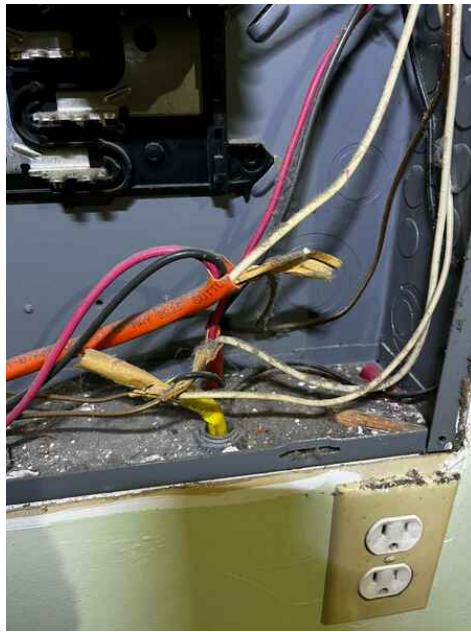
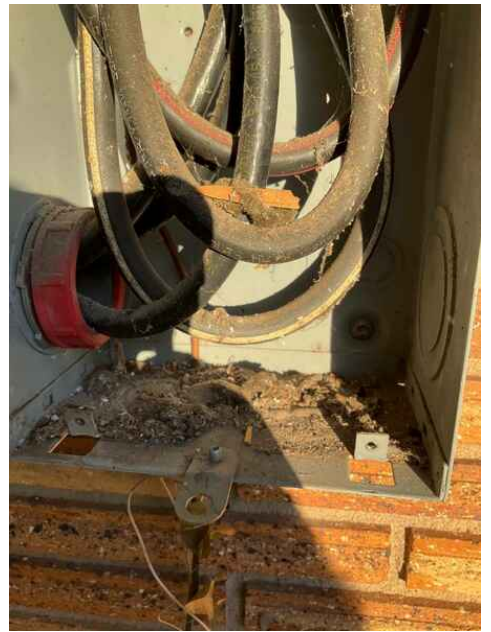
3.1.3 A. Service Entrance and Panels **DEBRIS IN PANEL**

Debris was observed in one or more electrical panels. Debris in the electrical panel can include dust, dirt, cobwebs, loose wires, or any foreign materials that have made their way inside the panel. Debris in the electrical panel can include dust, dirt, cobwebs, loose wires, critters, or any foreign materials that have made their way inside the panel. I recommend a licensed electrical contractor evaluate and remove all debris from inside the panel.

Contact a qualified professional.

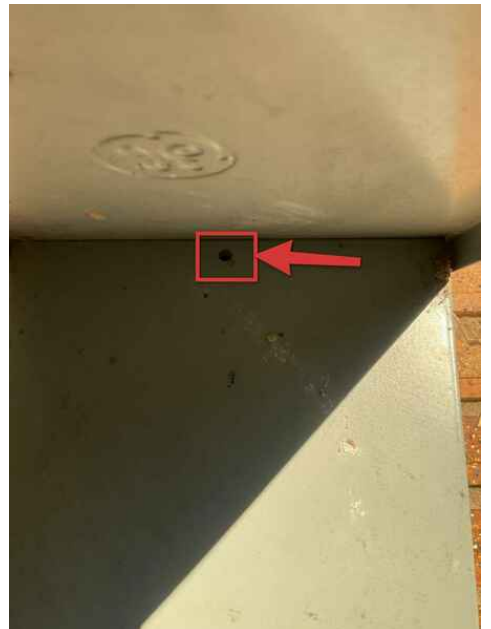
Main Panel

MISSING PANEL SCREWS

The panel is missing cover screws for the front cover. This is a safety issue that needs correcting. I recommend a qualified electrician be consulted for further evaluation and repair.

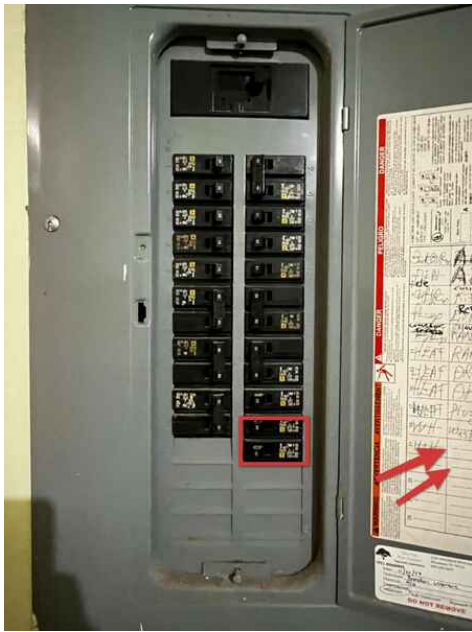
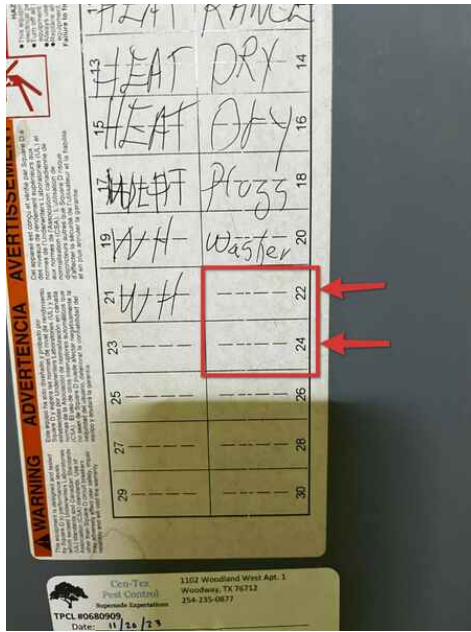
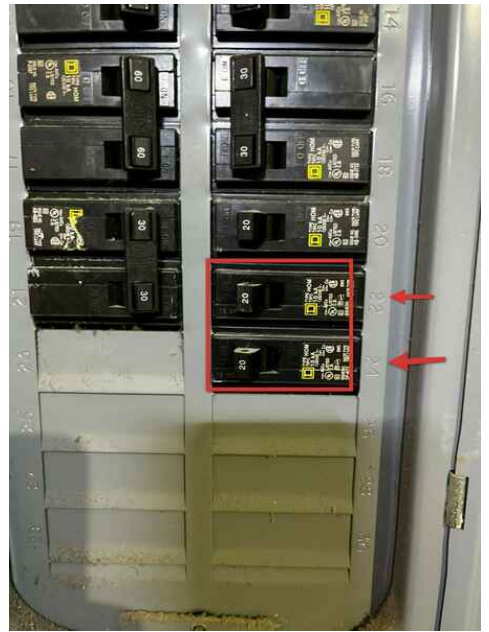
The electrical panel is not properly labeled. Labeling an electrical panel is an important safety measure that helps identify and organize the various circuits and breakers within the panel. Proper labeling makes it easier for electricians, homeowners, or building occupants to identify specific circuits for maintenance, troubleshooting, or emergency situations. I recommend a licensed electrical contractor evaluate and label panels correctly.
