SUMMARY
1234 Main Street Waco TX 76712
Buyer Name
01/26/2024 9:00AM

Jose Caraballo
TREC #25913
Rook Home Inspections LLC
(254) 856-3371
rookinpections@gmail.com

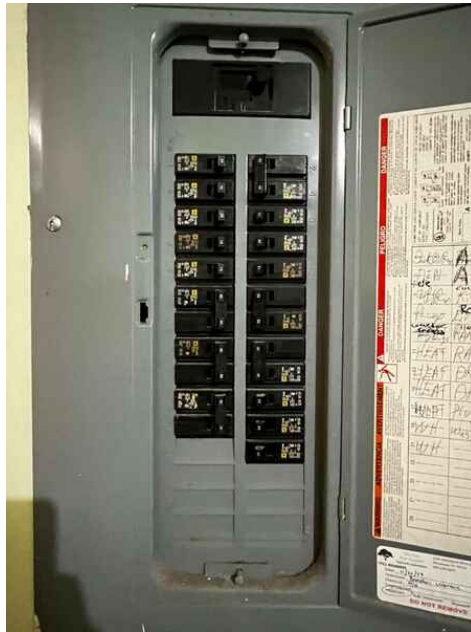
Subpanel

SURGE PROTECTOR MISSING

During the inspection, it was observed that there was a missing surge protector in the electrical panel. Surge protectors play a crucial role in safeguarding electronic devices and appliances from voltage spikes, helping prevent potential damage caused by power surges. The absence of a surge protector increases the vulnerability of sensitive electronic equipment to fluctuations in the electrical supply, which may occur due to lightning strikes, utility grid issues, or other electrical disturbances. I recommend a qualified electrician be consulted for further evaluation and repair.

Recommendation
Contact a qualified professional.

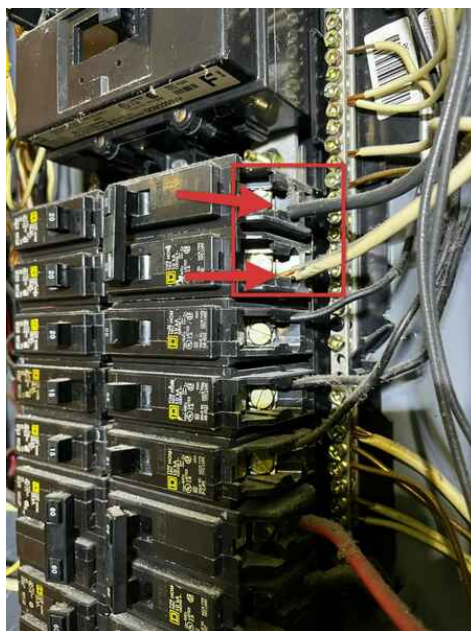
Subpanel

During the inspection, it was observed that oversized wires were connected to a breaker in the electrical panel. The use of oversized wires can pose significant safety risks, potentially leading to overheating, damage to the electrical panel, and increased fire hazards.

Recommendation
Contact a qualified professional.

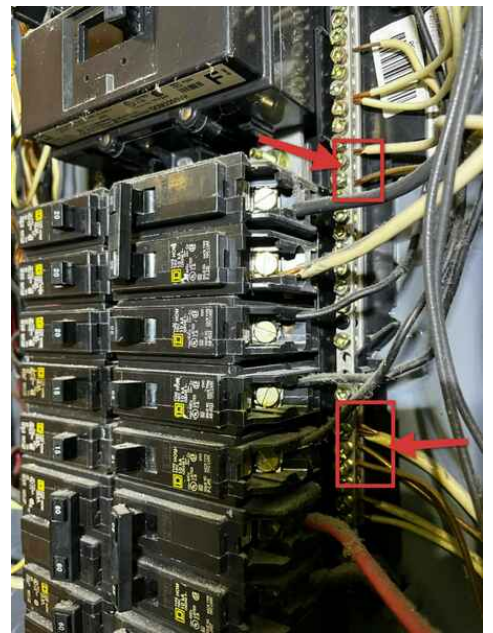
Subpanel

The electrical sub-panel was observed to have neutral and ground wires on the same bus bar. Combining neutral and ground wires on the same bus bar in an electrical sub-panel raises concerns about proper grounding practices and potential safety hazards. The neutral and ground wires serve distinct purposes in an electrical system, and keeping them separate is essential for maintaining a safe and effective electrical installation. The neutral wire returns the current from the electrical load to the source, typically the utility transformer. On the other hand, the ground wire is a safety feature that provides a path for fault currents to safely flow into the ground, preventing electrical shock hazards. I recommend a licensed electrician evaluate and repair the deficiency as needed.

Contact a qualified electrical contractor.

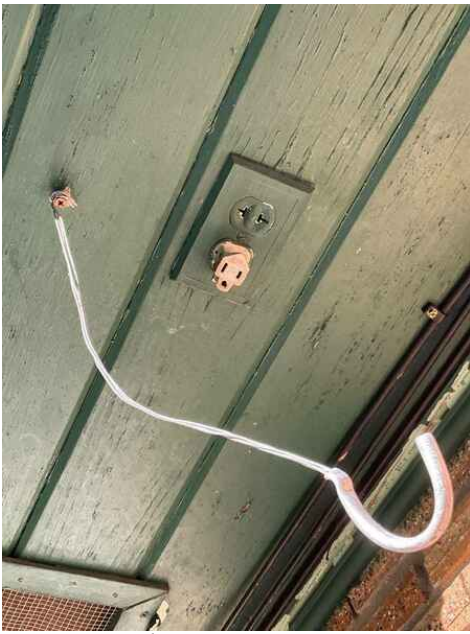
West- Outside

GFCI MISSING

Ground Fault Circuit Interrupter (GFCI) breakers are missing in the service panel. GFCIs are intended to protect personnel from shock during a ground fault. GFCIs are required in receptacles where water is present such as kitchen countertops, bathrooms, garages, laundry rooms, unfinished basements, unfinished detached buildings, crawlspaces, and outdoors. GFCIs are not required in locations that have an Arc Fault Circuit Interrupter (AFCI) already. I recommend a licensed electrician evaluate and repair as needed.

Contact a qualified professional.

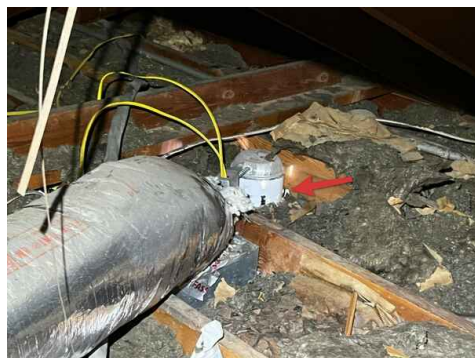
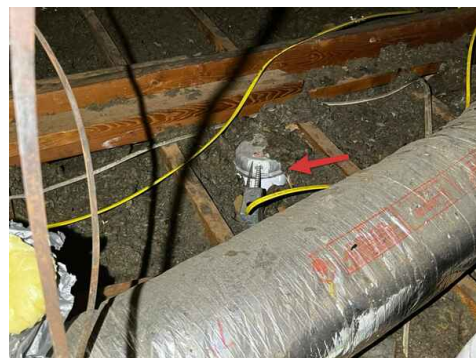
Light Fixture

There is a light fixture that is in contact with insulation in areas of the attic. I am unable to determine if the light fixture is rated to be in contact with insulation. I recommend a qualified contractor be consulted for further evaluation and repair as needed.

Recommendation
Contact a qualified professional.

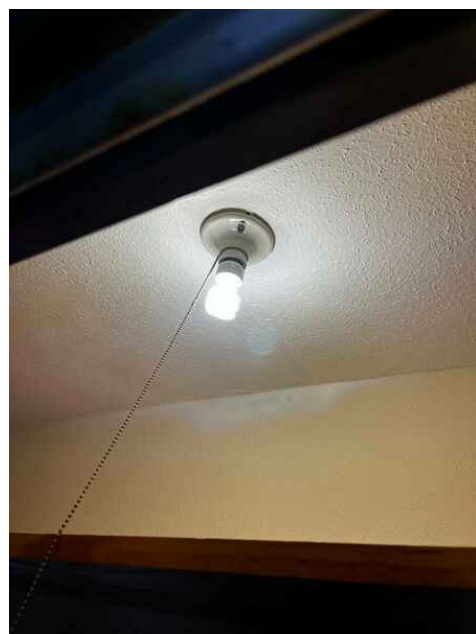
Closet Light

LIGHT FIXTURE COVER MISSING

Recommendation
Contact a qualified professional.

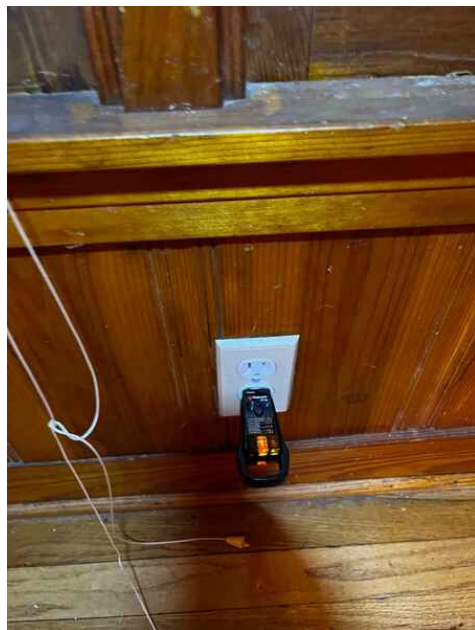
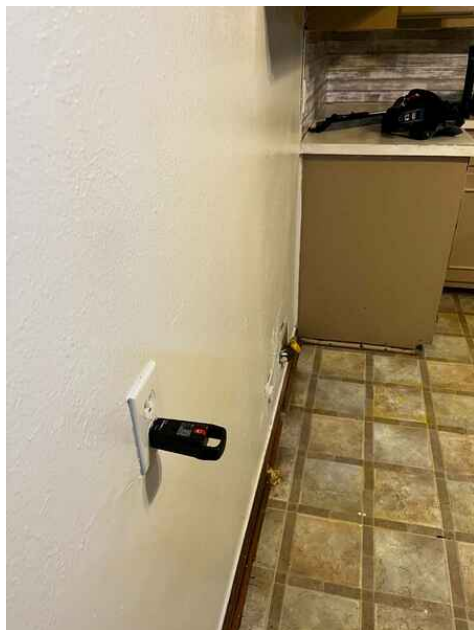
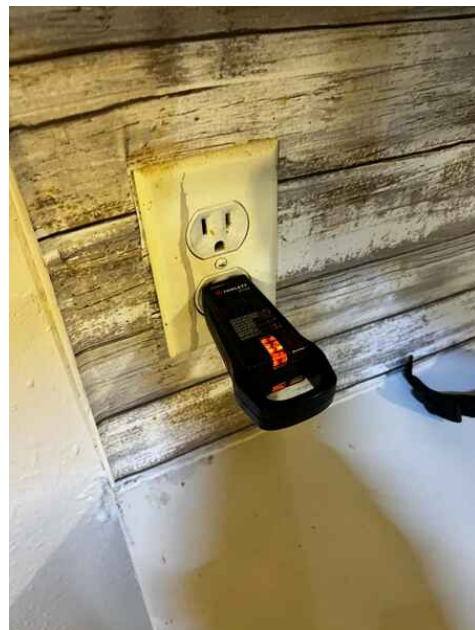
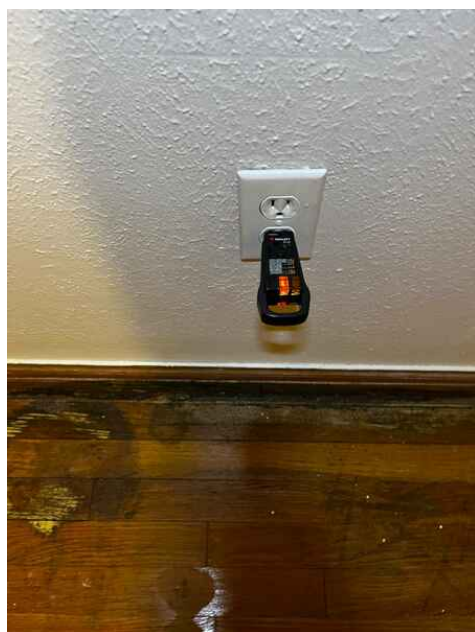
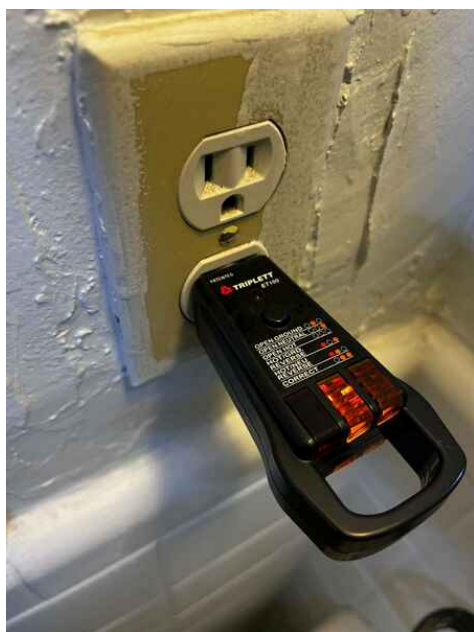
RECEPTACLE- COVER PLATES DAMAGED

Some outlets have a damaged cover plate in some areas. I recommend replacing it with a new cover plate.

Contact a qualified electrical contractor.

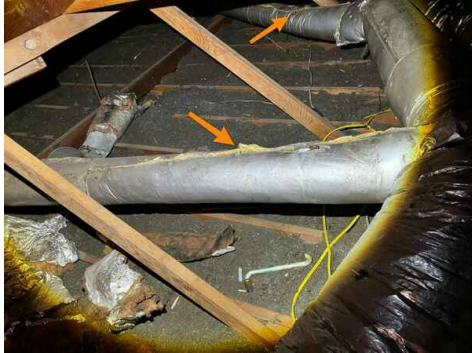
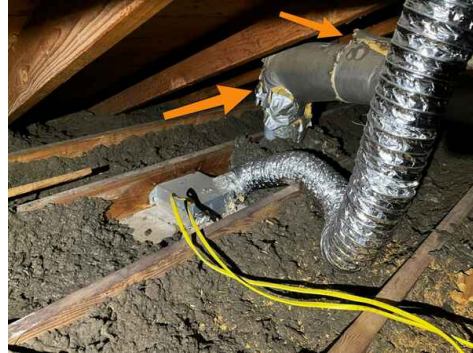
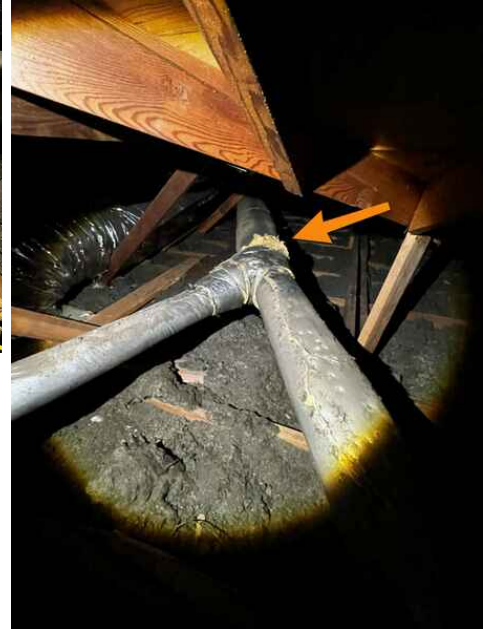
Ductwork

ATTIC
One or more of the insulated ducts were observed to be damaged and/or not properly sealed at the time of this inspection. This issue can lead to uneven heating or cooling, increased energy consumption, and reduced overall system effectiveness. Additionally, damaged ducts may contribute to the infiltration of contaminants, affecting indoor air quality. I recommend further evaluation and repair as needed to ensure optimum efficiency.

Recommendation
Contact a qualified HVAC professional.

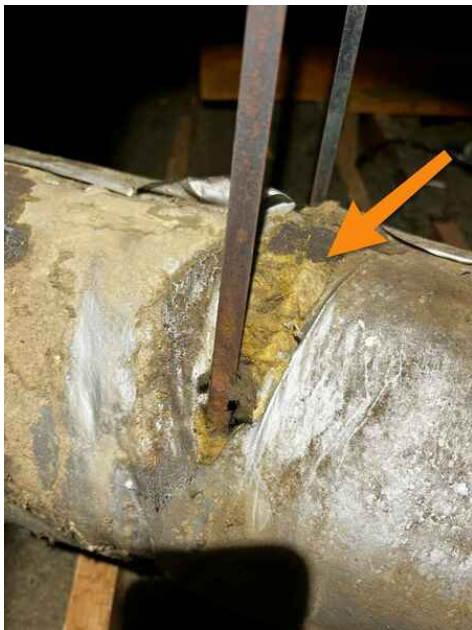
Ductwork

DUCTWORK DAMAGED

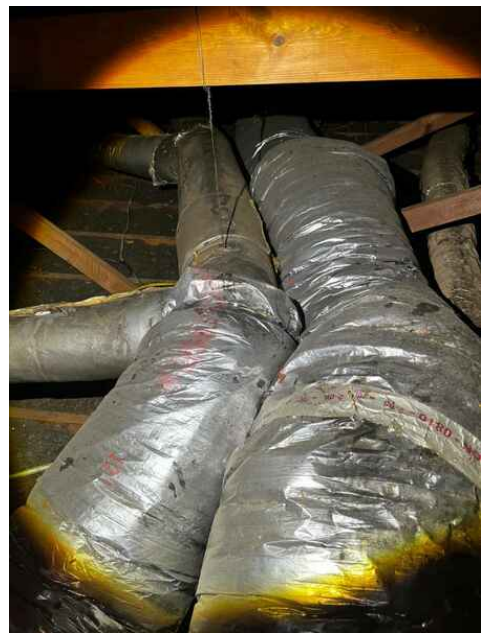
Ductwork

During the inspection, one or more ductwork were touching. Properly spaced and supported ductwork is essential for maintaining optimal airflow, reducing energy consumption, and prolonging the lifespan of the HVAC system. Neglecting to address ductwork contact may lead to increased operational costs, reduced system efficiency, the development of condensation, and potential discomfort for occupants. I recommend a licensed HVAC technician be consulted for further evaluation and repair.

Contact a qualified HVAC professional.

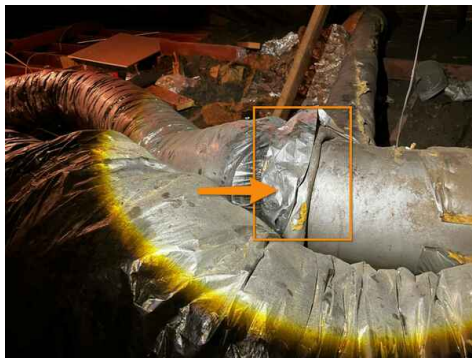
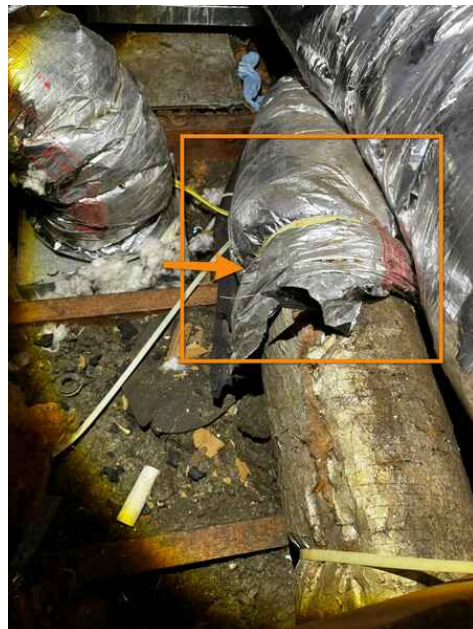
Attic

During the inspection of the ductwork in the attic, it was observed that one or more components were improperly installed. Common problems associated with improperly installed ductwork include air leaks, inadequate insulation, or improper connections. These issues can lead to uneven heating or cooling, increased energy consumption, and reduced overall system effectiveness. Additionally, poorly installed ducts may contribute to the infiltration of contaminants, affecting indoor air quality. I recommend a licensed HVAC contractor evaluate and repair as needed.

Contact a qualified HVAC professional.

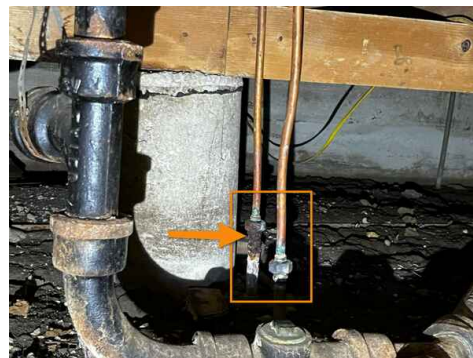
Crawlspace- Copper Pipe

GALVANIC CORROSION OBSERVED

Galvanic corrosion was observed in one or more areas. Galvanic corrosion, also known as bimetallic corrosion or dissimilar metal corrosion, is an electrochemical process that occurs when two different metals are in contact with each other in the presence of an electrolyte (such as water or moisture). Galvanic corrosion can lead to structural damage and reduced functionality in metal components, especially in marine environments or when dissimilar metals are used together in plumbing systems or construction applications. I recommend a licensed plumbing contractor evaluate and repair as needed.

Recommendation
Contact a qualified plumbing contractor.

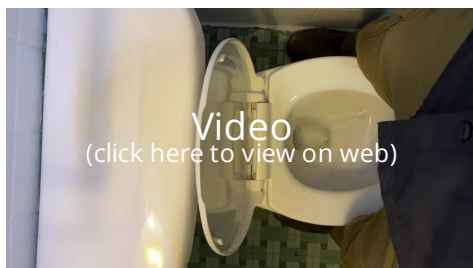
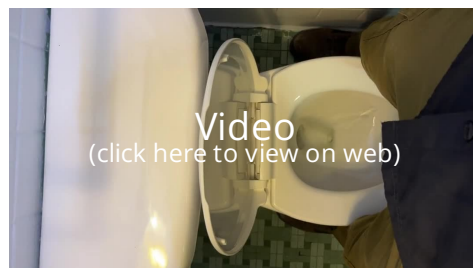
5.1.2 A. Plumbing Supply, Distribution Systems, and Fixtures **TOILET LOOSE**

During the inspection, one or more toilets were observed to be loose. A loose toilet is a notable concern that requires attention to prevent potential issues such as leaks, instability, and damage to the flooring. A securely anchored toilet is essential for proper functioning and to avoid water leaks, which can lead to more extensive damage over time. The looseness may be attributed to issues with the toilet bolts, wax ring, or the flooring beneath. I recommend a qualified contractor be consulted for further evaluation and repair.

Recommendation
Contact a qualified plumbing contractor.

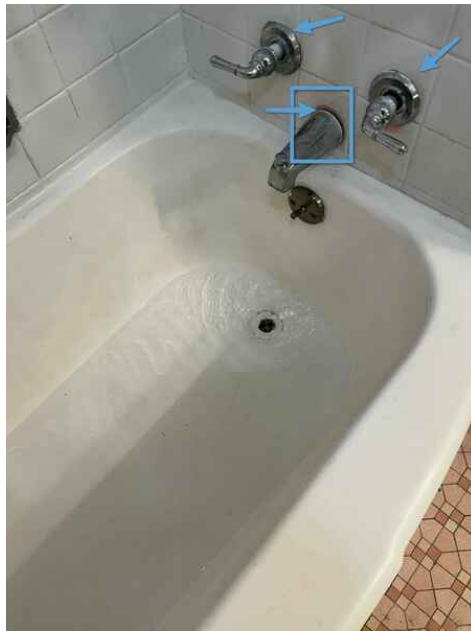
Bathroom

CAULK/ GROUT MISSING

During the inspection, one or more areas were observed to be missing caulk/ grout. Adequate caulking/ grouting plays a crucial role in maintaining the integrity of the building envelope, preventing water intrusion, and ensuring energy efficiency. The absence of caulking can lead to various issues, including air leaks, moisture penetration, and potential damage to structural components. I recommend a qualified professional contractor evaluate and repair as needed.

Recommendation
Contact a qualified professional.

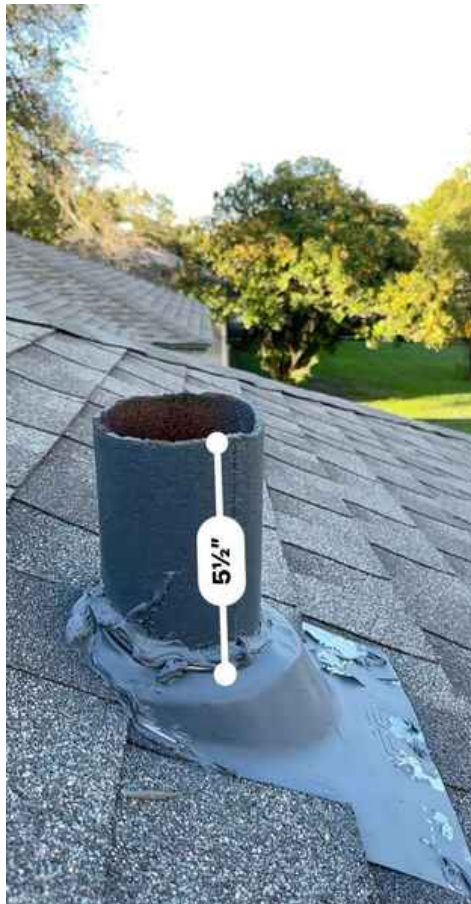
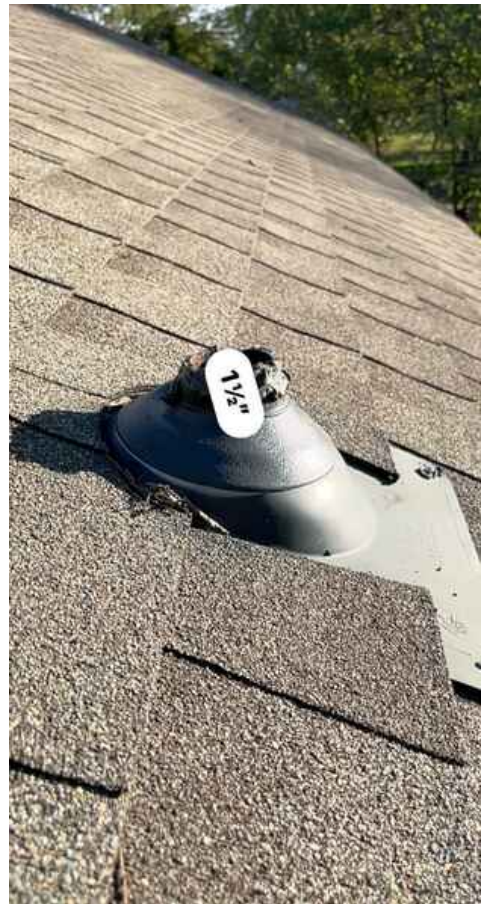
Vent Stack

5.2.1 B. Drains, Wastes, and Vents
PLUMBING STACK TOO SHORT

One or more of the plumbing stacks do not appear to extend to the proper height above the rooftop. Plumbing stacks that penetrate the roof should extend at least 6 inches above the roof structure. I recommend I licensed roofer evaluate and repair as needed.

Recommendation
Contact a qualified professional.

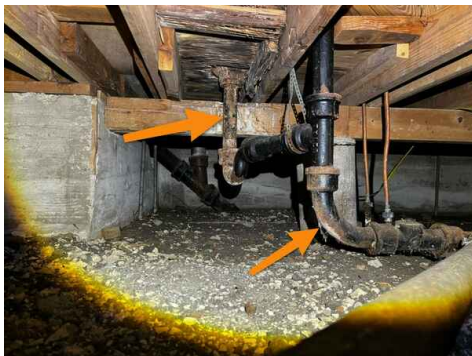
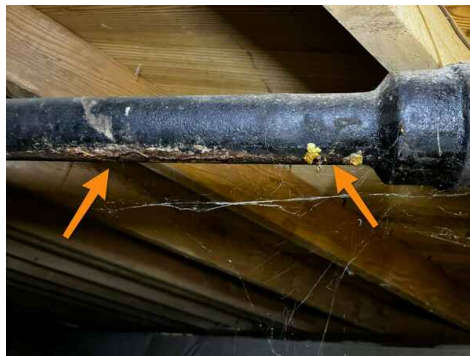
DWV Pipe

DWV PIPE CORRODED

During the inspection, it was noted that the DWV (Drain, Waste, Vent) pipe is exhibiting signs of corrosion. Corrosion on DWV pipes is a concerning issue that can compromise the integrity and functionality of the plumbing system. Corroded pipes may lead to leaks, blockages, or reduced drainage efficiency, posing potential water damage risks and impacting the overall plumbing performance. I recommend a licensed plumbing professional evaluate and repair as needed.

Recommendation
Contact a qualified plumbing contractor.

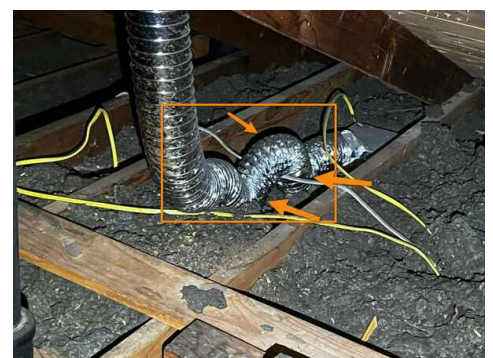
Exhaust Vent

During the inspection, it was observed that the bathroom exhaust vent features bends in its configuration. Proper venting is essential to ensure the effective removal of moisture and odors from the bathroom, contributing to indoor air quality and preventing potential issues such as mold growth. While some bends in the exhaust vent are acceptable, excessive or improperly angled bends can hinder the vent's efficiency. I recommend a qualified professional evaluate and repair as needed.

Recommendation
Contact a qualified professional.

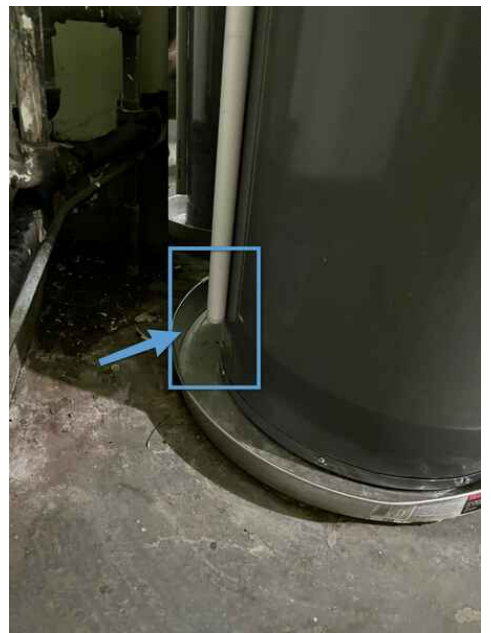
Garage- Water Heater TPR Valve

One or more of the temperature and pressure relief valve discharge pipes were terminated in a location that may cause damage or personal injury. It is recommended that the discharge pipe run downward to the exterior of the structure, turn downward, and terminate within 6- inches of the ground. I recommend a licensed plumber be consulted for further evaluation and repairs.

Contact a qualified plumbing contractor.

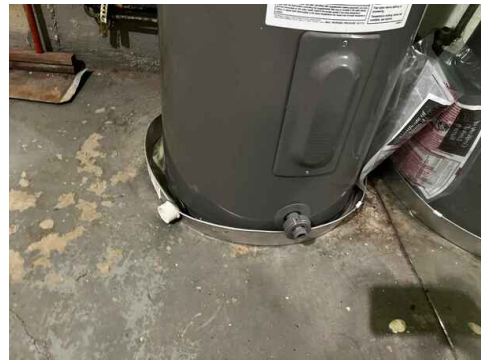
Garage- Water Heater Overflow Pan Discharge

During the inspection, the water heaters overflow pan was observed to discharge inside of the property. This could cause water to accumulate and cause damage to structural components of the property. It is recommended that the discharge be evacuated to the outside of the property. I recommend a qualified plumbing professional evaluate and repair as needed.

Contact a qualified plumbing contractor.

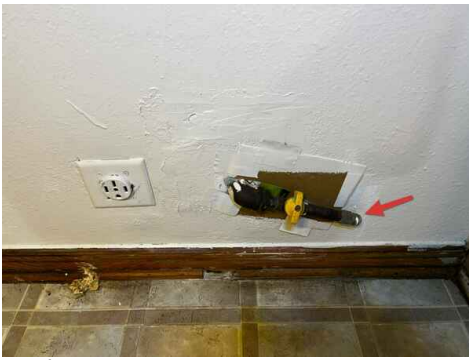
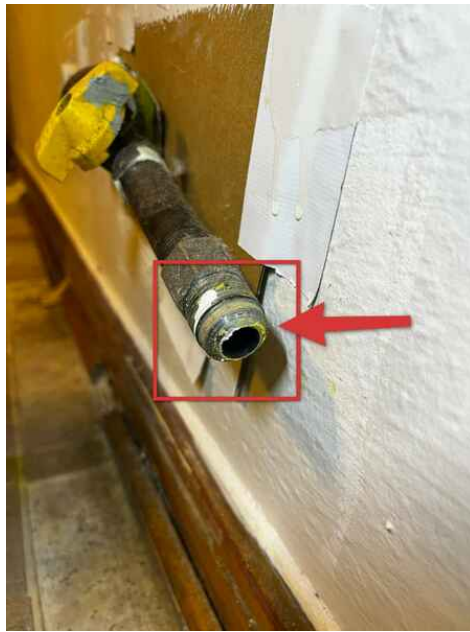
Kitchen- Gas Pipe

During the inspection, the gas distribution pipe was observed to not be capped. Though the gas shut-off lever was in the off position, this could still pose a possible safety concern. The area around the meter and the pipe was tested using a gas detection meter and it was determined that there was no concern at the time. I recommend a certified plumbing professional evaluate and cap the gas pipe as soon as possible.

Contact a qualified professional.

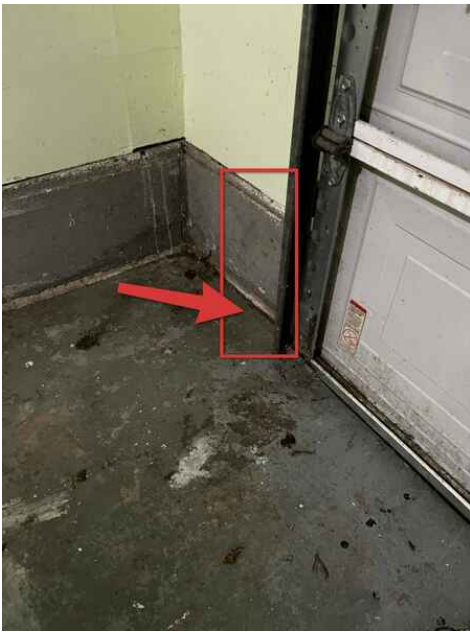
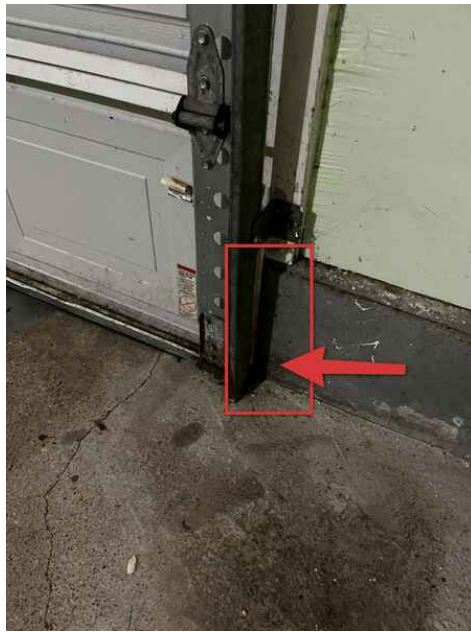
Garage

SAFETY REVERSING SENSORS MISSING

No safety reversing sensors were observed at the time of inspection. Photo sensors should be placed on either side of the garage door opening and at a height of at least 6 inches from the surface of the floor. This is a safety issue that needs correcting. I recommend a qualified contractor be consulted for installing needed safety sensors.

Contact a qualified professional.

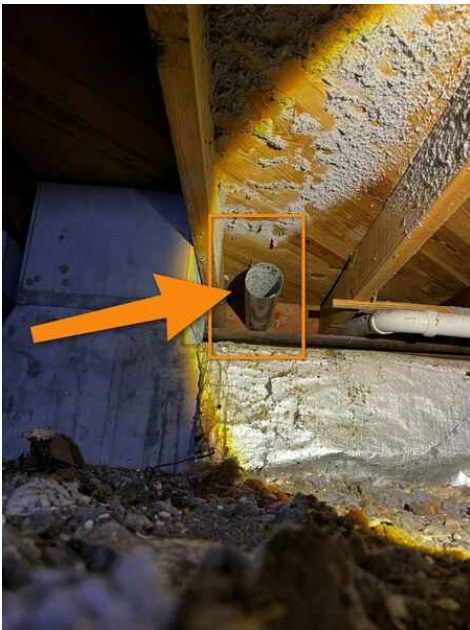
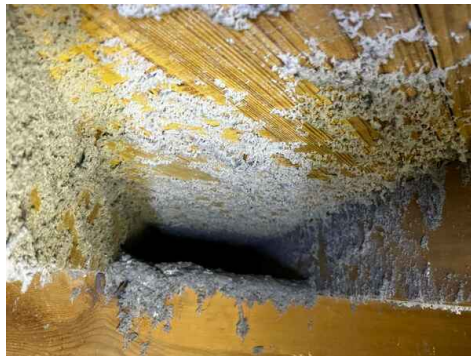
North Crawlspace

IMPROPER VENTING

Dryer vent is not terminating to the exterior, which can cause inefficient venting and/or a fire hazard. Recommend a qualified HVAC contractor or handyman vent to exterior.

Contact a qualified HVAC professional.
